SQ-3069  
SQ-3069

IN-SHUCK-CH 65km

2022 Inspection

Crossing Name 12 Mile Creek

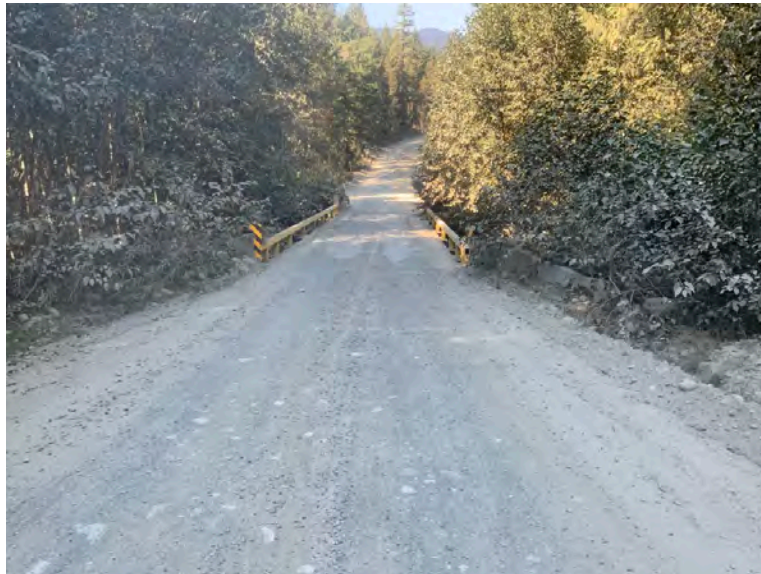
Approach from Left Bank when facing downstream

Bridge Ahead Signs  
Missing ☐ 0 ☒ 1 ☐ 2 Woods approach

| Repair Item | Repair Description |
|---|---|
| 1 Approach. Bridge Ahead<br>Signs. 1 # of signs.<br>Priority:Medium | Woods approach |

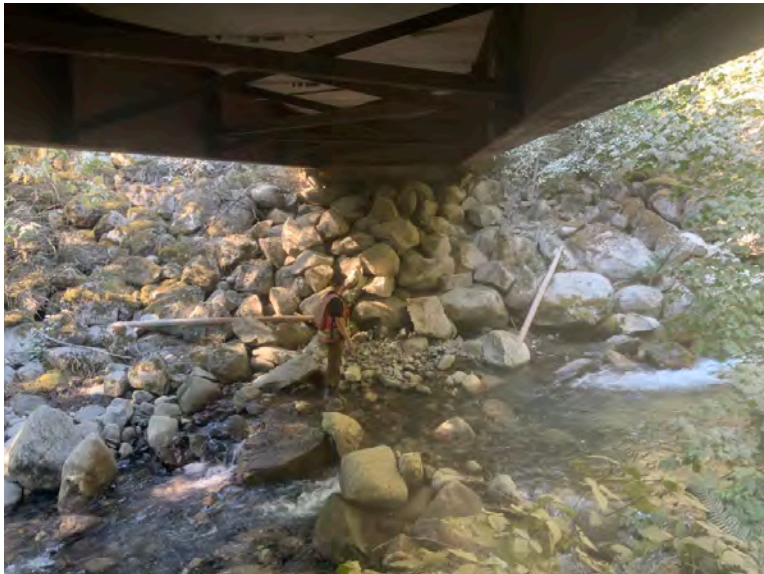
Right Bank Abutment when facing downstream

Riprap **Good** Monitor right bank for movement

| Item | Monitor Description | Frequency |
|---|---|---|
| 1 | Right bank riprap for movement | Routine Inspection |
