SQ-3070  
SQ-3070

## KAKILA CREEK 72km

2022 Inspection

Crossing Name Lower Lillooet River

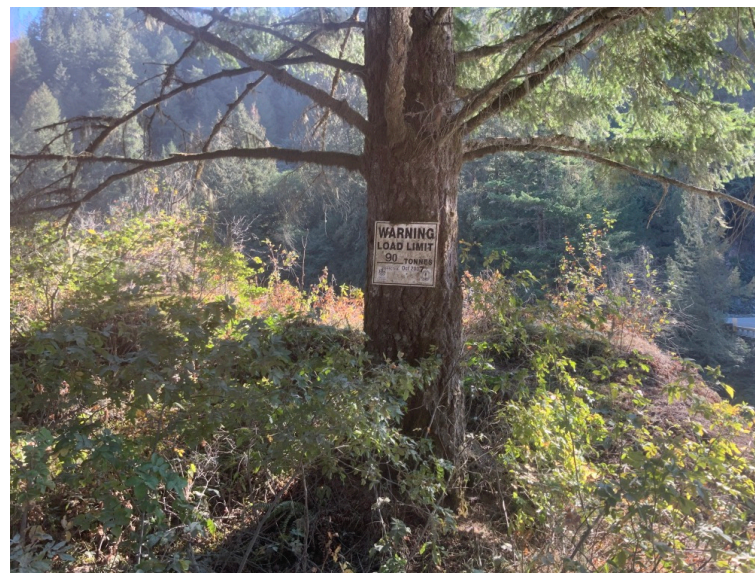
Load Rating Sign

Bridge Ahead Signs  
Missing ☐ 0 ☒ 1 ☐ 2 Town approach missing

| Repair Item | Repair Description |
|---|---|
| 1 Approach. Add Warning Signs. 2 # of signs. Priority:Medium | Re install approach sign and load rating on town approach. |

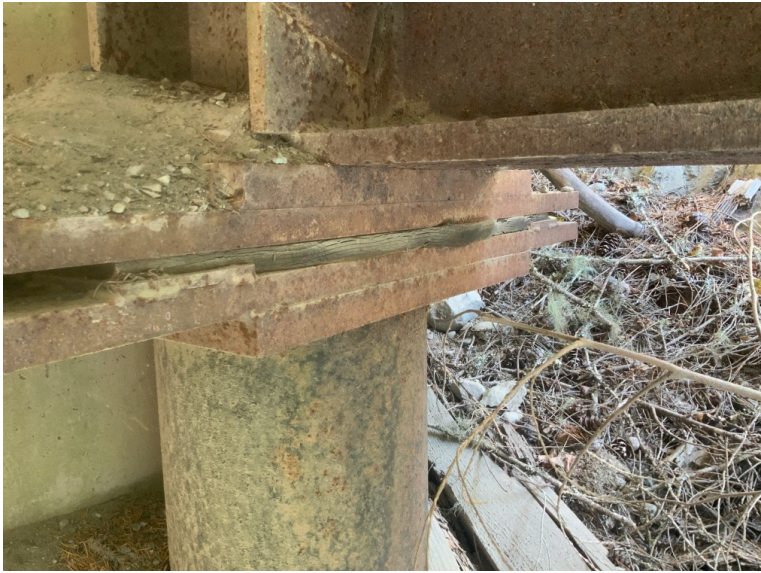
Bearing

Bearings Fair Bulging, cracking

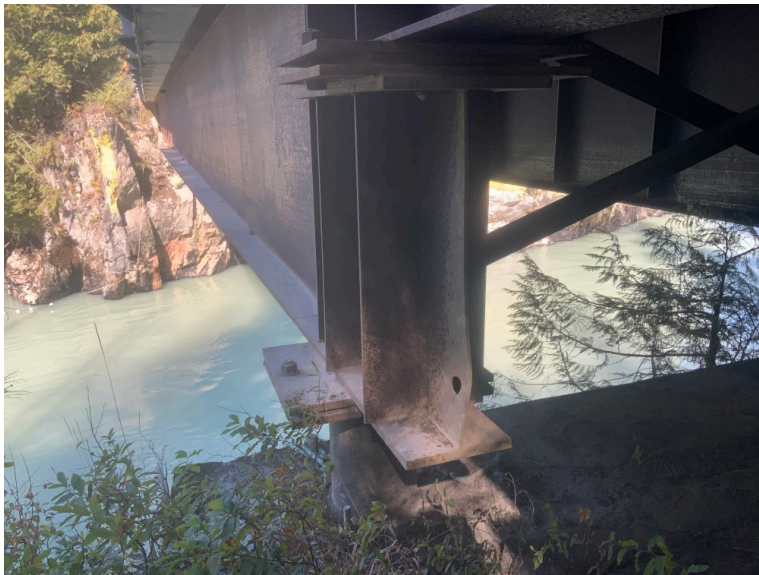
Deformation present at end of girders, where jumpspan is supported on left bank. Approximately 1-2cm out on both upstream and downstream side, where lifting hole is present. Check records to see if this is new... discuss re: structural impacts. Post inspection: nothing has changed and structurally this has no affect, per g.dohm

Jump span bearing. Ds. Deformation

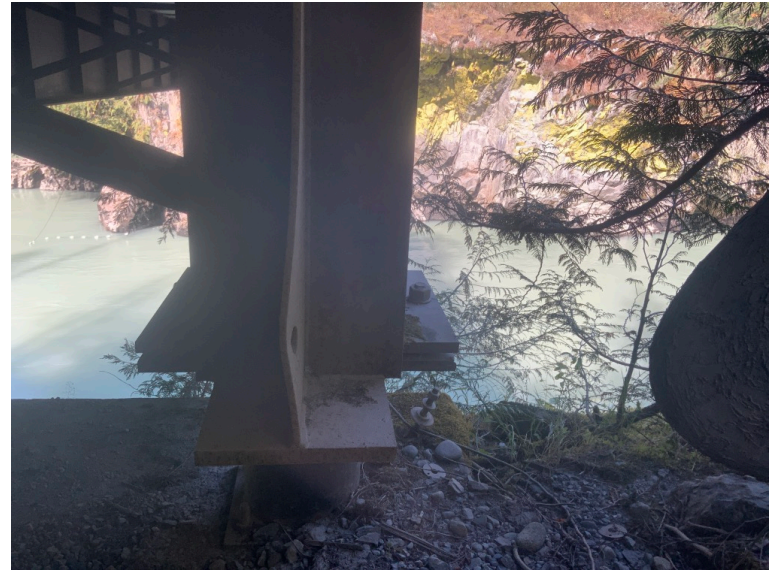
Jump span bearing. Upstream. Deformation
