SQ-3074  
SQ-3074

CHANCE CREEK 0.05km

2022 Inspection

Crossing Name Cheakamus River

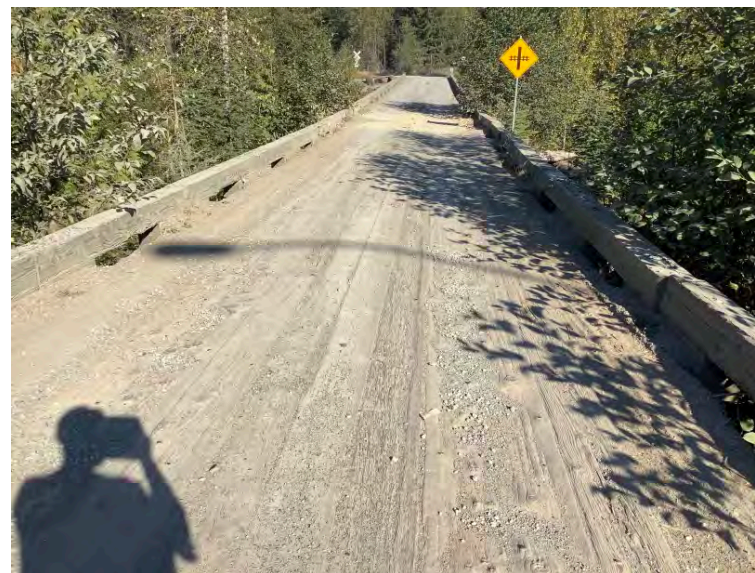
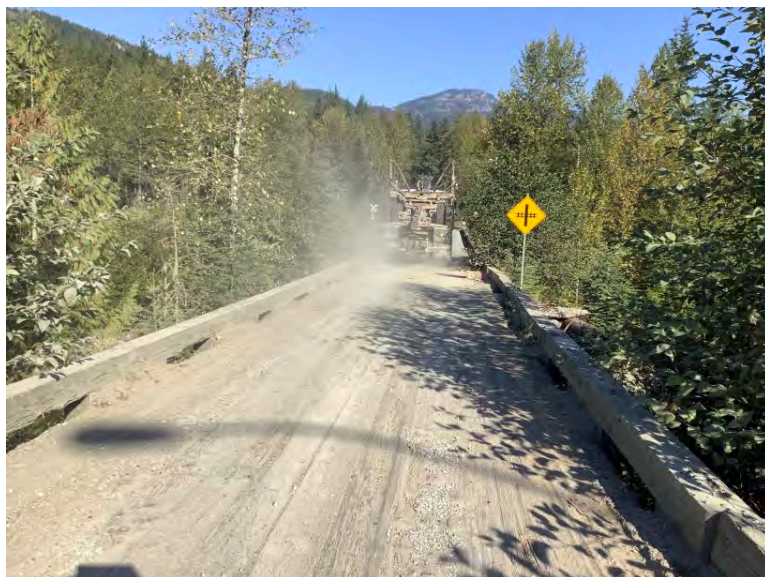
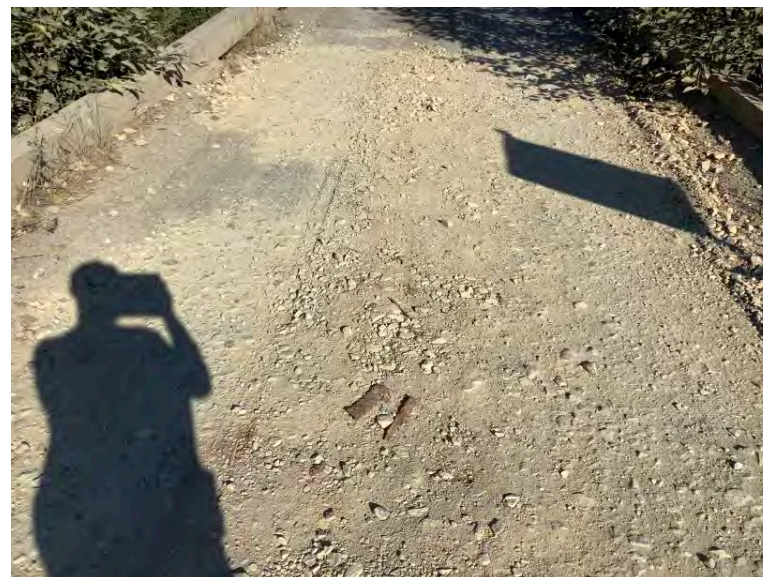
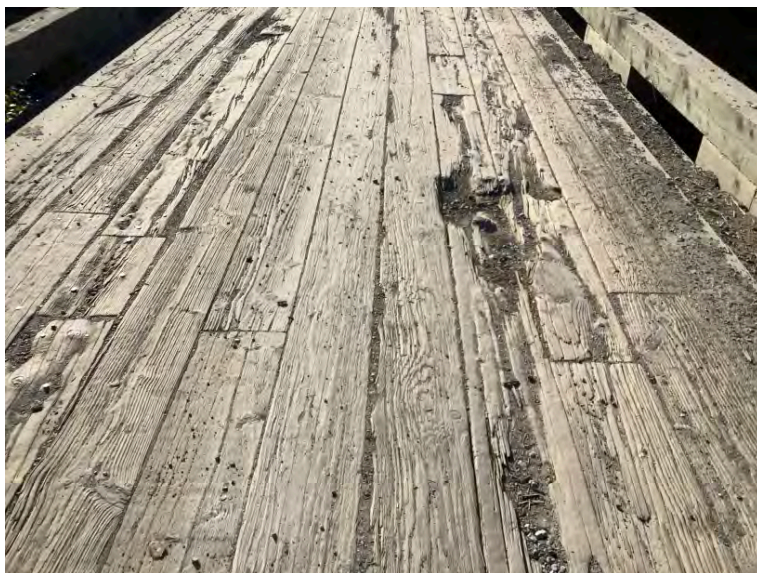
Deck

Running Planks      Poor      Starting to age and wear down in several locations. Likely to require replacement by next inspection.

| Repair Item | Repair Description |
|---|---|
| 3 Structure. Minor redecking (wearing surface). m.<br>Priority:Low | Plan to replace wear decking by 2024 |

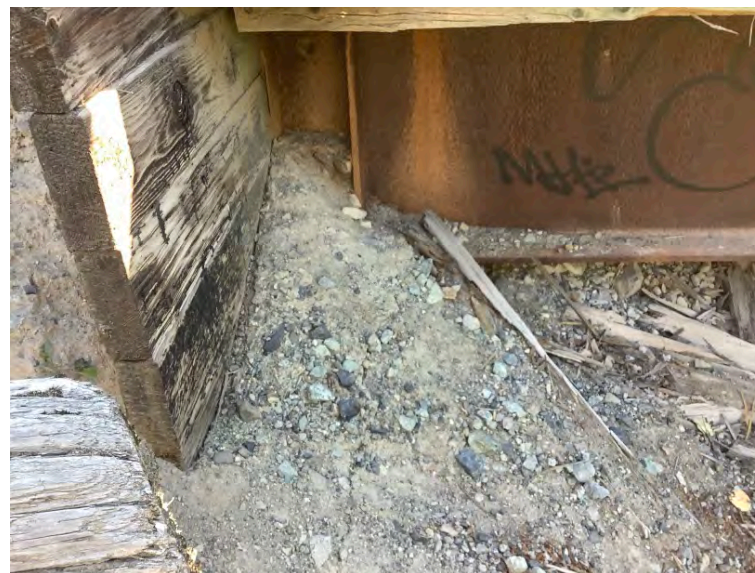
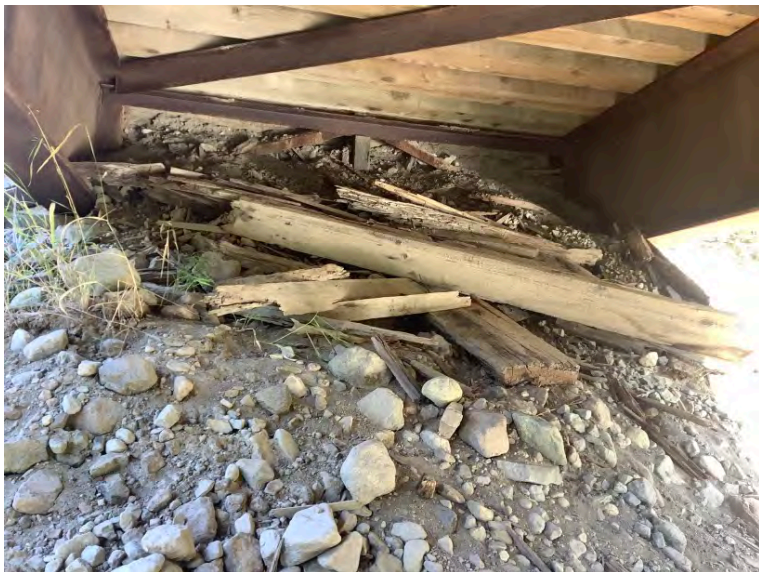
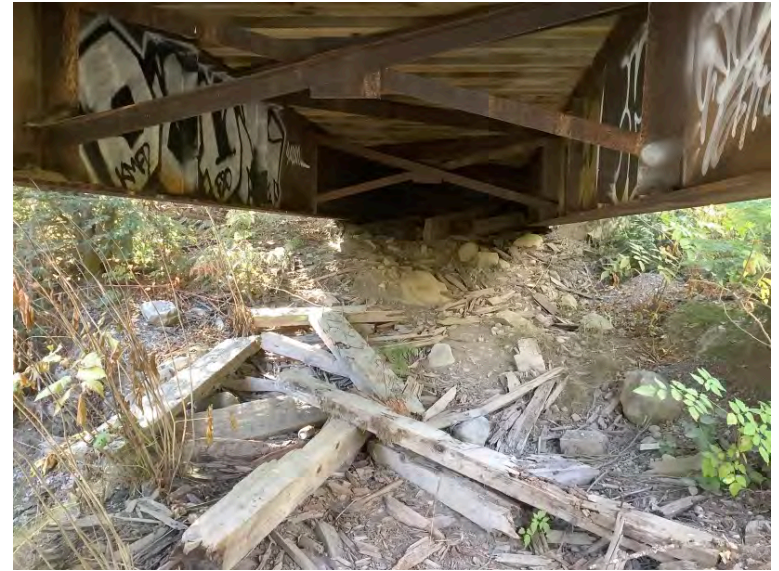
Bearings Fair

| Repair Item | Repair Description |
|---|---|
| 4 Structure. Bearing replacement. # of items.<br>Priority:Medium | Clean dirt from girder ends |

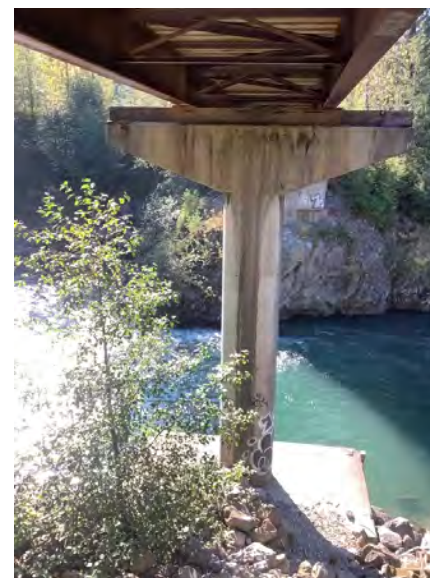
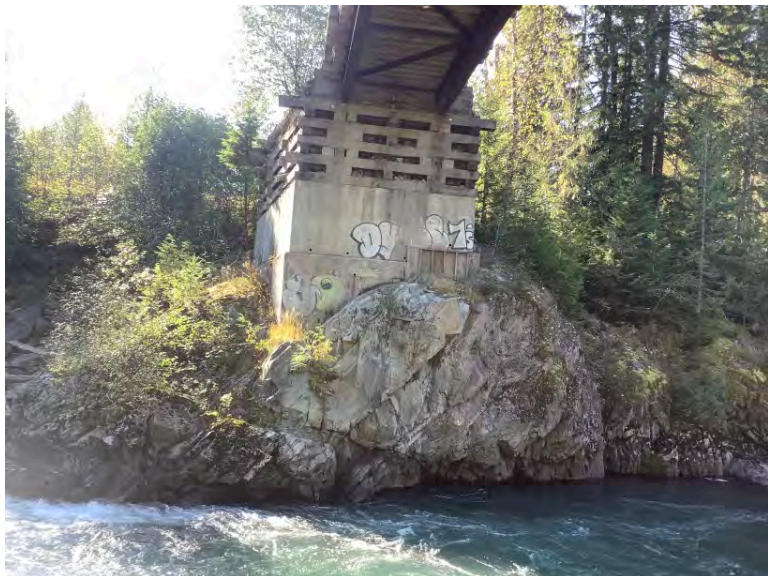
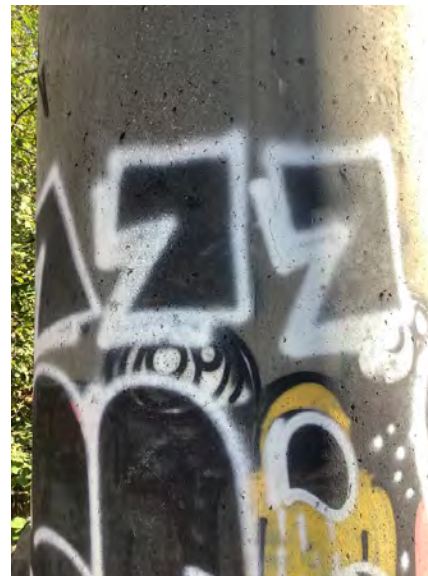
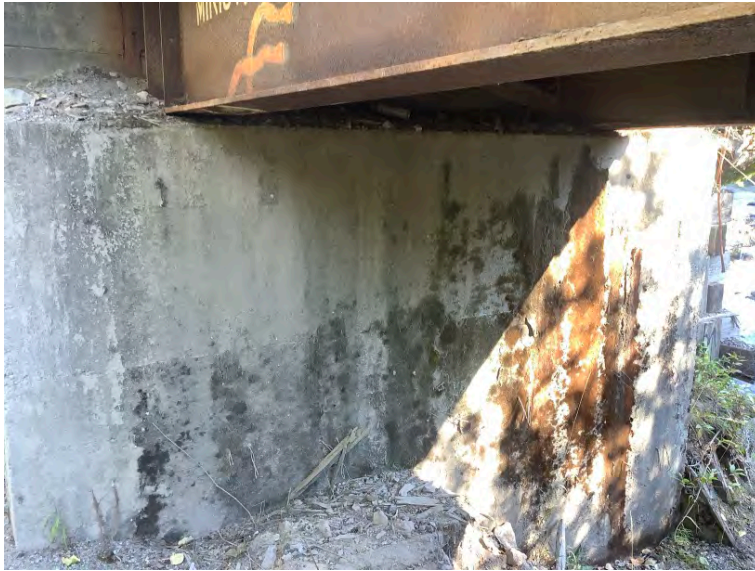
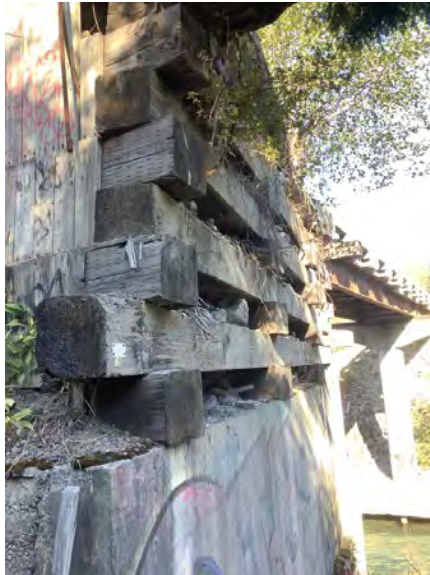
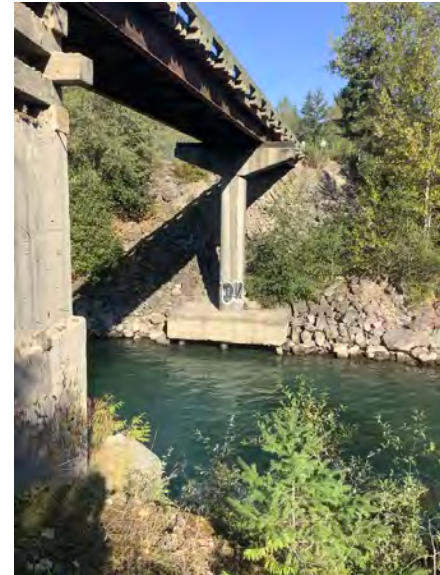
Pier

Recommend more frequent inspections given condition of pier 1 timbers.

Post inspection comments: discussed condition of pier 1 timbers and it is considered to be stable and not deteriorating rapidly.

Concrete Fair Unable to fully assess. Some cracking, present in pier 2.

Corrosion Protection Poor Suggest investigating options to coat piles in pier 2.

| Repair Item | Repair Description |
|---|---|
| 1 Substructure. Piling/pedestal maintenance. m².<br>Priority:Medium | Suggest coating piles below concrete pier 2 |
| 2 Substructure. Piling/pedestal replacement. # of items.<br>Priority:Medium | Suggest replacing pier 1 timbers by next inspection unless recent snooper results have proven favourable. Post Inspection: greg dohm reviewed with inspector and concluded pier condition is adequate and best approach is not monitor at routine inspections. In future can plan to replace pier with possible steel post columns on top of concrete pier. |
