SQ-3076  
SQ-3076A

SOO RIVER SOUTH 8.2km

2022 Inspection

Crossing Name Tributary to Soo

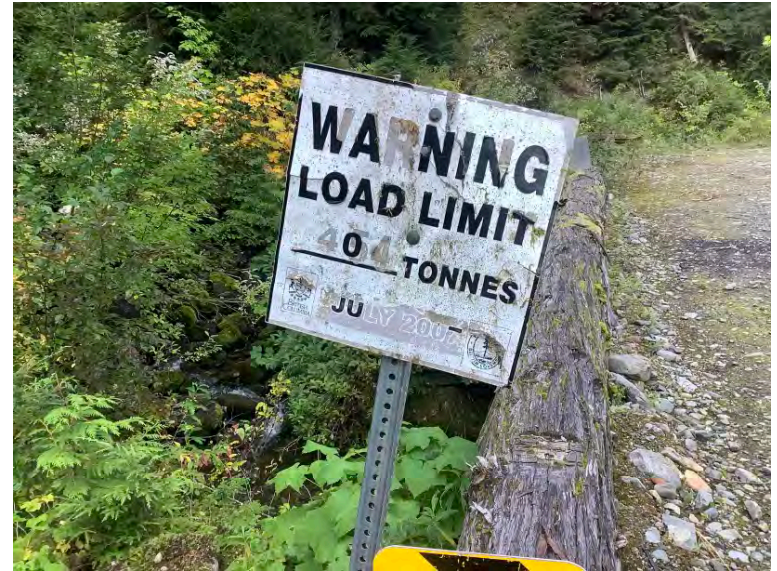
Load Rating Sign

Load Rating: BCL625 or 63 tonnes

Comments: Downrate to 63 tonnes based on my detailed information provided.

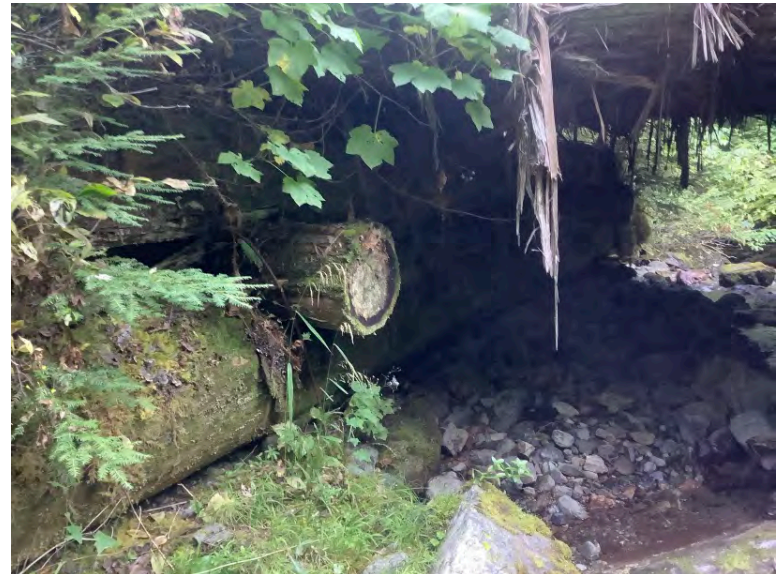
Left Bank Abutment when facing downstream

Log/Timber Cribbs **Poor** Old logs cribs in poor condition. Some undermining under both.

Caps or Sills **Good** Sills approximately 2m back from old cribs in good condition.

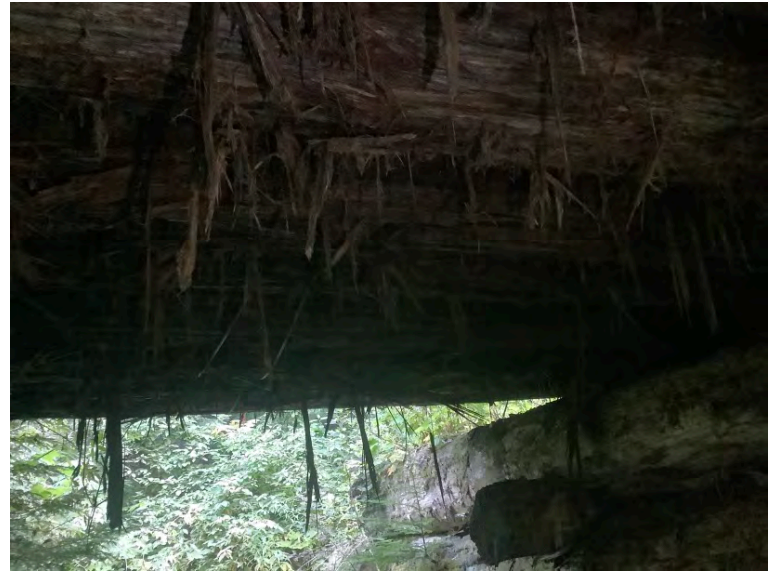
Stringers

No issues, well built superstructure.
