SQ-3078  
SQ-3078

RING CREEK NORTH 5.2km

2022 Inspection

Crossing Name Brandvold Creek

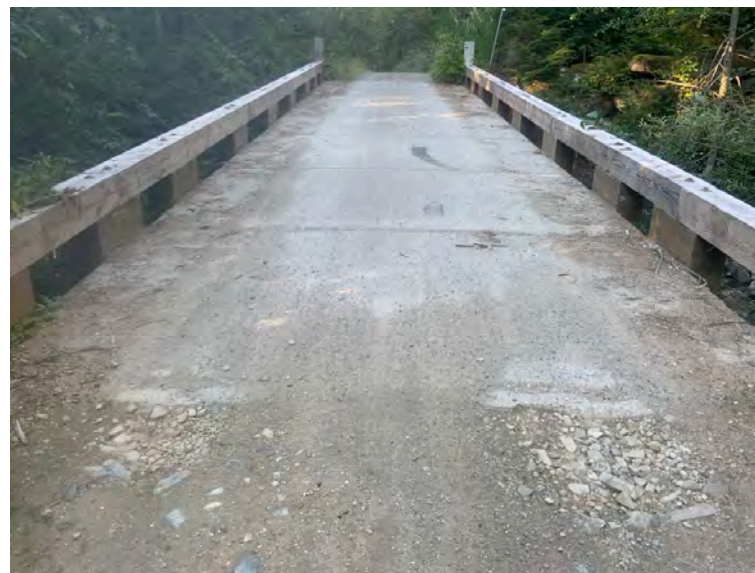
Concrete Deck      **Fair**      Minor damage

Deck Joints      **Fair**      No paraseal. Filled with dirt

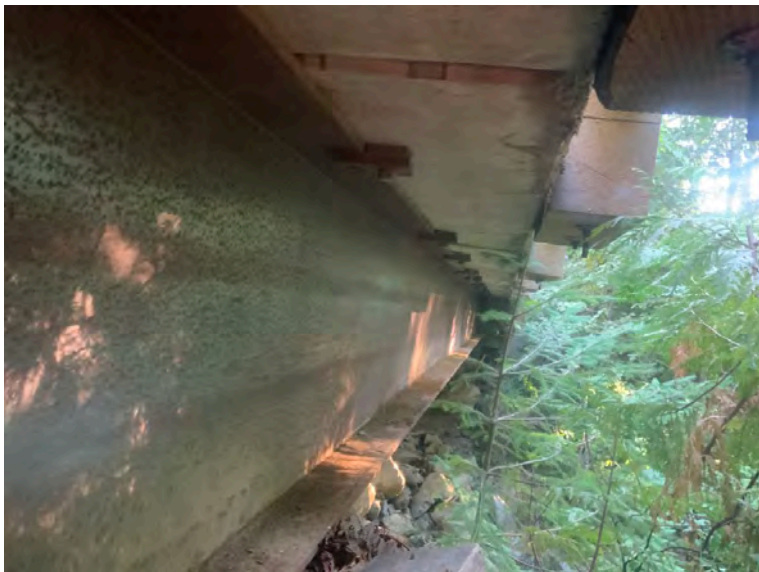
Deck clips

Deck to Girder Bolts      **Good**      Clips

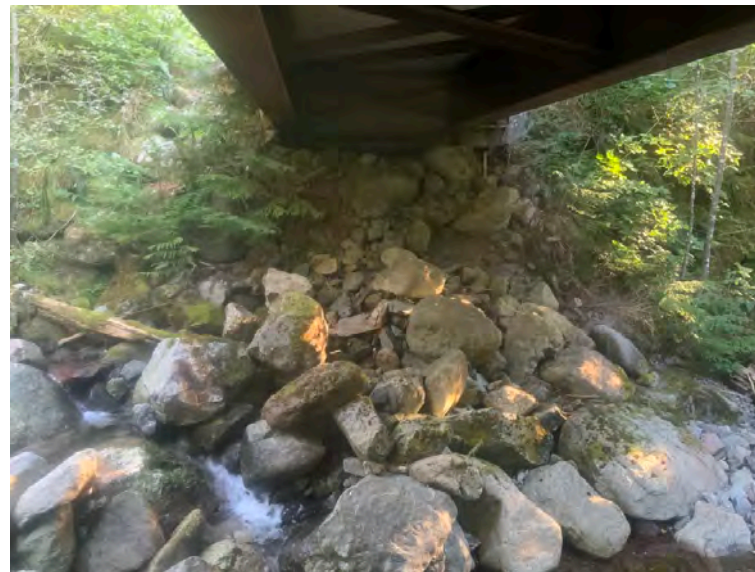
Left Bank Abutment when facing downstream

Riprap **Poor** **Left bank has shifted, fill exposed.**

Re-install riprap or reinspect after storm season.

| Repair Item | Repair Description |
|---|---|
| 2 Channel. Add Riprap (placed). m³. Priority:High | Re-install riprap left bank |

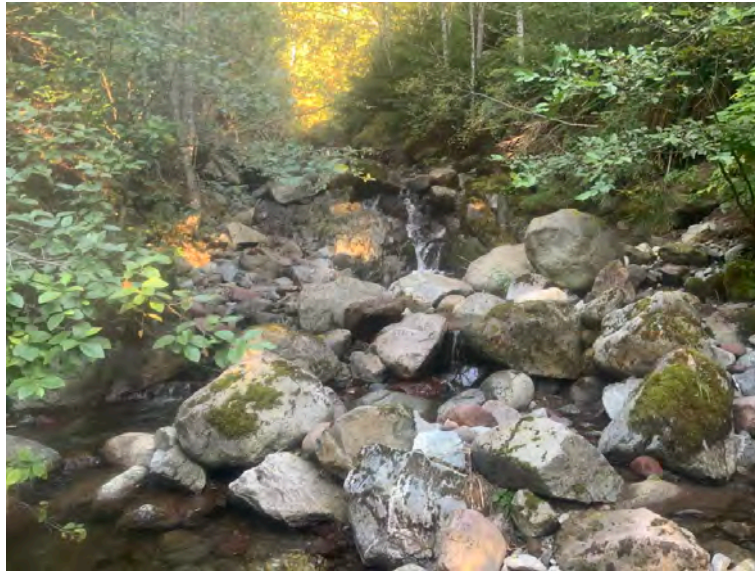
Upstream from Crossing

| Comments | Evidence of debris flow | | | | |
