SQ-3079  
SQ-3079

HURLEY 10.1km

2022 Inspection

Crossing Name Rail Road Creek

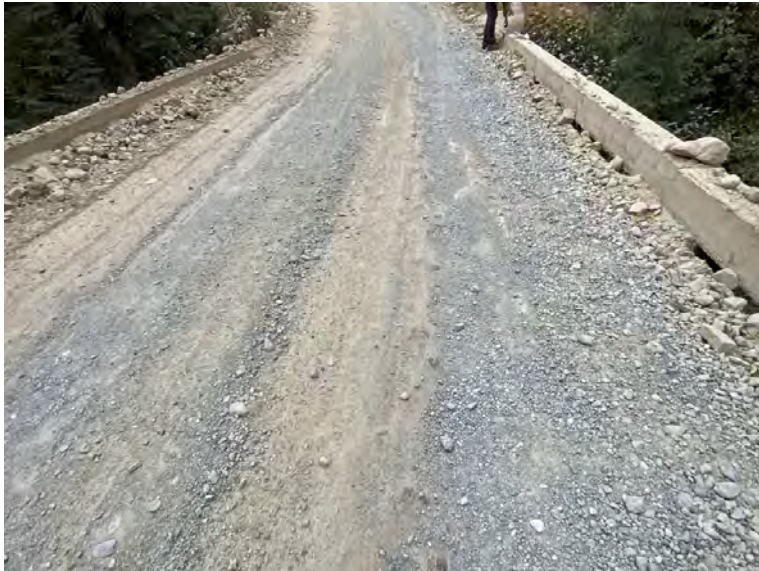
Running Surface Fair

Running Planks Fair

Worn running deck

| Repair Item | Repair Description |
|---|---|
| 1 Structure. Minor redecking (wearing surface). m. Priority:Medium | Will need to be replaced over next 2 years with guardrails. |

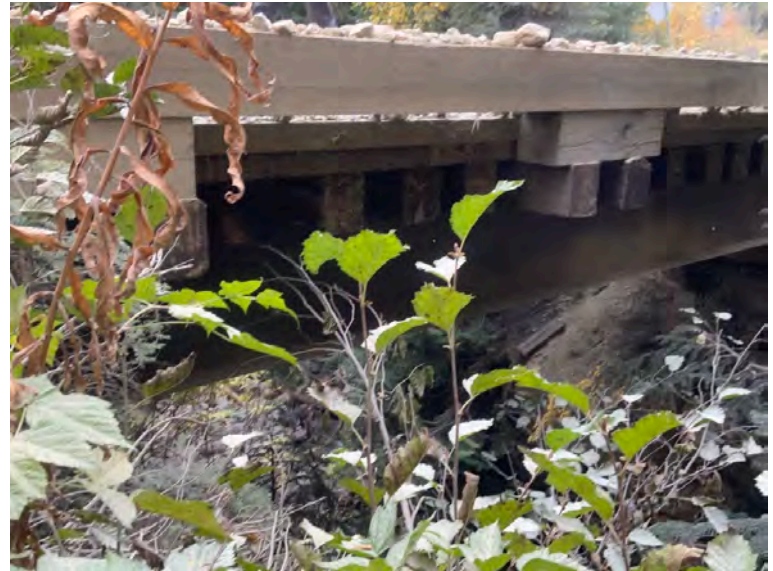
Deck

Curb Rail/Blocks/Posts Fair

Will need to be replaced in near future

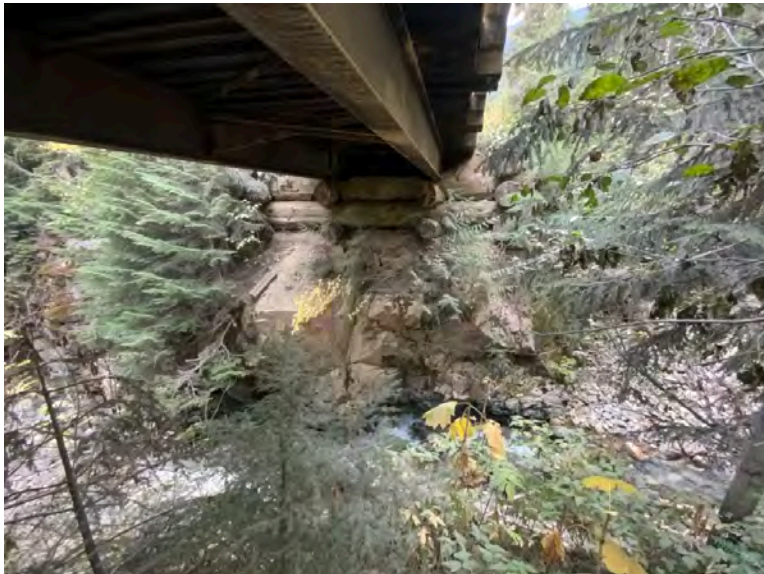
Right Bank Abutment when facing downstream

Log/Timber Cribs Fair 3 high cw both sides
