SQ-3085  
SQ-3085

LILLOOET SOUTH 01 10.3km

2022 Inspection

Crossing Name Trib to Lillooet River

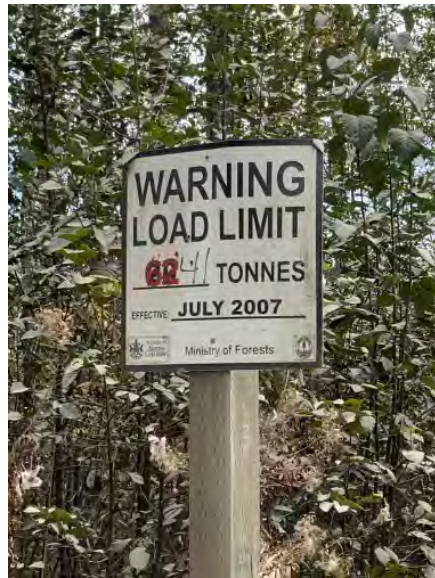
Load rating sign should be updated

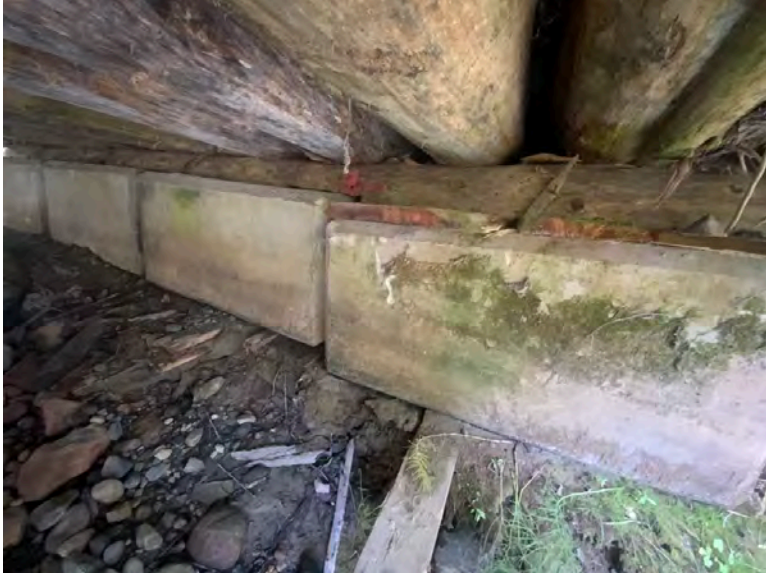
Concrete Poor Locbloks need to be on spread footings to prevent settlement on these soft soils

Comments Foundation at risk of erosion and settlement of locblock.

Shimmed locblock woods side due to block settlement

| Repair Item | Repair Description |
|---|---|
| 1 Substructure. Log crib/<br>spread footing/binwall<br>maintenance. # of sites.<br>Disturbance Medium | Add another row of blocks to left side to prevent collapse under poor foundation. |
| 2 Substructure. Log crib/<br>spread footing/binwall<br>maintenance. # of sites.<br>Disturbance Medium | Should add spread footing to both sides under blocks to prevent differential settlement. |
