SQ-3086  
SQ-3086

LILLOOET SOUTH 01 23.9km

2022 Inspection

Crossing Name Perkins Creek

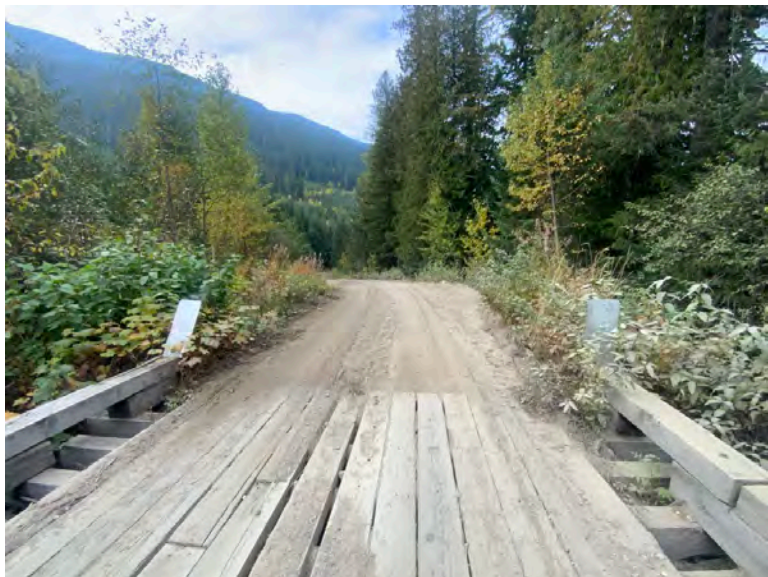
Approach from Left Bank when facing downstream

Fender Condition Fair Left side has no approach logs. Could add some

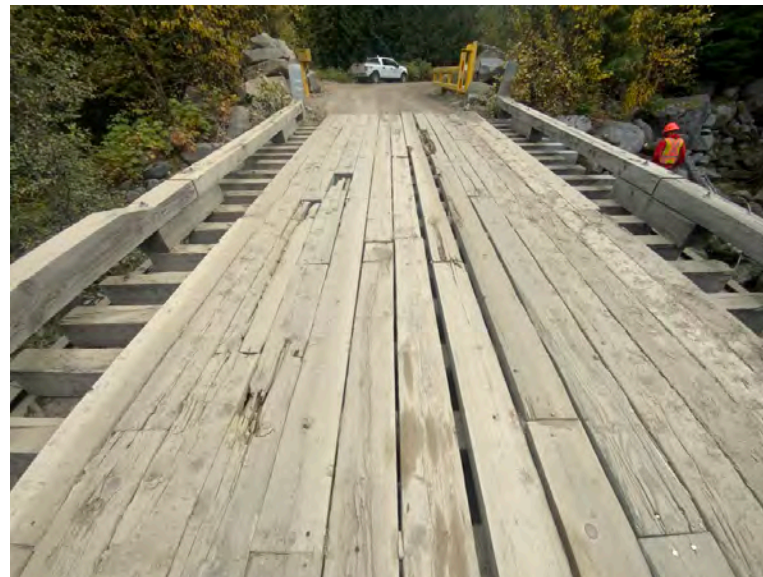
| Running Planks | Poor | Rotting deck and holes appearing |
| Ties | Poor | Ties sounded and minimum 50% are rotten. Replace all ties with deck and rails |
| Nails | Poor | Starting to pop with the warm ties |
| Curb Rail/Blocks/Posts | Poor | Easily move due to rotten ties and loose bolts. |
| Overall Deck Condition | Poor | Replacement needed. |

Replace full deck components due to rot. Consider downrating structure until completed.

| Repair Item | Repair Description |
|---|---|
| 1 Structure. Major redecking (crossties or laminated deck). m. Priority:High | Replace ties, deck and guardrails. Should replace sills Botha sides as well. |

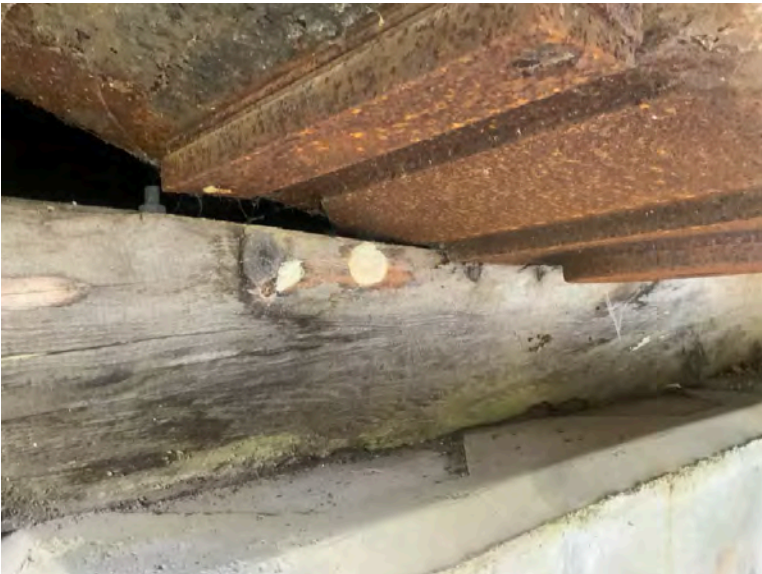
Caps or Sills Poor Starting to crush. Should consider replacement as deck is replaced

Sills showing age and crushing

Comments: Downrate load rating to L45 or 41 tonnes due to deteriorating timber deck. Replace full deck components and ideally replace crushing timber sills with treated or cedar timber sills for continued industrial use.
