SQ-3103  
SQ-3103

## PHYLIS CREEK 0.6km

2022 Inspection

Crossing Name Phyllis #3

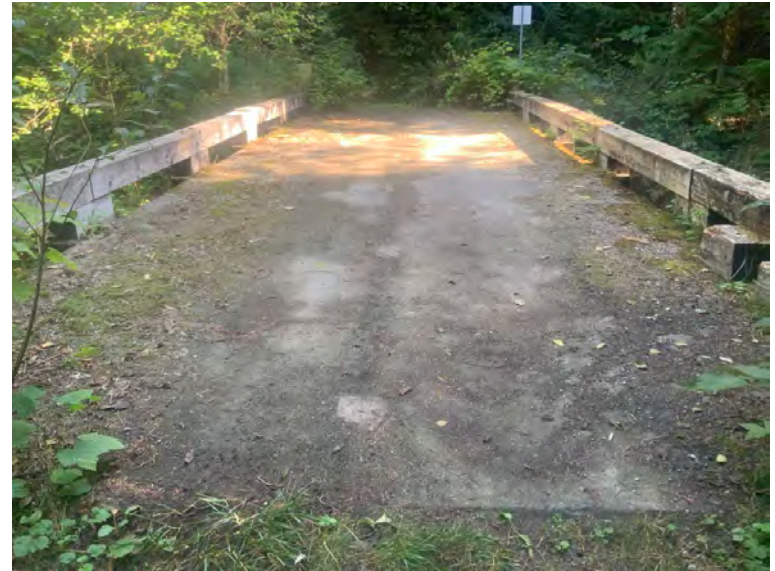
Concrete Deck      **Good**

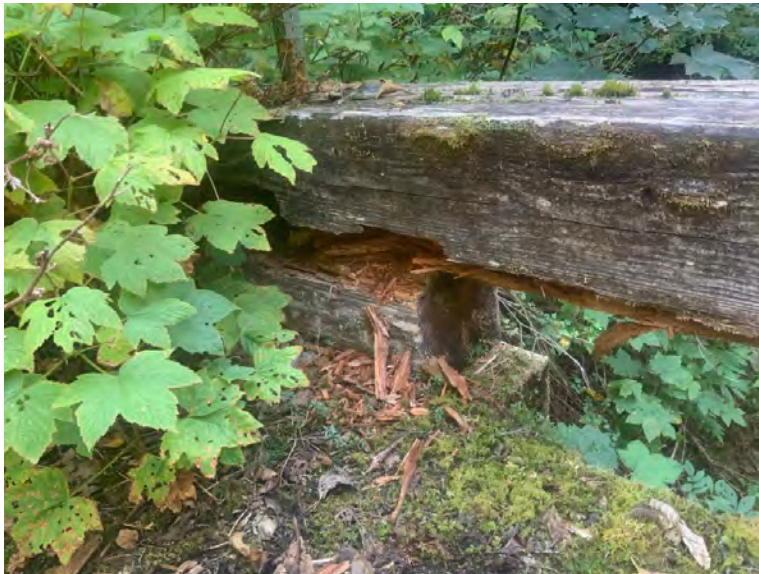
Guard Rail

Guardrails and risers are rotten, some better than other, but all extremely, loose... replace all.

Curb Rail/Blocks/Posts      **Poor**      Rotten and loose

Hardware      **Poor**      Loose guard rails

Overall Deck Condition      **Poor**      Due to guardrails

Load Rated by: MOF, Greg Dohm, PEng., Oct. 5, 2022  
Load Rating: L75 or 68 tonnes  
Next Inspection: 2023  
Comments: replace curb rails and risers for continue use of bridge.

| Repair Item | Repair Description |
|---|---|
| 1 Structure. Full Curb Replacement. . Priority:High | Replace gaurd rila |
