SQ-3104  
SQ-3104

FURRY CREEK 03 0.1km

2022 Inspection

Crossing Name Phyllis Creek

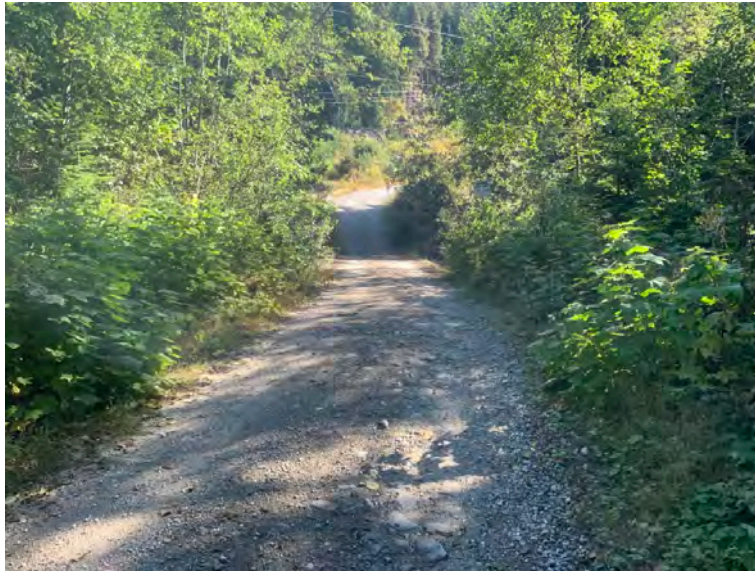
Approach from Left Bank when facing downstream

Alignment Fair

Horizontal curve and steep grade

Fender Condition Poor

| Repair Item | Repair Description |
|---|---|
| 1 Approach. Approach fenders (install). 4 # of units.<br>Priority:High | Install approach barriers |

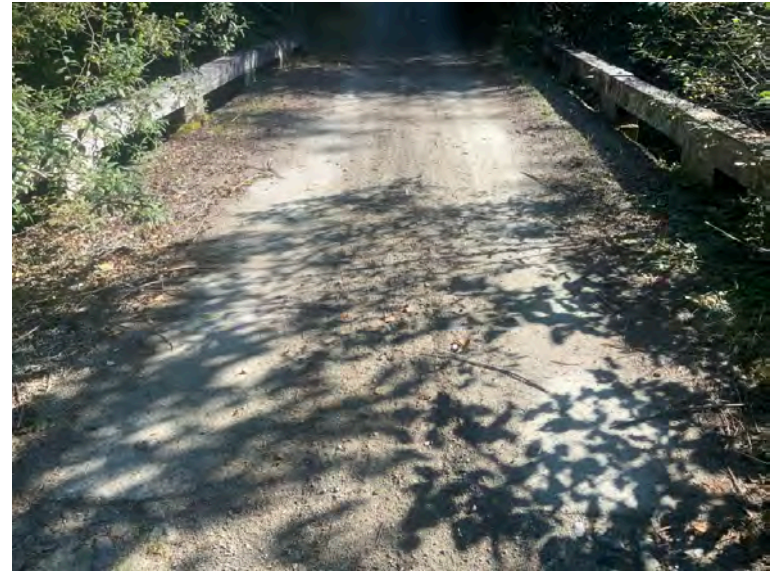
Running Surface      Fair

Concrete Deck      Good

Deck Joints      Good

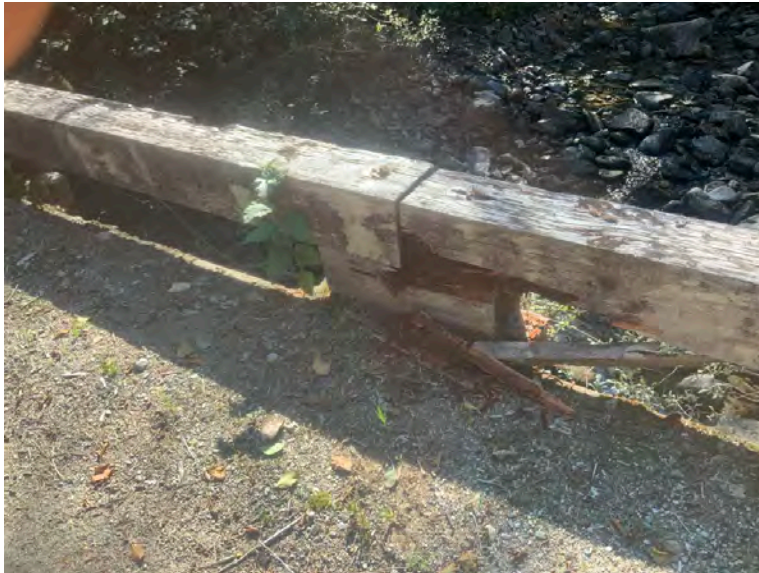
Guard Rail

Curb Rail/Blocks/Posts      Poor      Guard rails completely rotten and loose

Hardware      Poor      Loose guardrails

Overall Deck Condition      Poor      Due to guardrails

| Repair Item | Repair Description |
|---|---|
| 2 Structure. Full Curb Replacement. . Priority:High | Replace all guardrails |

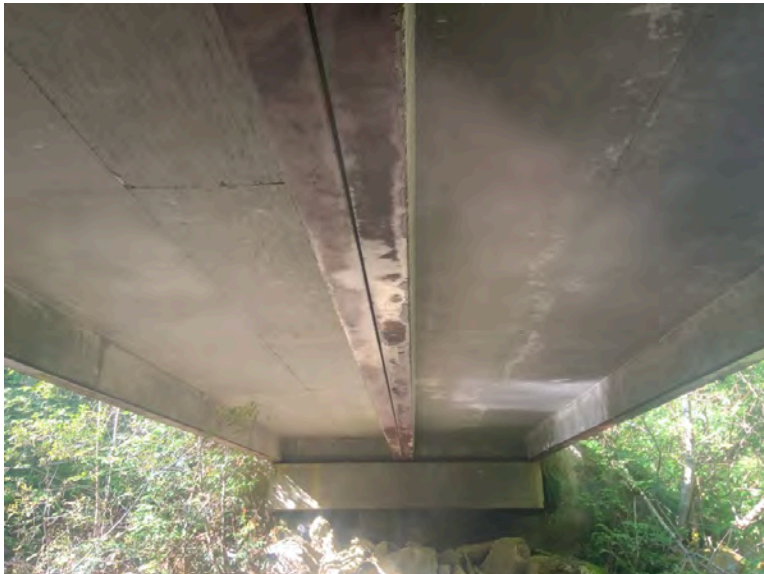
Superstructure

Girders Good
