SQ-3105  
SQ-3105

PHYLIS CREEK 0km

2022 Inspection

Crossing Name Phylis Creek #1

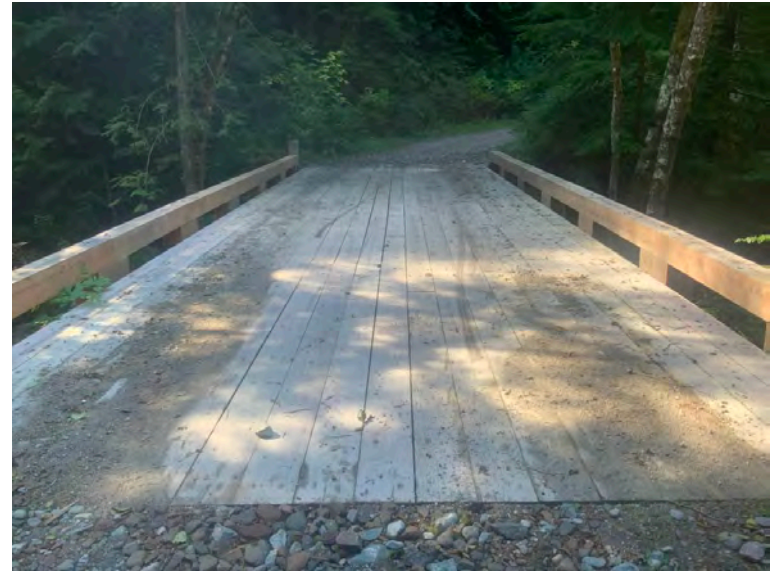
Deck

Curb Rail/Blocks/Posts      **Good**      New timber rails

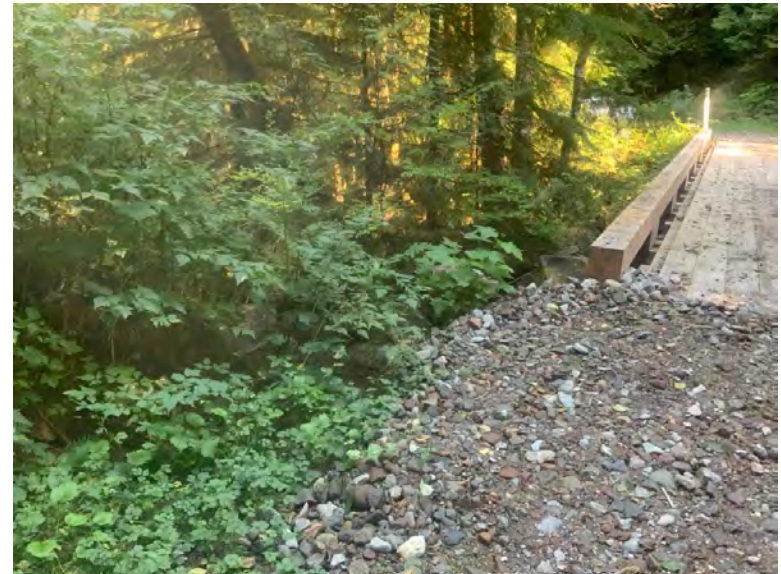
Approach Barrier

Fender Condition Poor

Missing left downstream

| Repair Item | Repair Description |
|---|---|
| 2 Approach. Approach fenders (install). 1 # of units. Priority:High | |

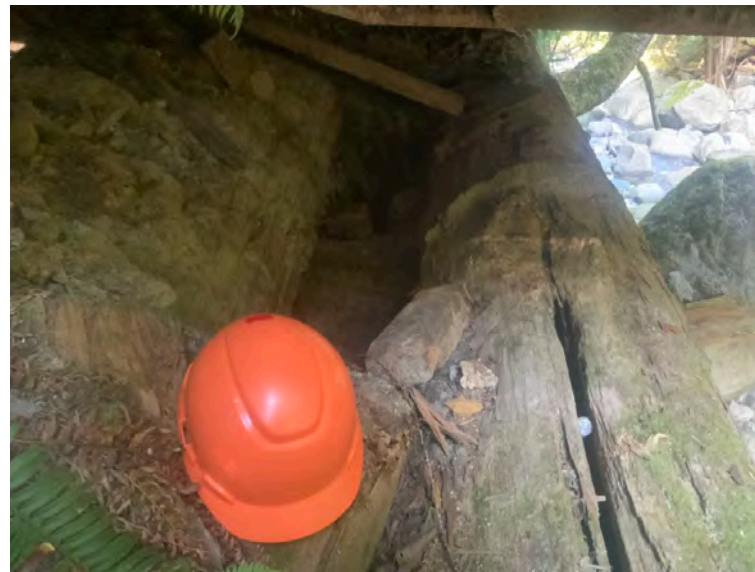
Left bank crib

Log/Timber Cribbs Poor Old, rotting. Undermined

| Repair Item | Repair Description |
|---|---|
| 1 Approach. Reconstruct fill. m³. Priority:High | Repair abutments. |

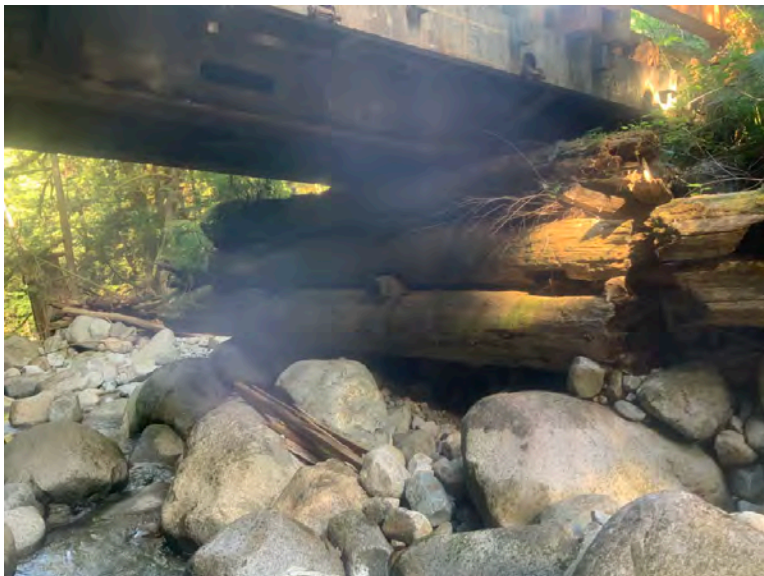
Right Bank Abutment when facing downstream

Bridge is sitting on sill logs set back from cribs. Both cribs undermined, right bank extremely so. Bottom sill log fully suspended in places (80c-120cm vertical gaps) sitting on 2 or 3 single rocks. No riprap, but large rock in creek, extremely exposed, fill has been eroded from behind crib (roughly 1.5m of solid fill in front of sill log on right side. Check record to see if this has worsened since last years inspections. Entire deck a has been recently replaced... to standard, Timbers appear to be not treated. Post inspection comments: discussed and there has been no change to bridge. Timber deck was recently completed, per g.dohm

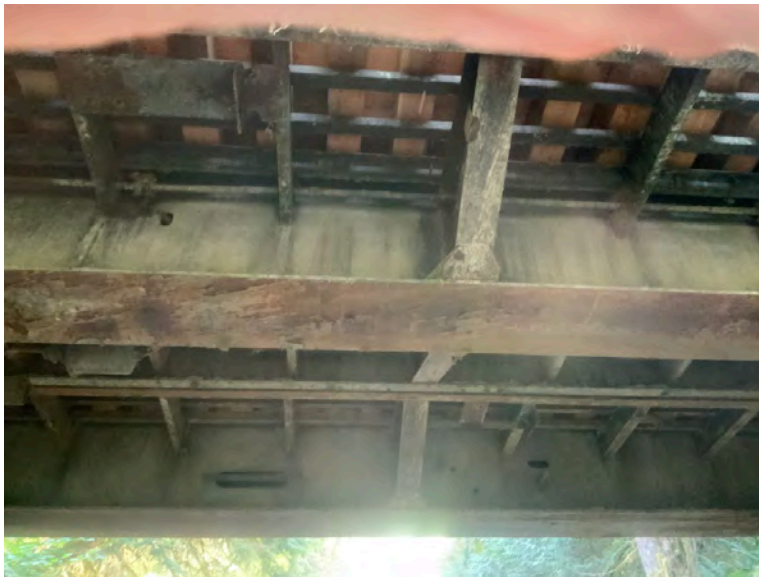
Superstructure

Girders Fair

Old steel rail car

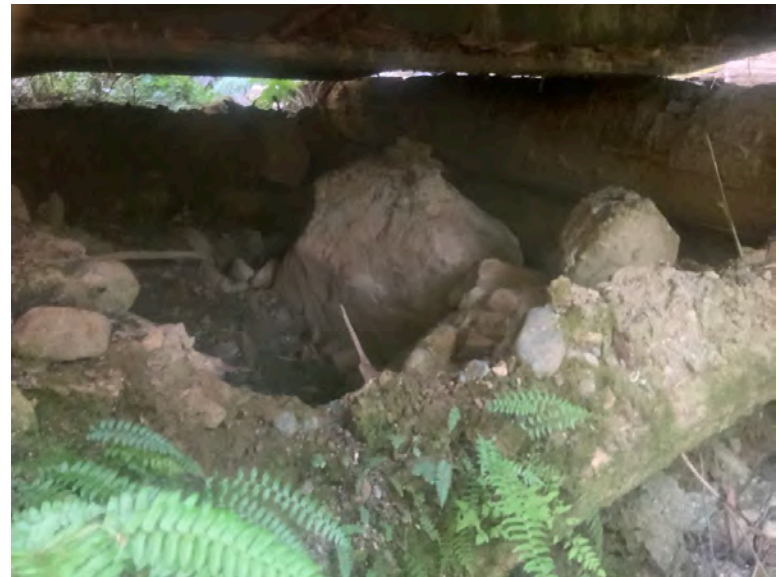
Fill Poor At risk of scour, eroding from behind cribs

Right bank. Fill eroding from behind crib.
