SQ-3106  
SQ-3106

## BLACKWATER CREEK 0.1km

2022 Inspection

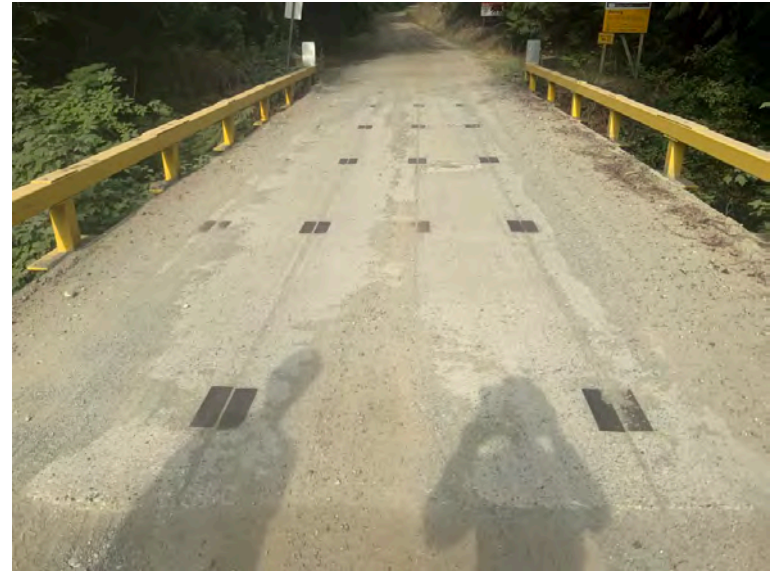
Concrete Deck      **Fair**      Surface damage. Rebar exposed. Patch

| Repair Item | Repair Description |
|---|---|
| 1 Structure. Concrete structural maintenance. m².<br>Priority:High | Patch deck in multiple places. |

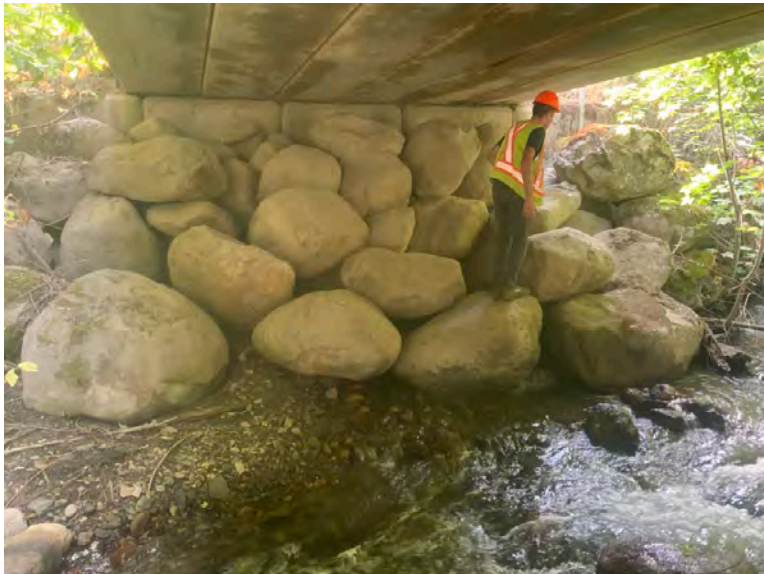
Right Bank Abutment when facing downstream

Right bank riprap large and poorly graded. Creek is travelling under upstream corner of riprap. Depending how many rows of lock blocks, Footings at risk of scour if continues to migrate/erode. Underside of girders have hairline cracks running laterally and longitudinally. All girders, multiple places mid span. Monitor both items. Consider increasing inspection frequency y to annual.

Riprap **Poor** Right bank large, but poorly grade. Getting Undermined

| Item | Monitor Description | Frequency |
|---|---|---|
| 2 | Right bank riprap/abutment forms undermining and scour | Anually |

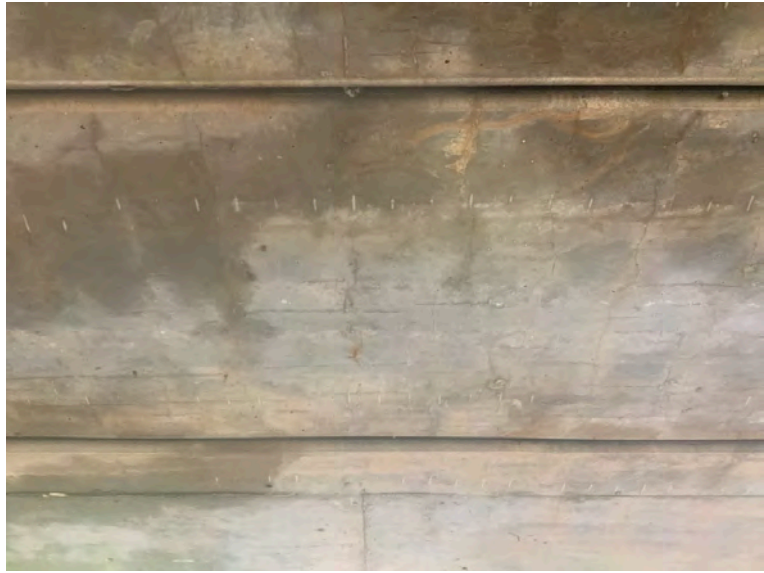
Superstructure

Girders Fair

Cracks in concrete, see notes.

| Item | Monitor Description | Frequency |
|---|---|---|
| 1 | Concrete slab girders for hairline crack growth, | Anually |
