SQ-3107  
SQ-3107

HIXON 0.8km

2022 Inspection

Crossing Name Hixon Creek

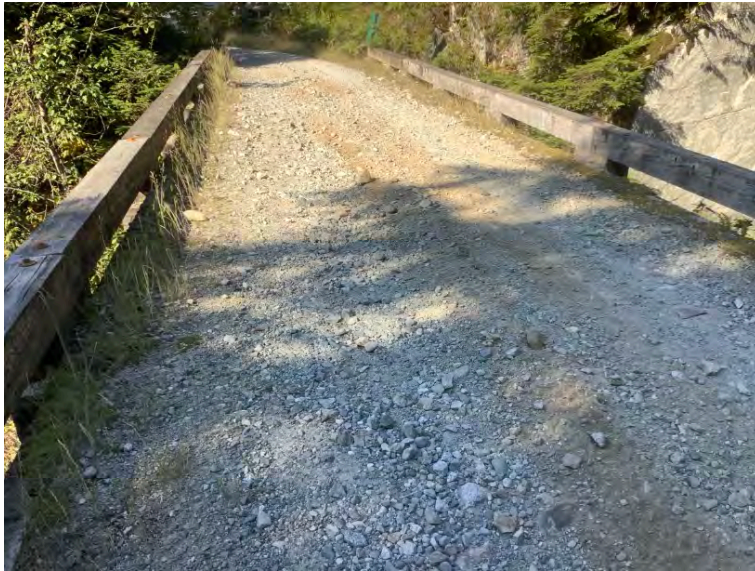
| Curb Rail/Blocks/Posts | Poor | Rotten |

| Overall Deck Condition | Fair |

1 Structure. Full Curb  
Replacement. . Priority:High

2 Structure. Clean Deck. # of  
delineators. Priority:High Is this a gravel over bridge? If so, retaining board should be replaced and deck should be graded.

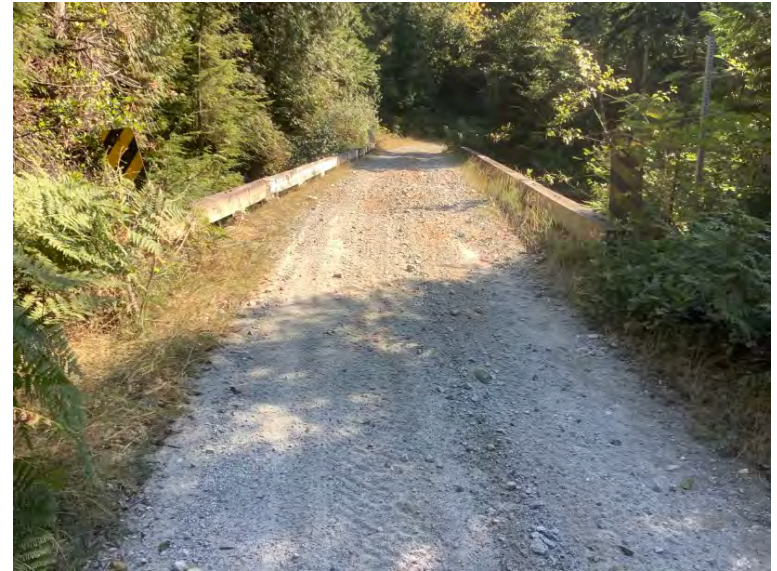
Approach from Right Bank when facing downstream

Alignment Fair

Steep grade onto bridge

Fender Condition Fair

Given risk, suggest upgrading to no post barrier

3 Approach. Approach fenders  
(re-Install). # of units.  
Priority:High Suggest upgrading approach approach barriers

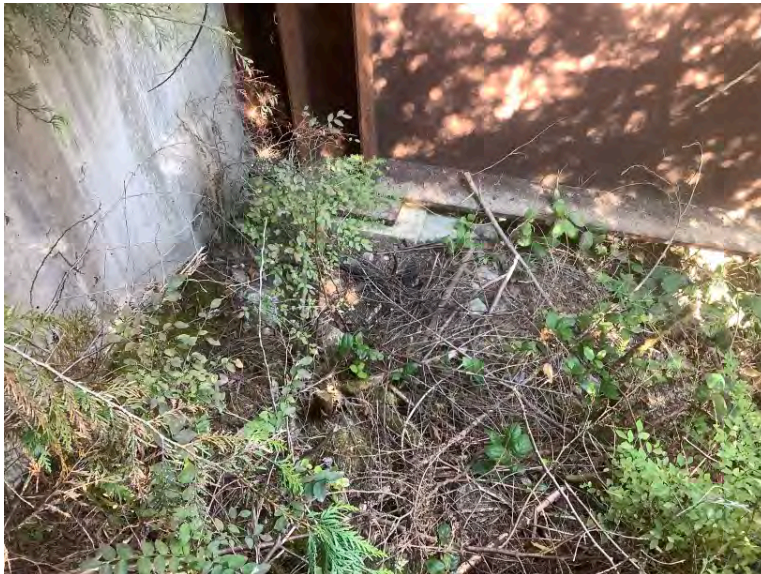
Bearing

Bearings Good
