SQ-3108  
SQ-3108A

## BLACKWATER CREEK 12km

2022 Inspection

Crossing Name Phelix Creek

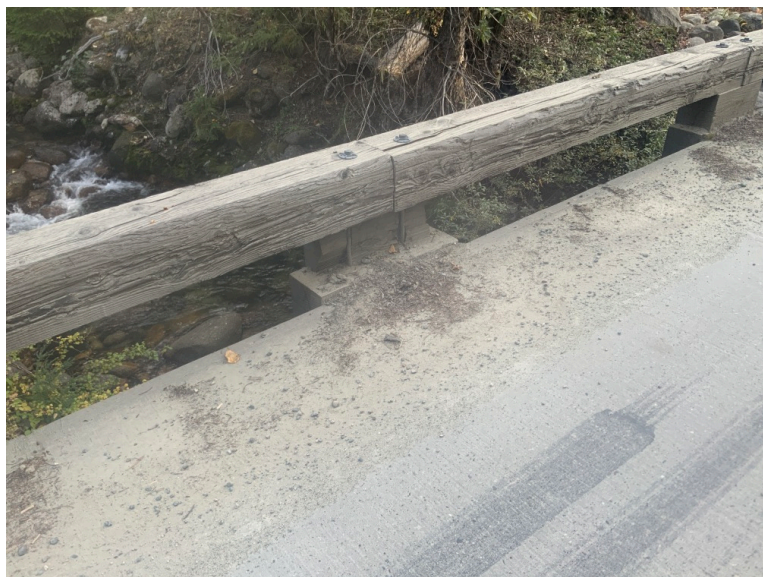
Guard Rail

Curb Rail/Blocks/Posts      Fair      Wood Rails, solid. Replace single riser

| Repair Item | Repair Description |
|---|---|
| 1 Structure. Curb Maintenance. 1 # sites. Priority:High | Replace damaged riser block. Single. |

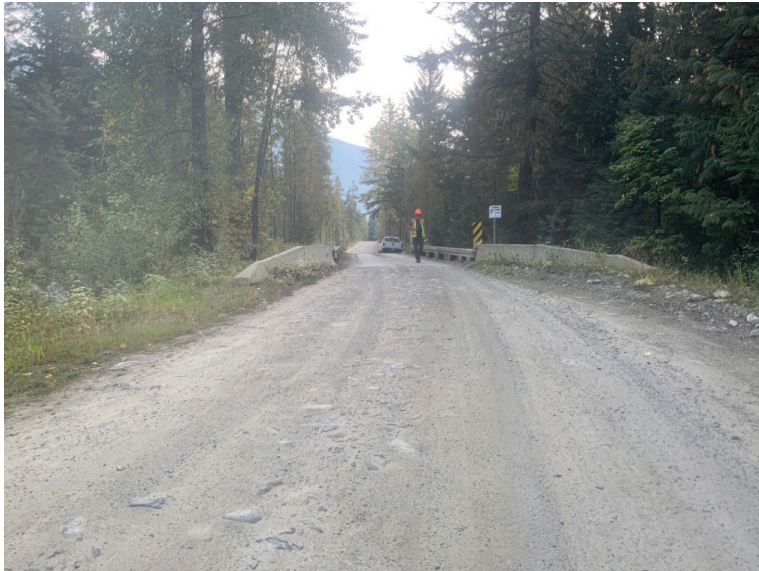
Approach from Right Bank when facing downstream

Minor potholes right bank approach

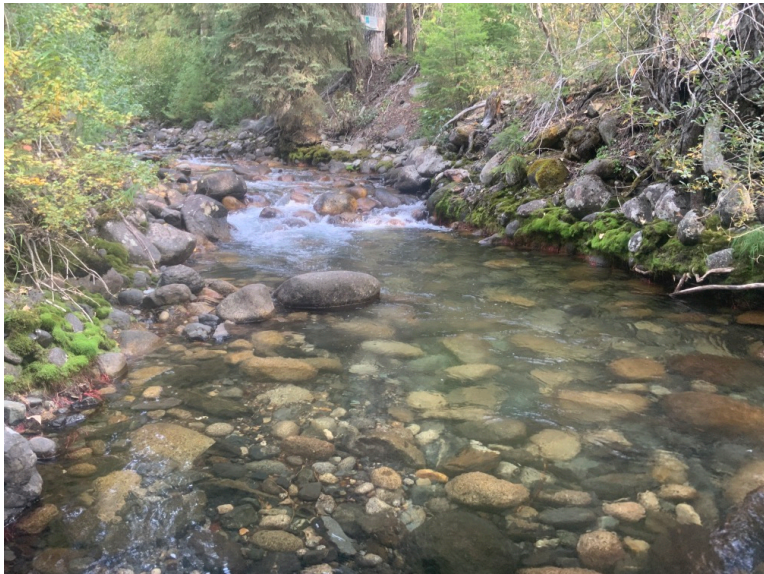
Upstream from Crossing

Comments Scour upstream from crossing
