SQ-3113  
SQ-3113

LILLOOET WEST 72.9km

2022 Inspection

Crossing Name Fire Creek

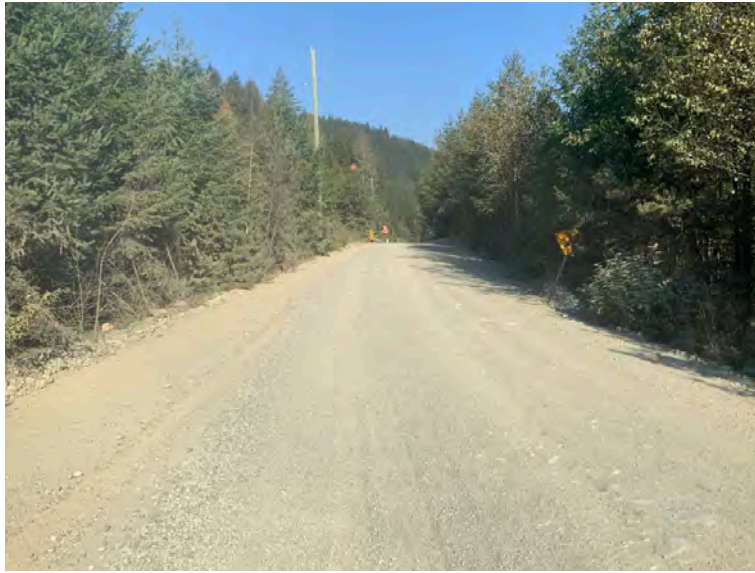
Approach from Right Bank when facing downstream

Fender Condition Poor

| Repair Item | Repair Description |
|---|---|
| 1 Approach. Approach fenders (install). 4 # of units.<br>Priority:High | Install approach barriers |

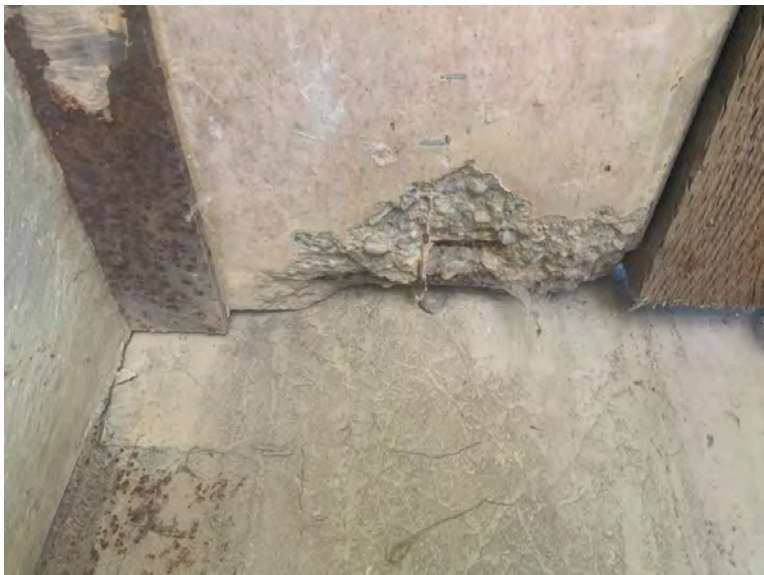
Concrete Deck      **Fair**      Minor surface damage. Rebar exposed underside.

First panel, left bank underside. Rebar showing

| 2 | Deck for further damage | Routine Inspection |

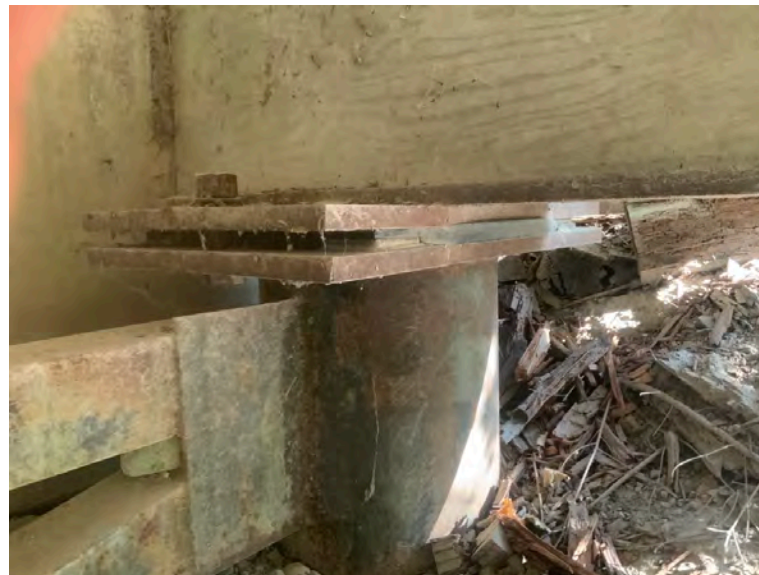
Bearing

Bearings Fair

Bulging pads left bank

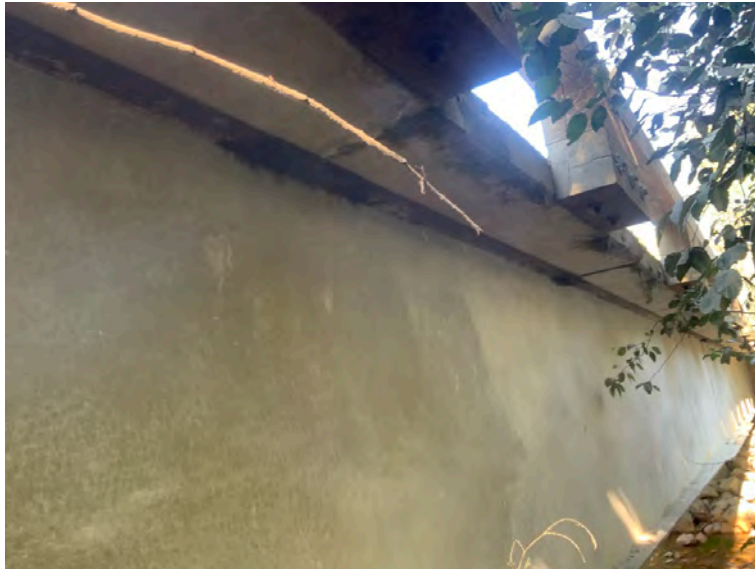
Concrete/steel girders. Hairline fractures have been identified and tagged previously (unknown when) New ones have appeared and grown since. Significant corrosion/flaking of girders under deck joints. Recommend close proximity inspection. Post inspection comments: tagged hairline cracks date back to 15 years or more. Hairline cracks in this type of girder is expected as determined by previous studies. Monitor during routine inspections, per g.dohm

Hairline cracks present in concrete. Corrosion.

Superstructure, corrosion under deck joints

| Item | Monitor Description | Frequency |
|---|---|---|
| 1 | Hairline fractures in girders, corrosion/flaking | Routine Inspection |
