SQ-3114  
SQ-3114A

LILLOOET WEST 66.7km

2022 Inspection

Crossing Name Spring Creek (11 mile)

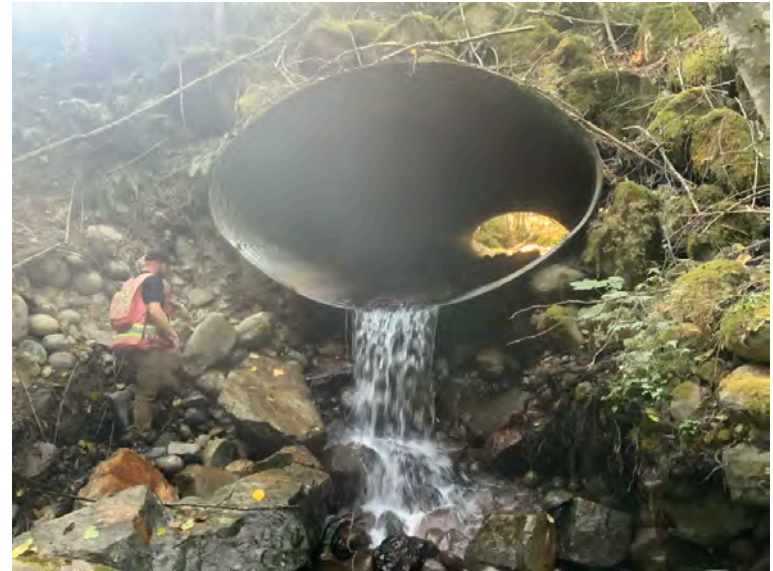
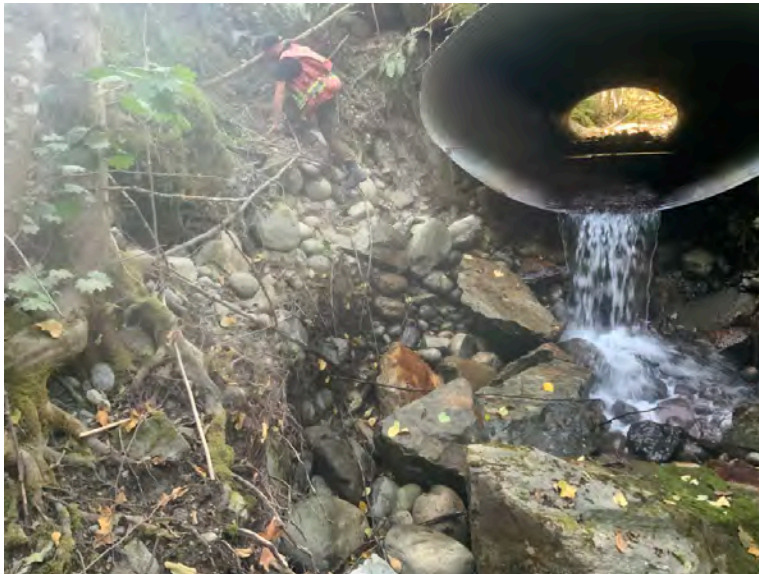
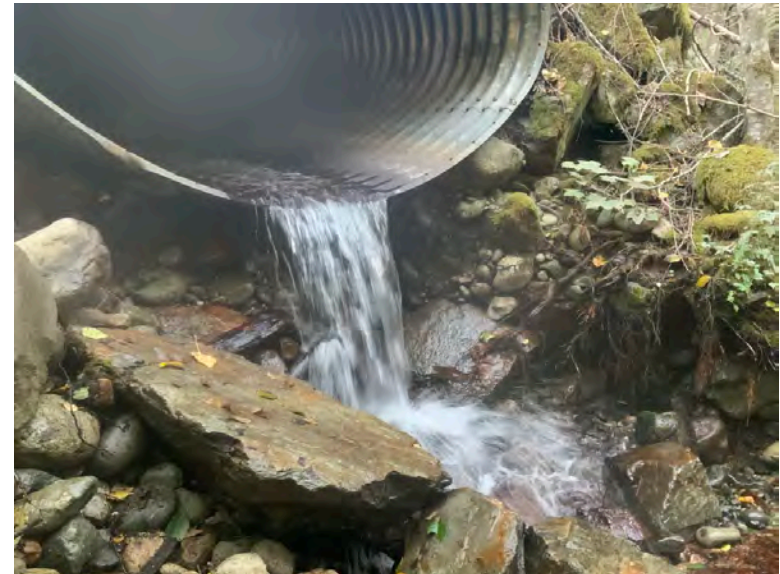
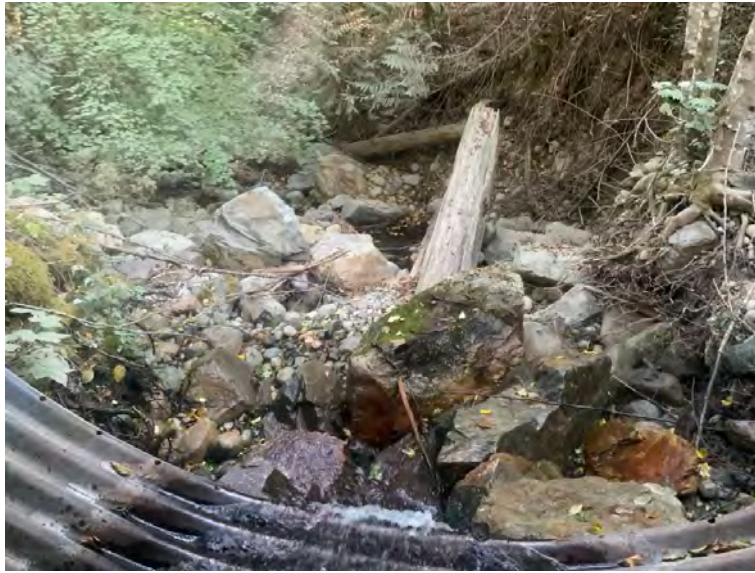
Outlet hanging, riprap has moved from right bank. Scour along banks downstream. Monitor.

Outlet Good Hanging slightly, scour present

| Item | Monitor Description | Frequency |
|---|---|---|
| 1 | Outlet for further scour, riprap movement. | Routine Inspection |

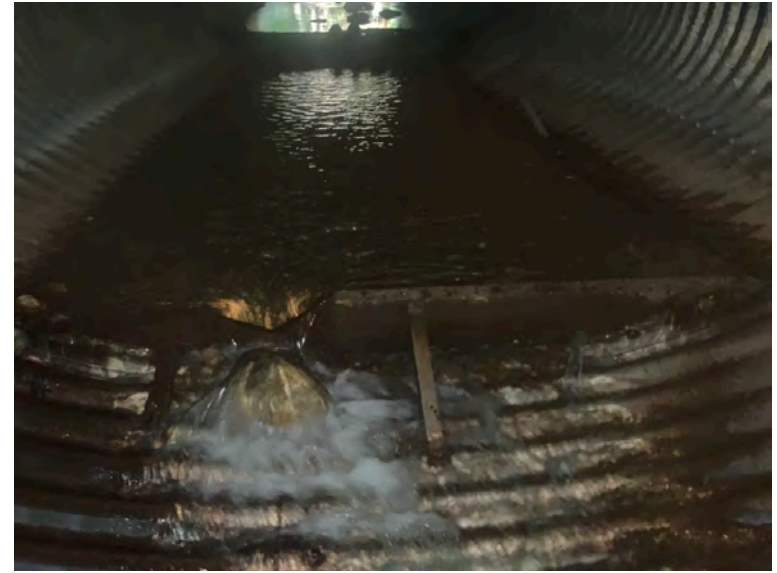
Baffles Good

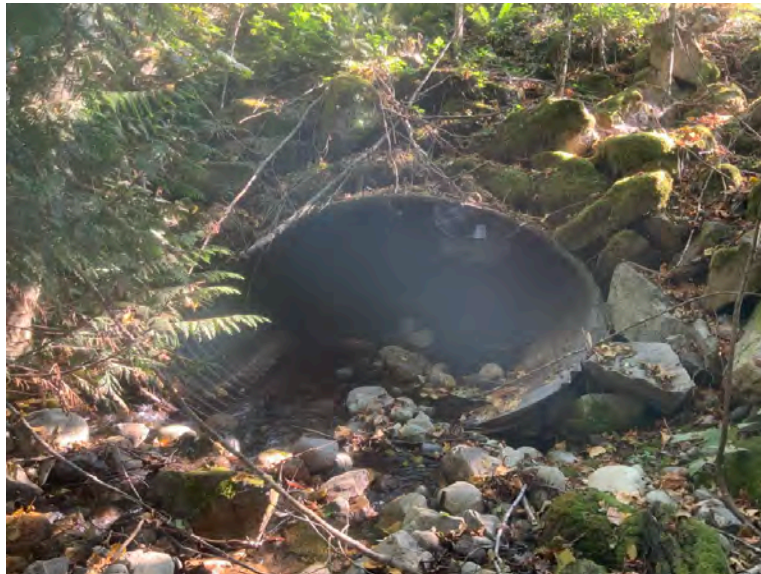
Inlet Good

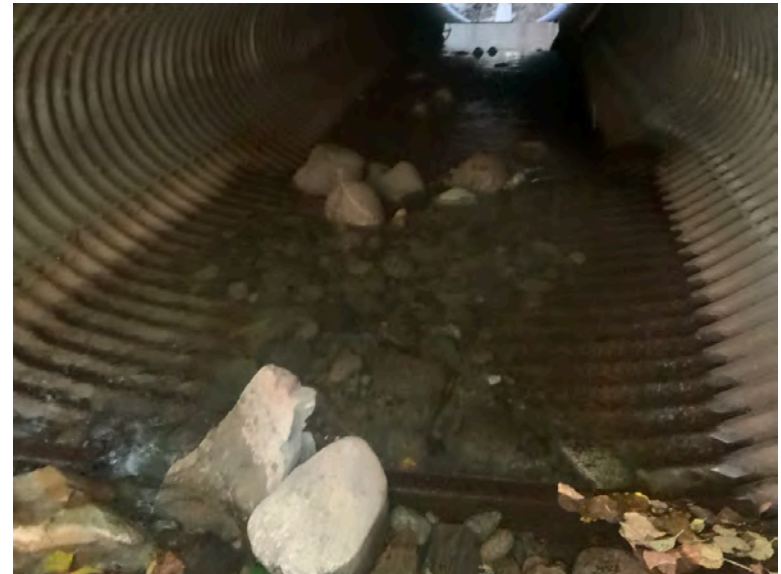
Culvert Floor

Coating Fair Worn floor

Floor Fair Worn
