SQ-3115  
SQ-3115

LILLOOET WEST 63.5km

2022 Inspection

Crossing Name Beverley Creek

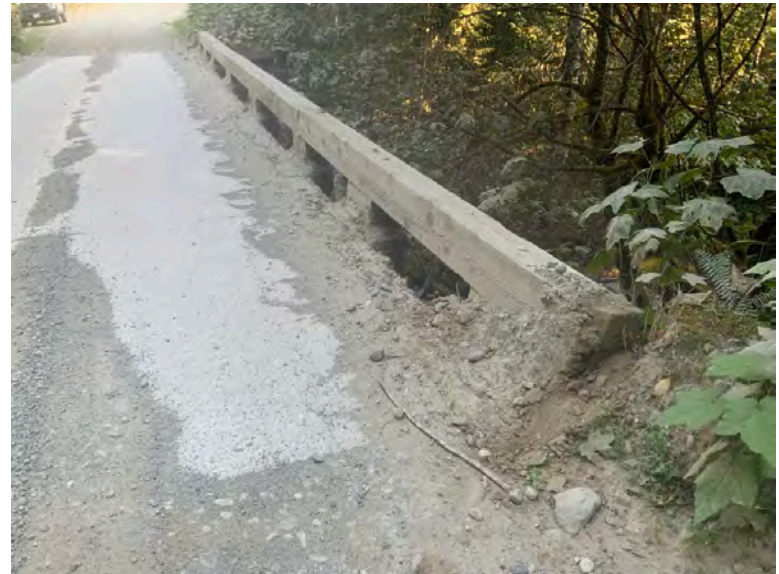
Guard Rail

Curb Rail/Blocks/Posts      **Fair**      Wood Rails. Solid but have been hit.
