SQ-3122  
SQ-3122A

LILLOOET WEST 34km

2022 Inspection

Crossing Name Billy Goat Creek

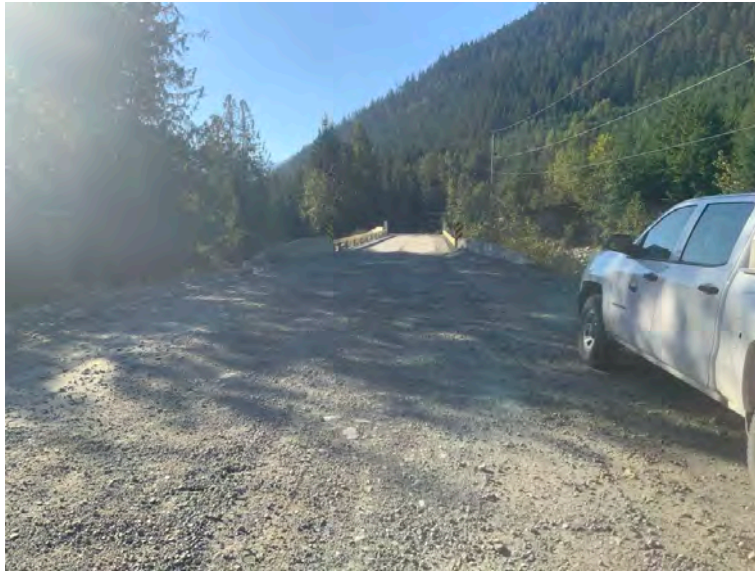
Approach from Left Bank when facing downstream

Road Surface **Good** Grader berm against approach barriers

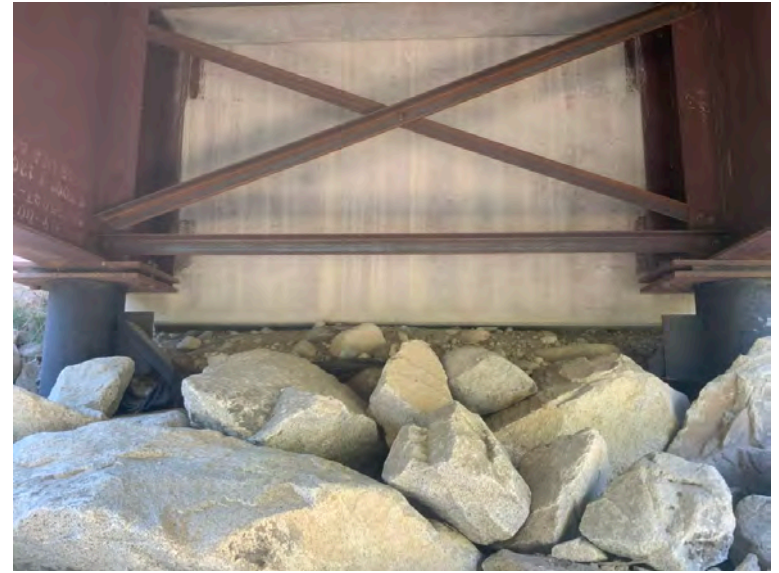
Right Bank Abutment when facing downstream

Large riprap may have been moved, right bank, center, bottom of slope. Monitor.

Riprap **Good** Monitor right bank. Large rock may have moved.

| Item | Monitor Description | Frequency |
|---|---|---|
| 1 | Large riprap may have been moved, right bank, center, bottom of slope. Monitor. | Routine Inspection |
