SQ-3130  
SQ-3130

MAMQUAM 4.5km

2022 Inspection

Crossing Name Stawamus River

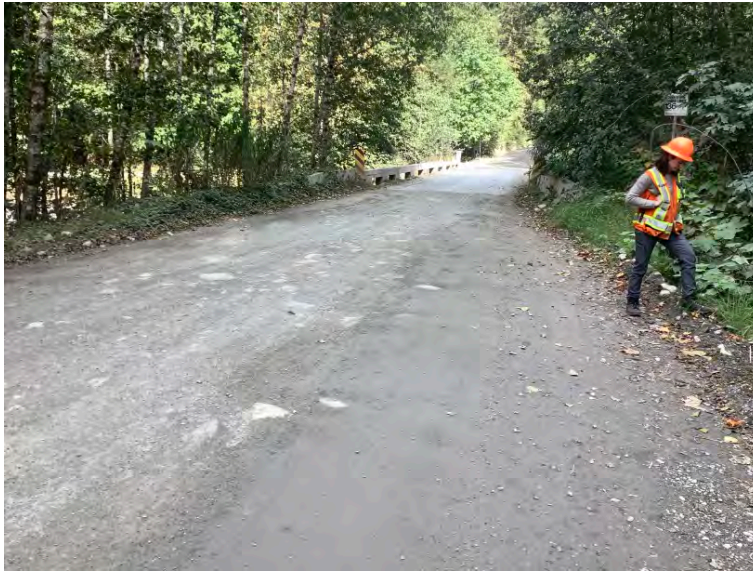
Approach from Left Bank when facing downstream

Delineator Missing  
Left ☐ 0 ☒ 1 ☐ 2

| Repair Item | Repair Description |
|---|---|
| 1 Structure. Delineator maintenance. 1 . Priority:Low | Install 1 LH delineator |

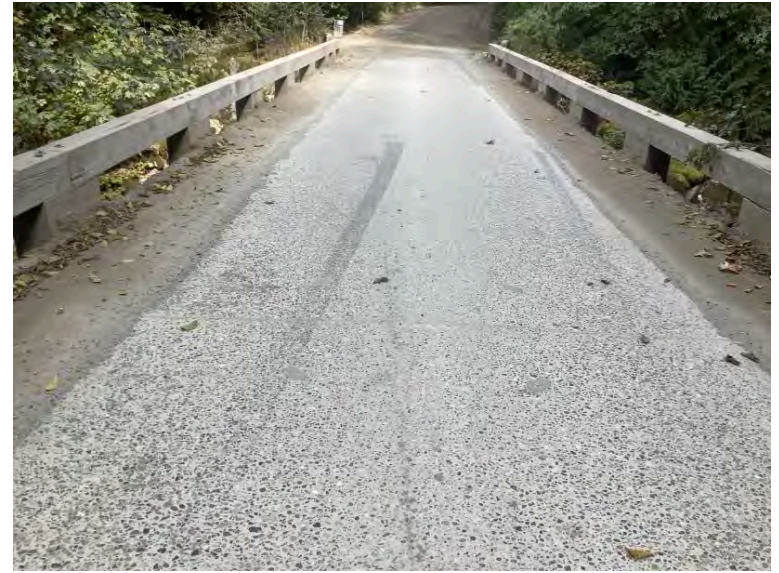
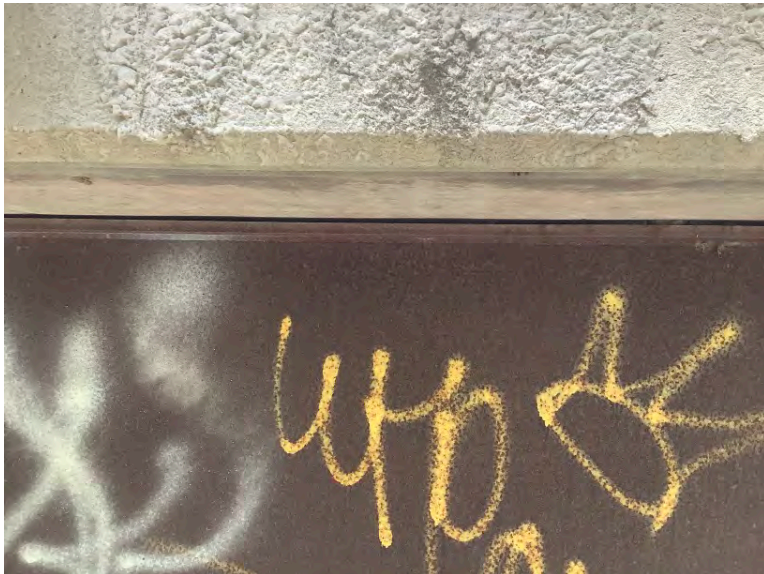
Deck Joints Fair Calcium leeching through concrete

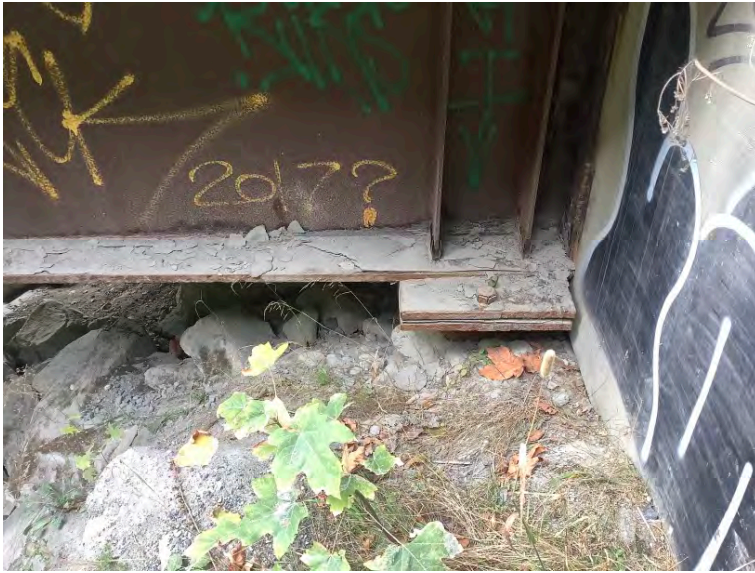
Bearing

Bearings **Poor** Very delaminated. Badly corroded.

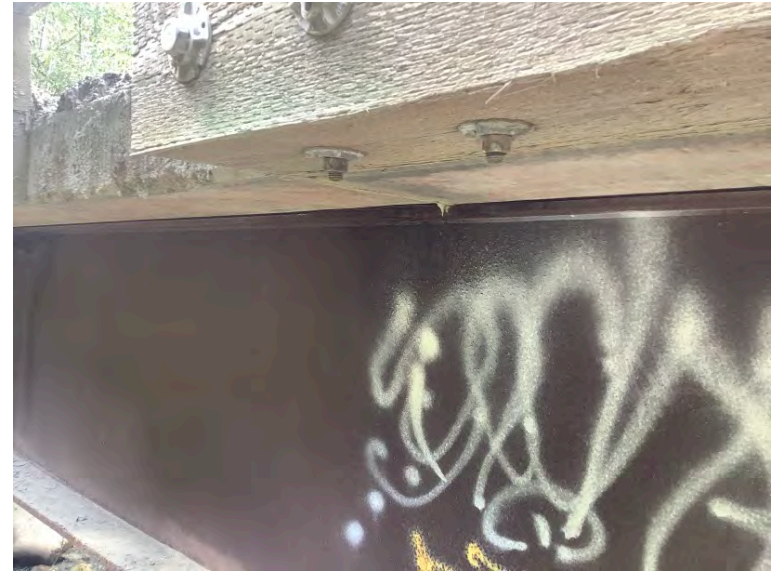
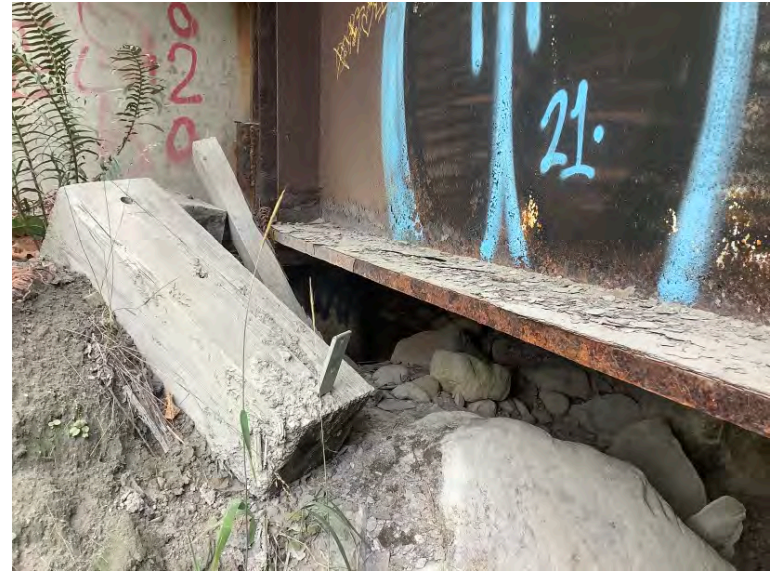
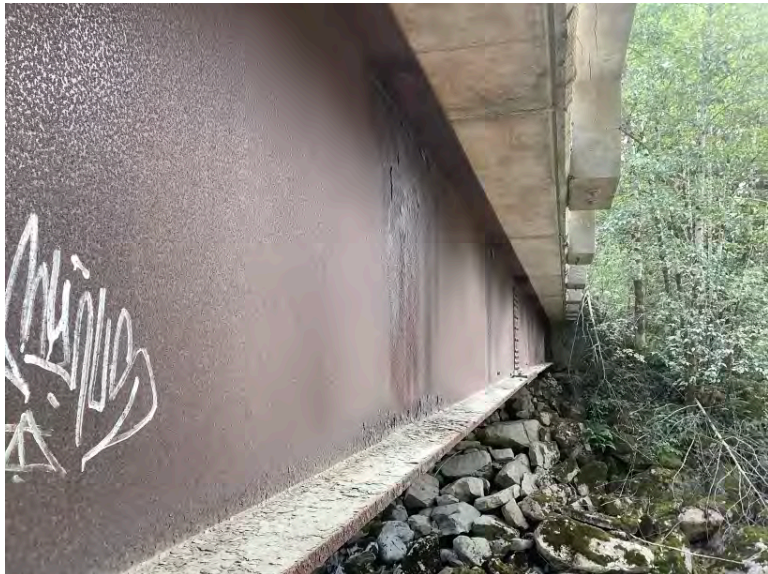
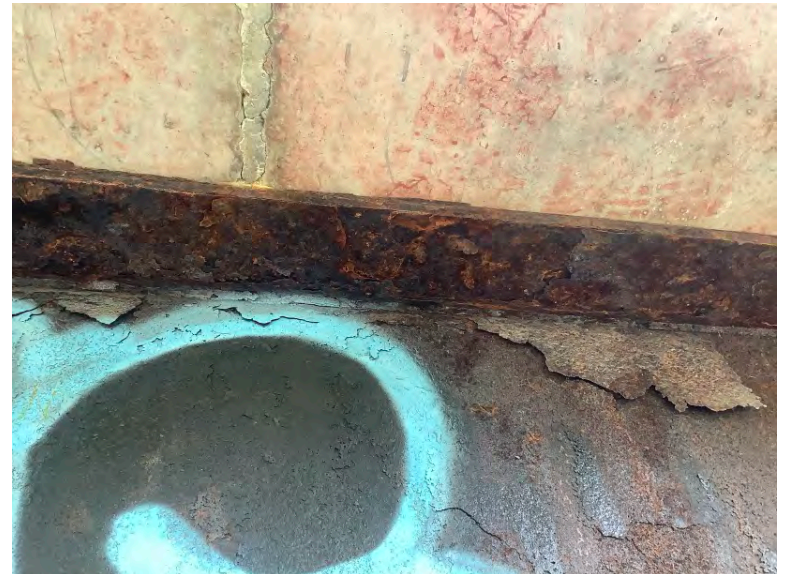
Girders Poor

Corrosion occurring at all deck joints. Corrosion start to occur on top and bottom flanges in several locations.

Diaphragms Poor

Corrosion occurring at all deck joints

| Repair Item | Repair Description |
|---|---|
| 3 Miscellaneous. Other (specify in comments). # of items. Priority:High | Unsure if snoopers or close proximity has been completed. Check corrosion against past inspections. Recommend snoopers and detailed assessment if it has not been done recently. Suggest developing some type of repair plan. More investigation required. |

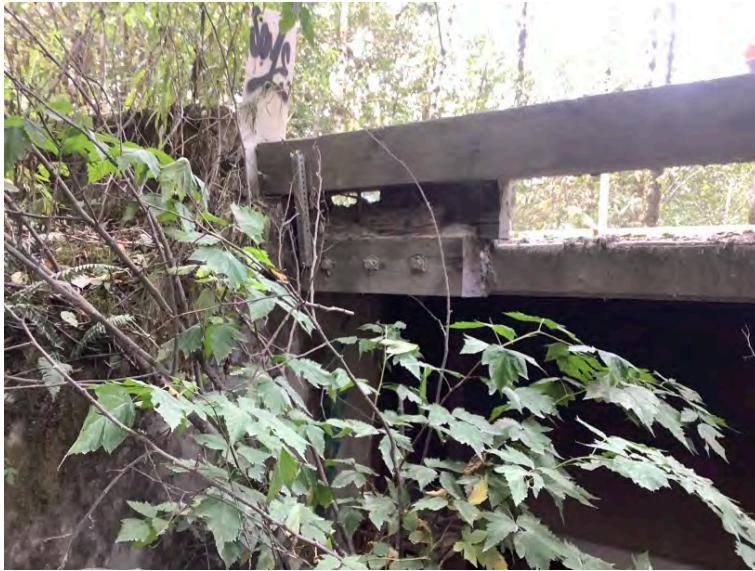
Guard Rail

Curb Rail/Blocks/Posts Poor 1 riser block has been struck and is rotting. Replace

| Repair Item | Repair Description |
|---|---|
| 2 Structure. Curb Maintenance. # sites. Priority:Medium | Replace upstream river left outer most riser and block. |

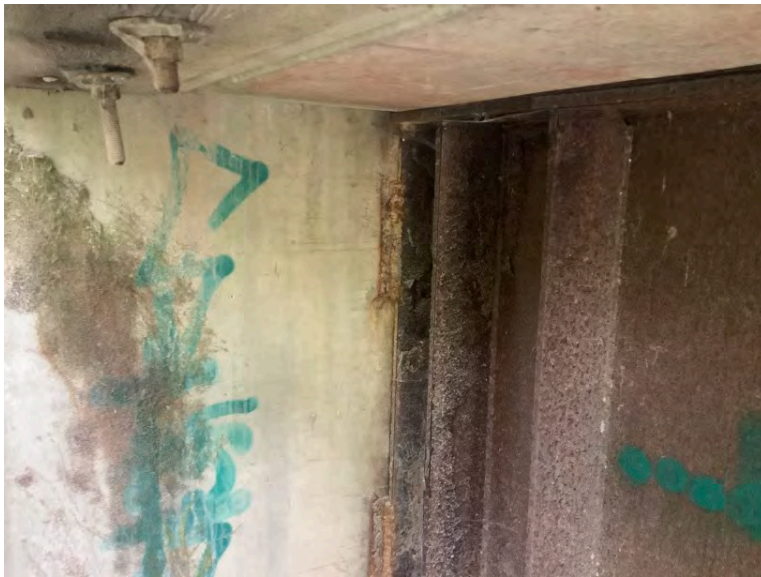
Ballast Wall **Poor** Concrete is in good condition, but ballast wall plates and welds are badly corroded.
