SQ-3132  
SQ-3132A

MAMQUAM 10.5km

2022 Inspection

Crossing Name Raffuse Creek

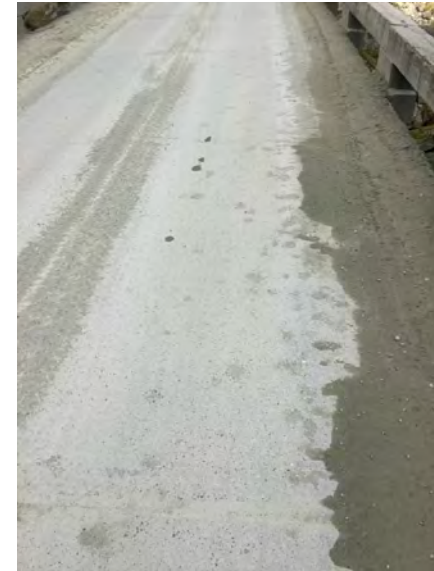
Deck

Some spalling on deck surface but okay.

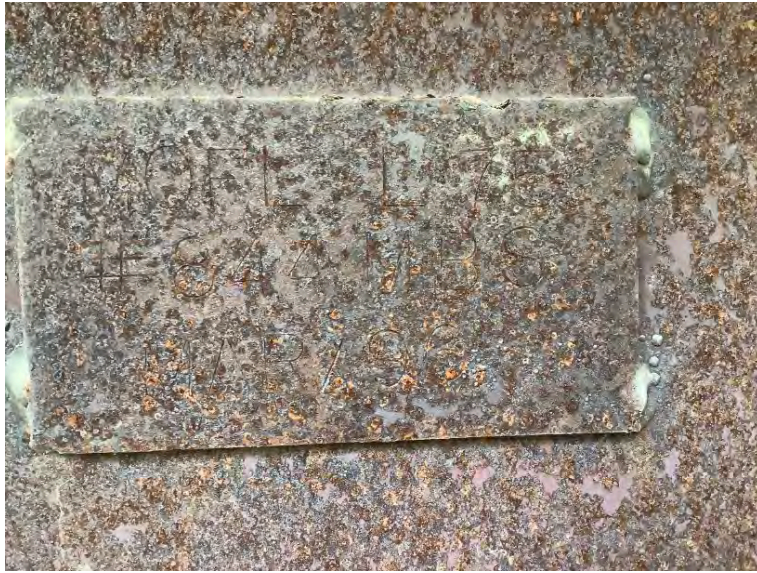
Structure ID

Inspector Comments Serial/ID Plate  
No issues

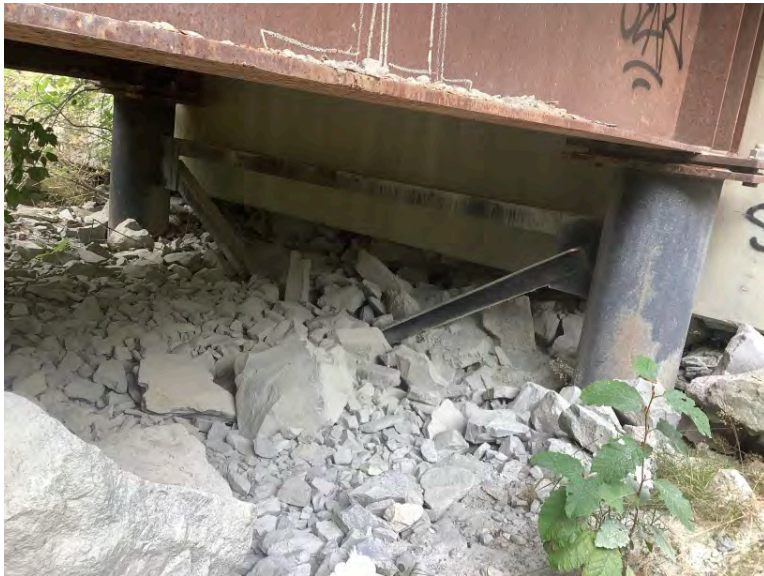
Bearing

Bearings **Fair**
