SQ-3133  
SQ-3133

MAMQUAM 14.2km

2022 Inspection

Crossing Name Trib to Mamquam

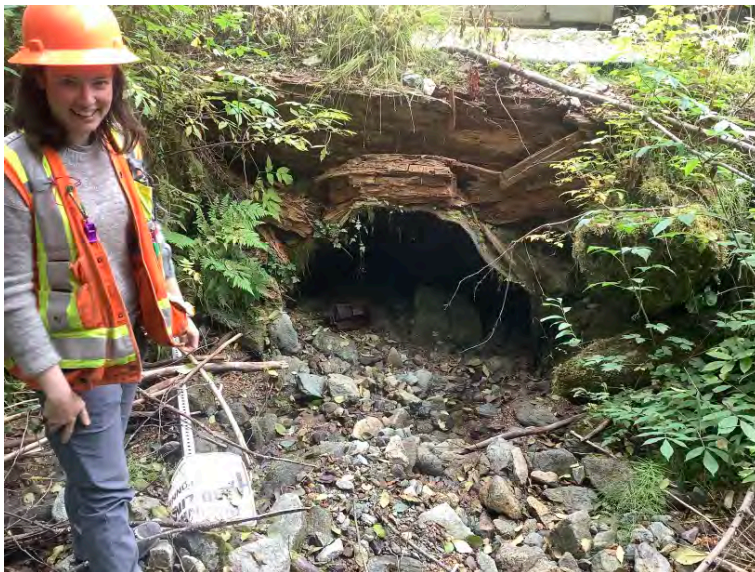
Inlet

Some erosion occurring at inlet

Old log bridge holding up inlet fill is rotting.

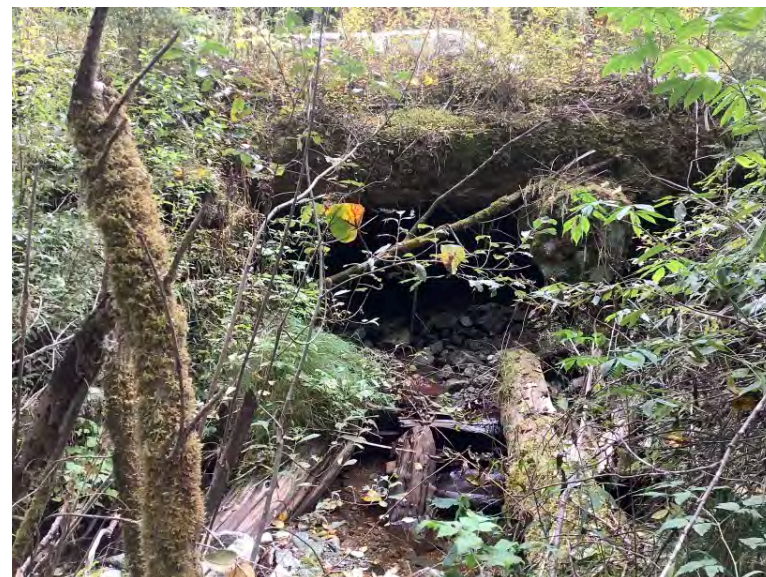
Outlet

Old log bridge holding up inlet fill is rotting.
