SQ-3144  
SQ-3144

## SQUAMISH RIVER 41.8km

2022 Inspection

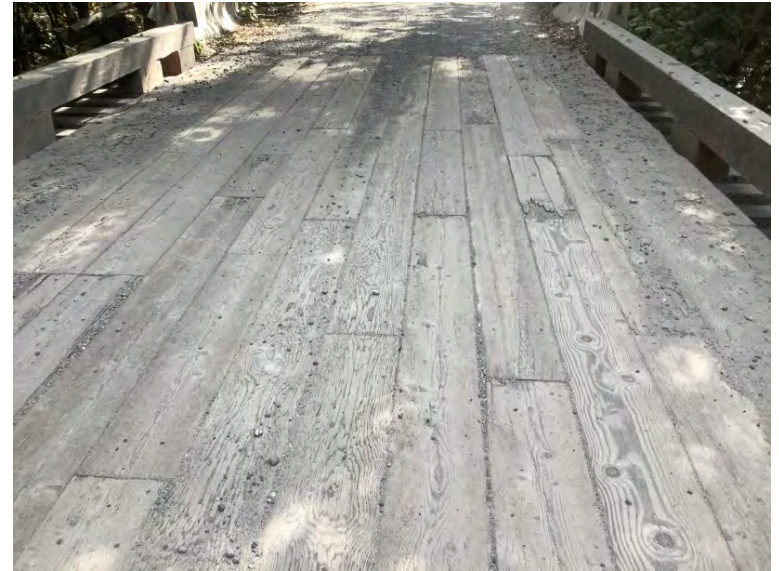
Sub Deck      **Poor**      Old sub deck below ties.

Deck to Girder Bolts      **Poor**      Not present other than timber washers through rails

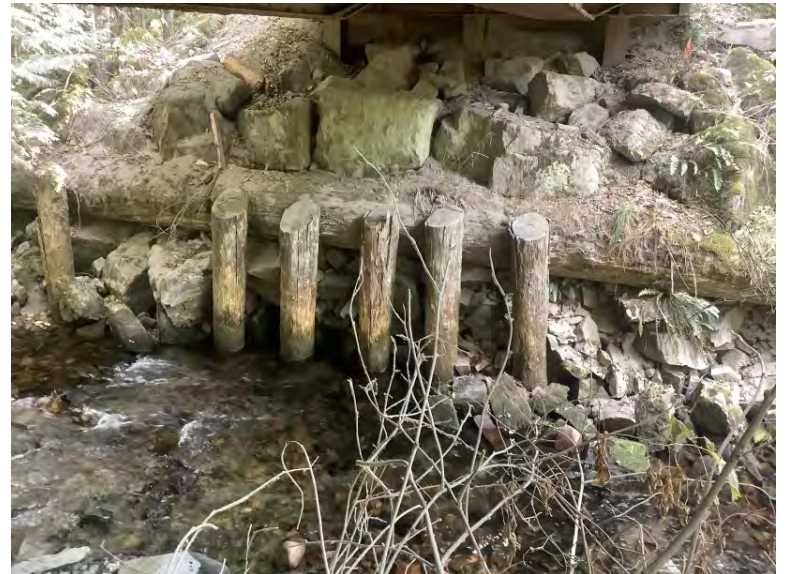
Right Bank Abutment when facing downstream

Piles or Posts **Poor** Old and rotten wood piles in front of steel H-piles

Riprap **Poor** Riprap behind piles

1 Monitor riprap behind old piles.

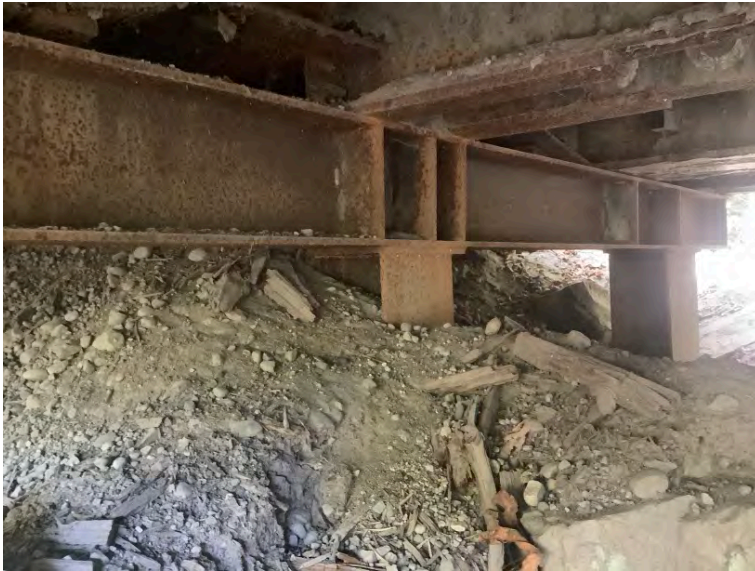
Bearing

Bearings **Good**

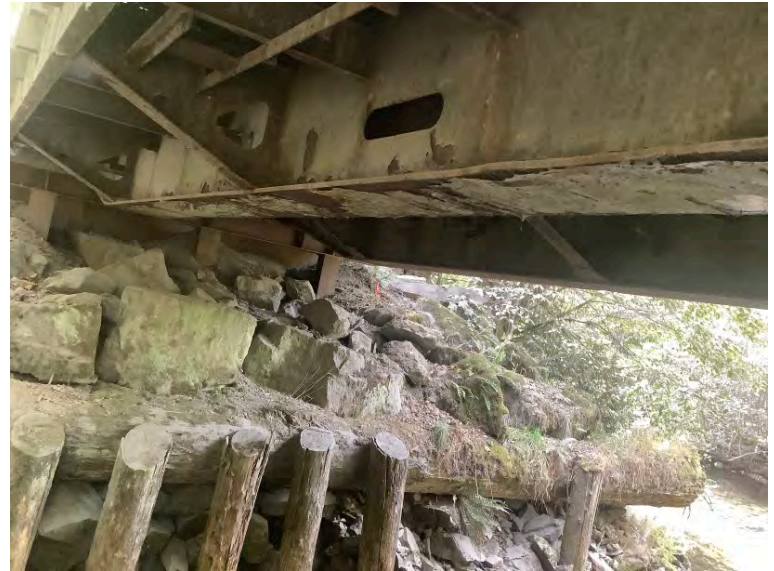
Superstructure

Girders Fair

Diaphragms Fair

Bracing Fair
