## BRITANNIA CREEK 2.5km

2022 Inspection

Crossing Name Trib to Daisy Creek

FSR # 8321 Branch # 1

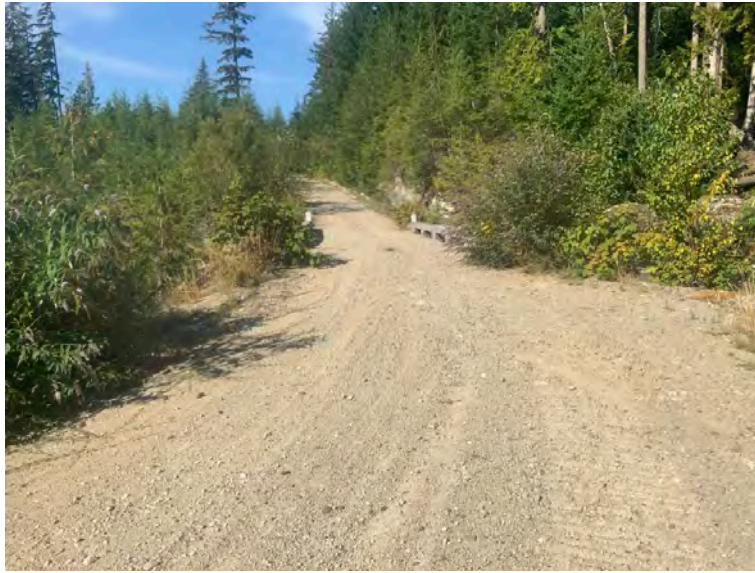
Approach from Left Bank when facing downstream

Curve and grade

Bridge Ahead Signs  
Missing

| Repair Item | Repair Description |
|---|---|
| 1 Approach. Approach fenders (install). 4 # of units.<br>Priority:High | Install approach barrieirs |

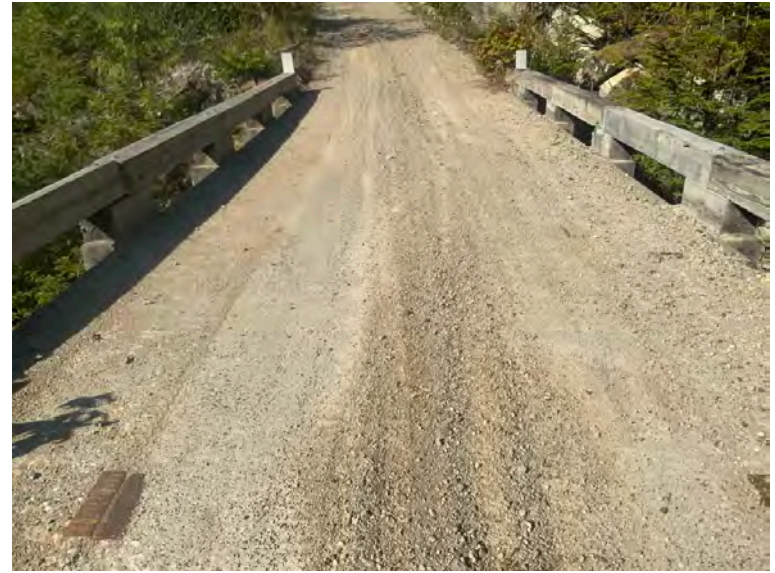
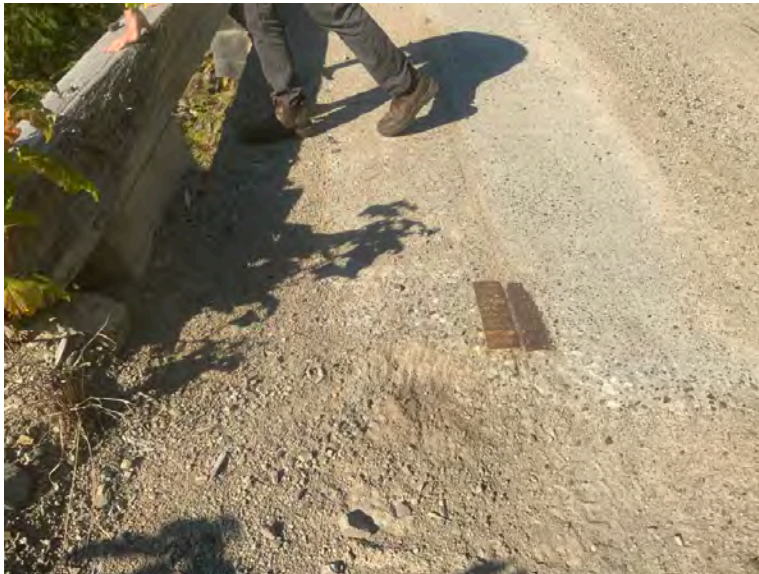
Concrete Deck      **Fair**      Minor damage on deck ends

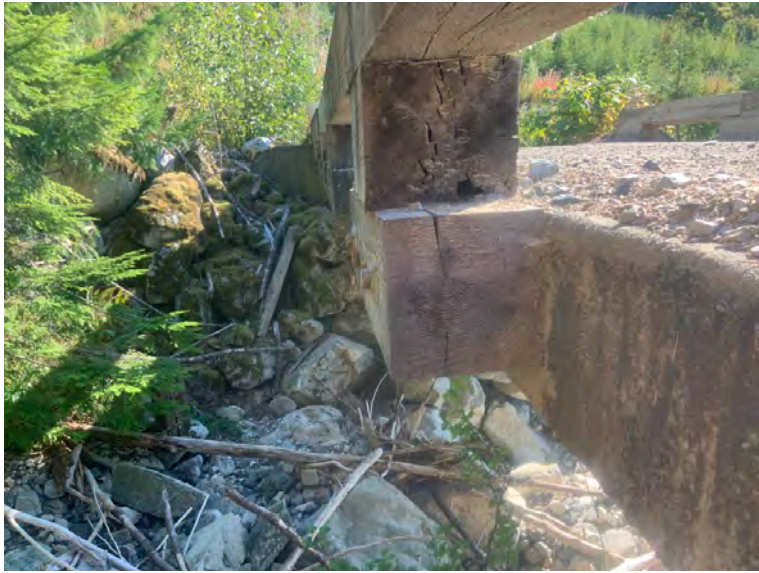
Guard Rail

Curb Rail/Blocks/Posts      **Fair**      Wood rails, risers signs of rot

Hardware      **Fair**      Rails slightly loose

Plan for guardrail replace,ent

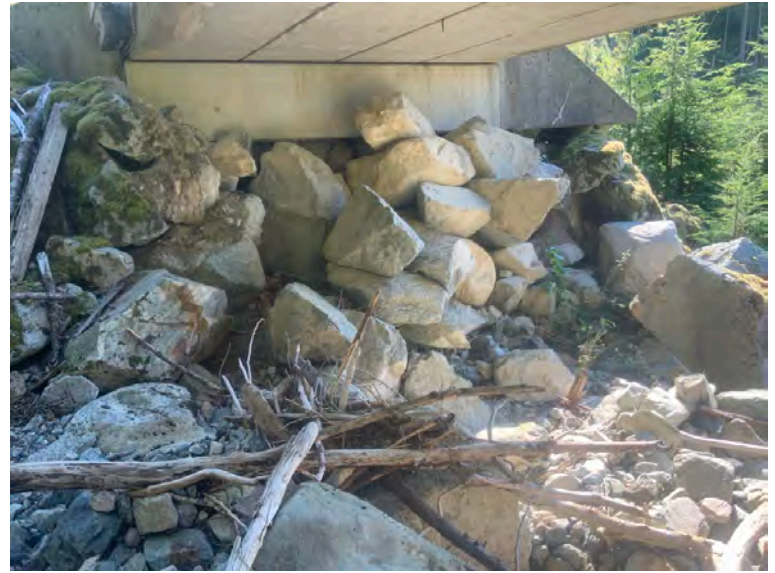
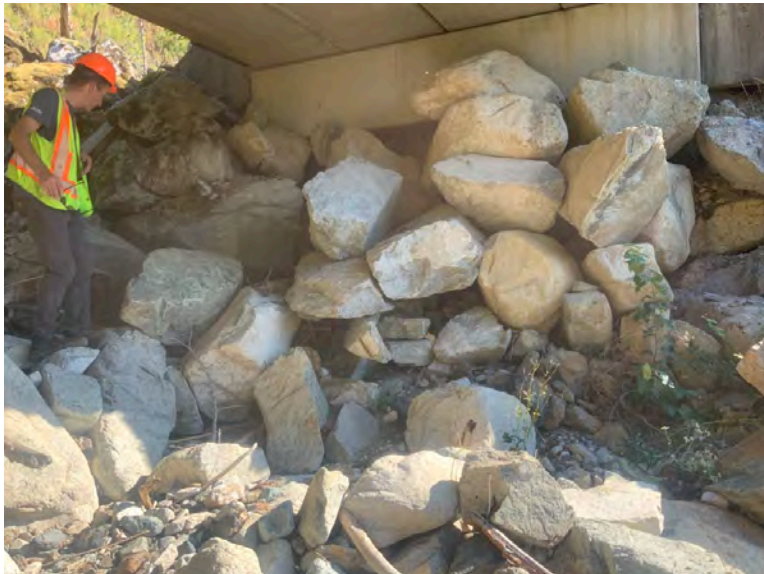
Left Bank Abutment when facing downstream

Riprap has shifted both abutments. Steep and at Risk of further movement, and consequent footing erosion. Right bank may be cast in place, bedrock present. Monitor.

Riprap Poor

Has shifted

| Item | Monitor Description | Frequency |
|---|---|---|
| 1 | Riprap for further movement and fill erosion | Routine Inspection |

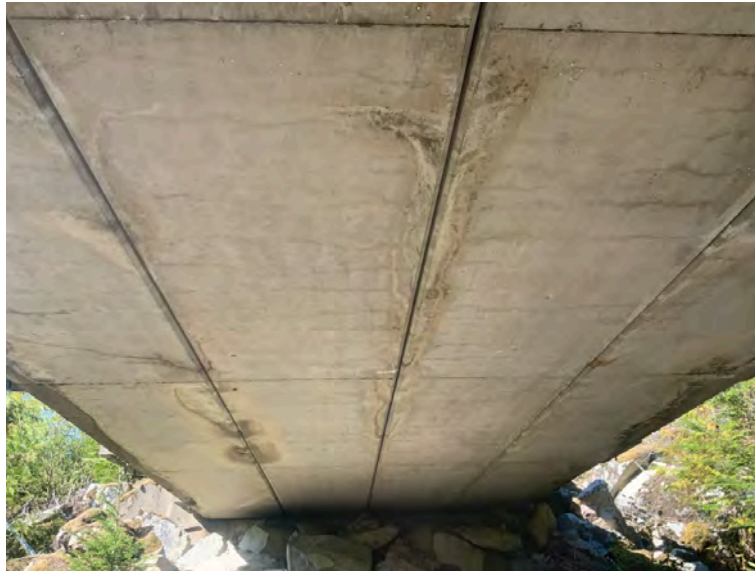
Superstructure

Girders **Good**
