SQ-3150  
SQ-3150A

## BRITANNIA CREEK 2.8km

2022 Inspection

Structure Class Major Culvert

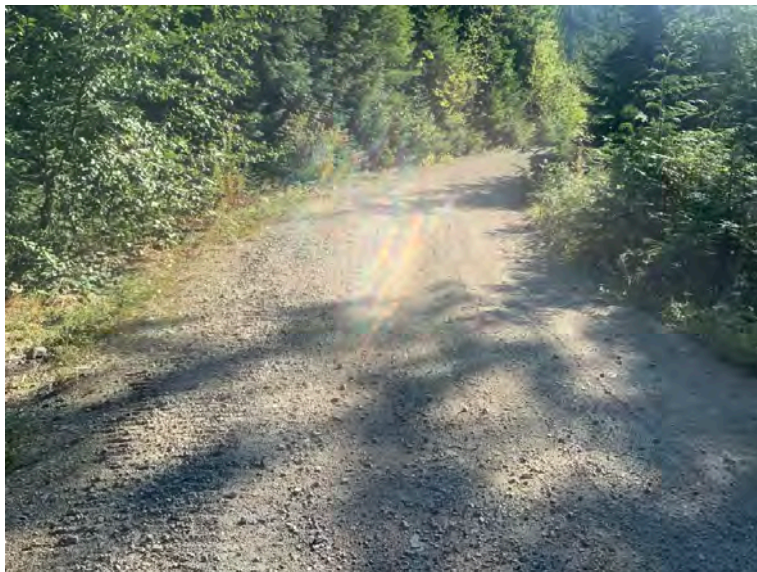
Approach from Right Bank when facing downstream

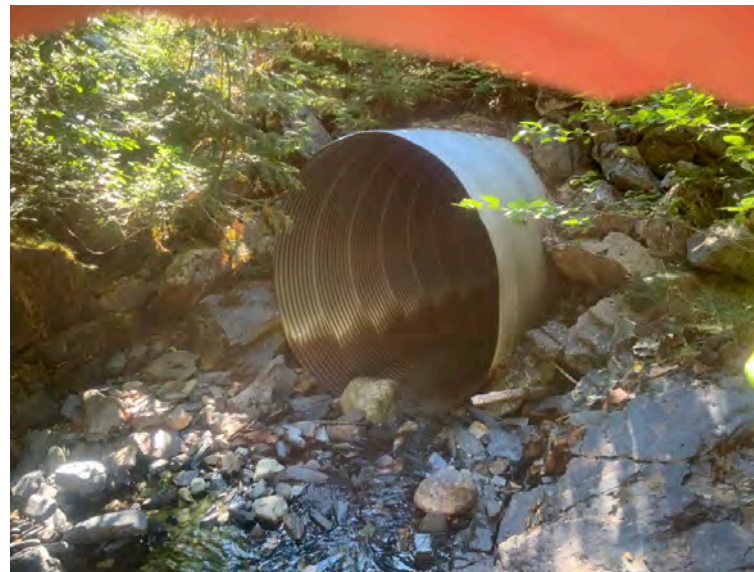
Inlet      Good

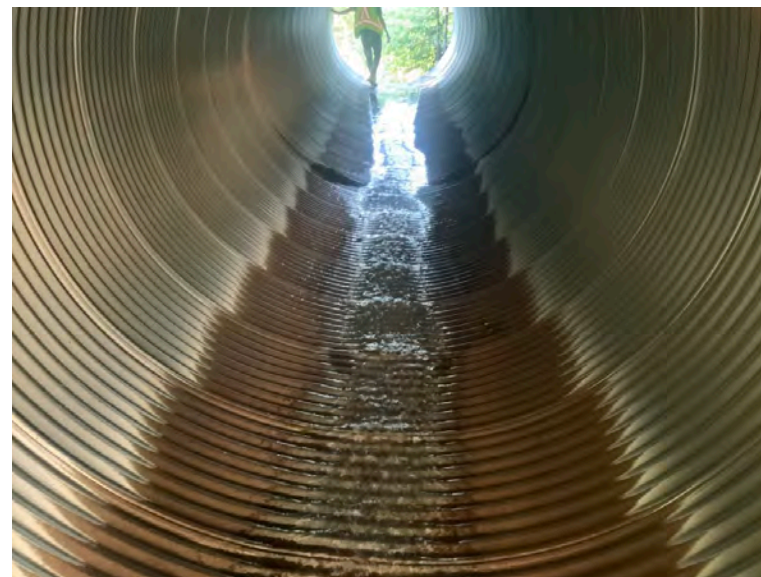
Coating      Fair      Worn floor

Floor      Fair      Rusted

Culvert Floor

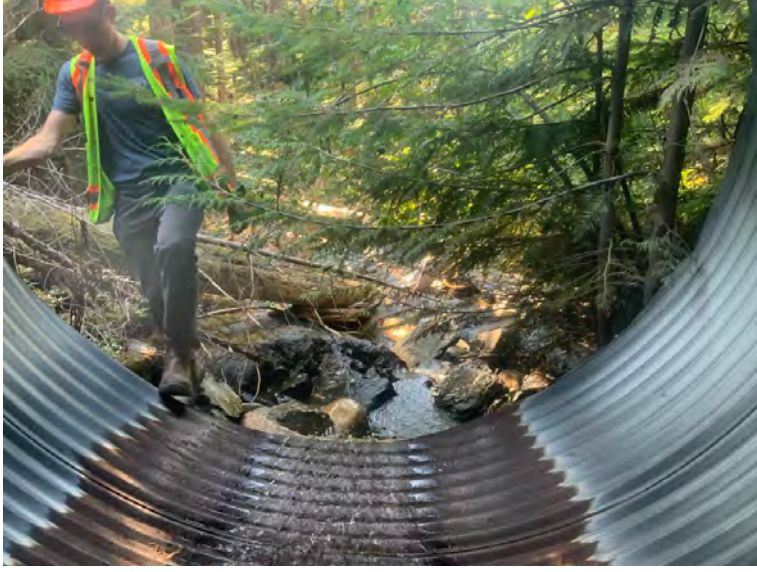
Outlet      Good
