SQ-3151

BRITANNIA 01 2.9km

2022 Inspection

Crossing Name Trib to Thistle Creek

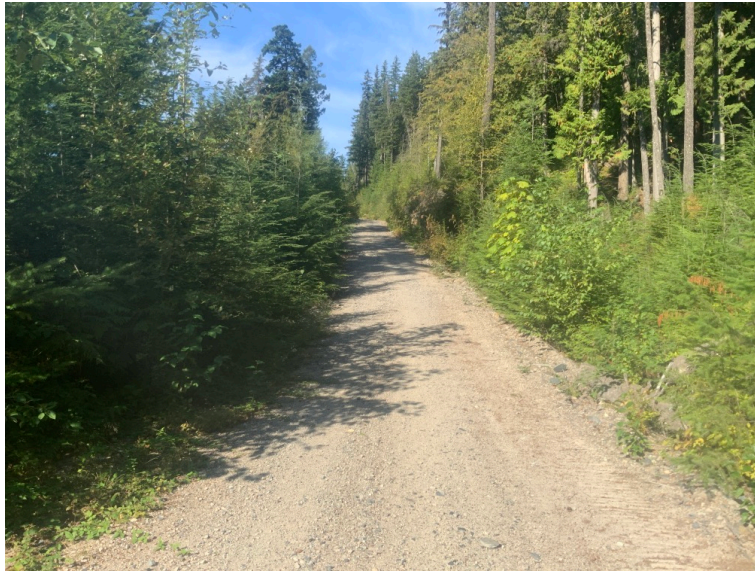
Approach from Left Bank when facing downstream

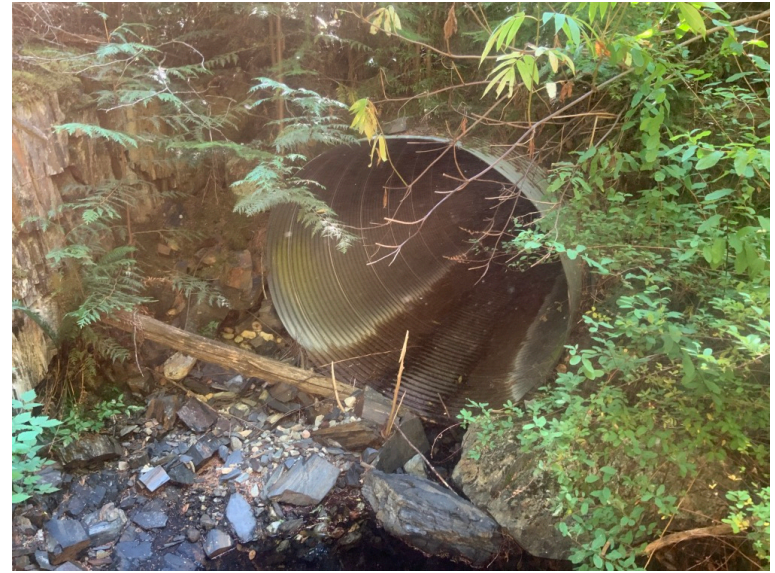
| Inlet | Good |

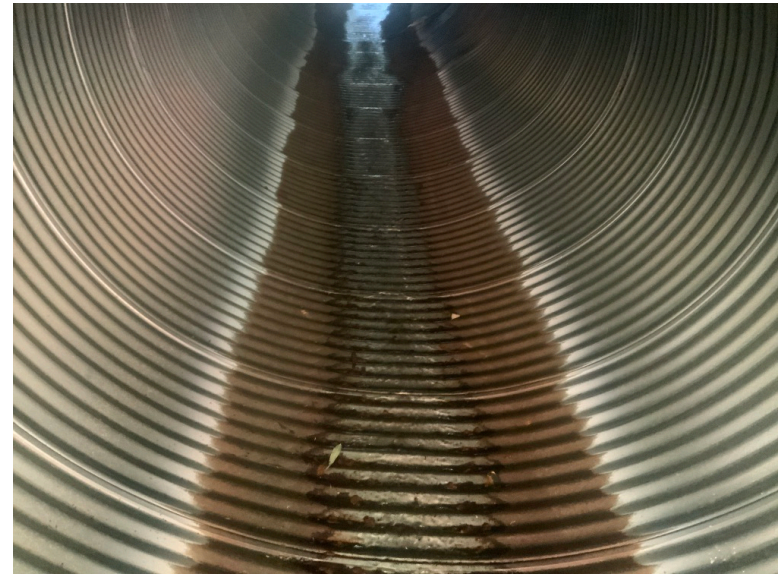
Culvert Floor

| Coating | Fair (worn floor) |
| Floor | Fair (worn, rusting) |

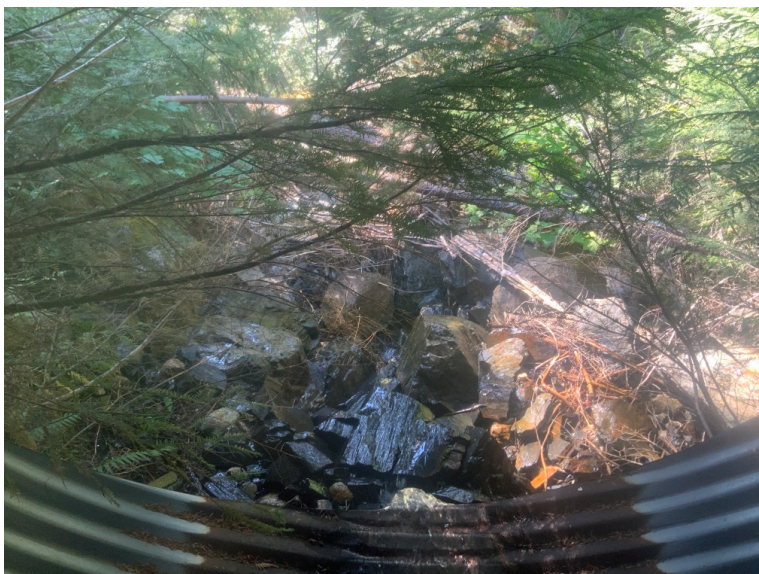
| Outlet | Good |

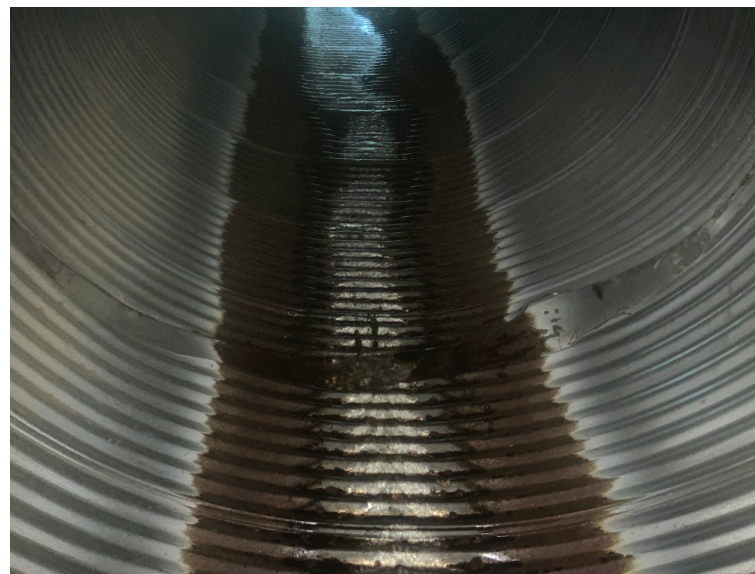
Coupler

| Coupled Connections | Fair (slight gap) |
