SQ-3152  
SQ-3152A-1

## BRITANNIA CREEK 4.5km

2022 Inspection

Structure Class Major Culvert

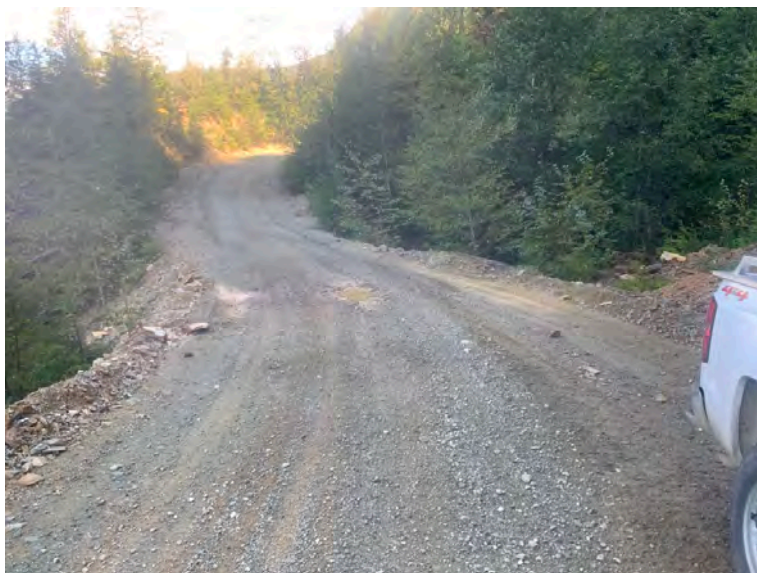
Approach from Left Bank when facing downstream

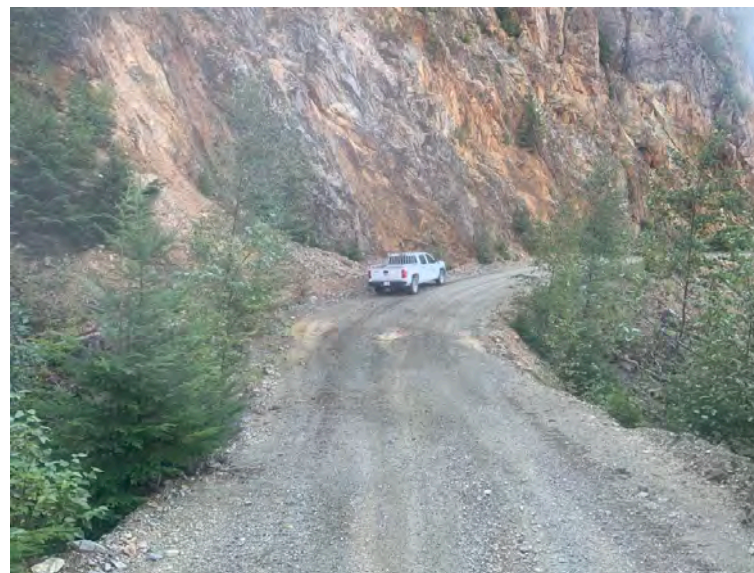
Road Surface **Fair** **Ruts over top of culvert**

Approach from Right Bank when facing downstream

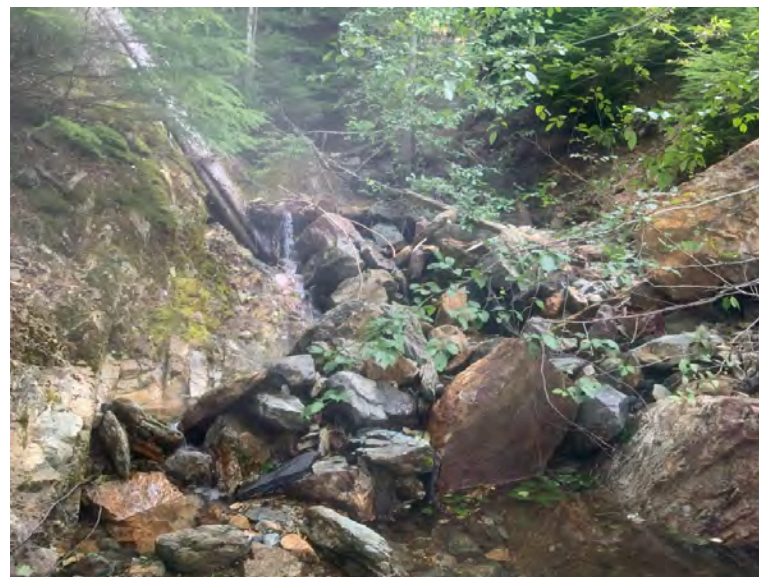
Upstream from Crossing

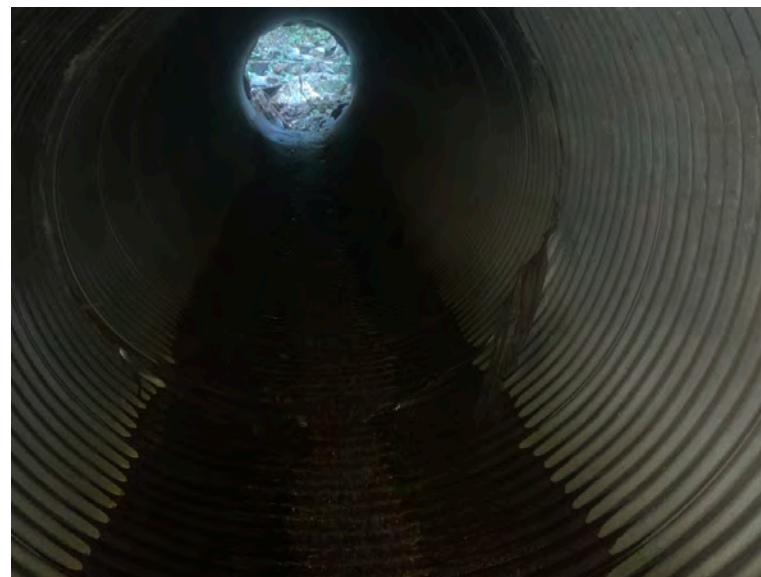
Coupled Connections      Fair

Coupled connection. Fabric sticking through

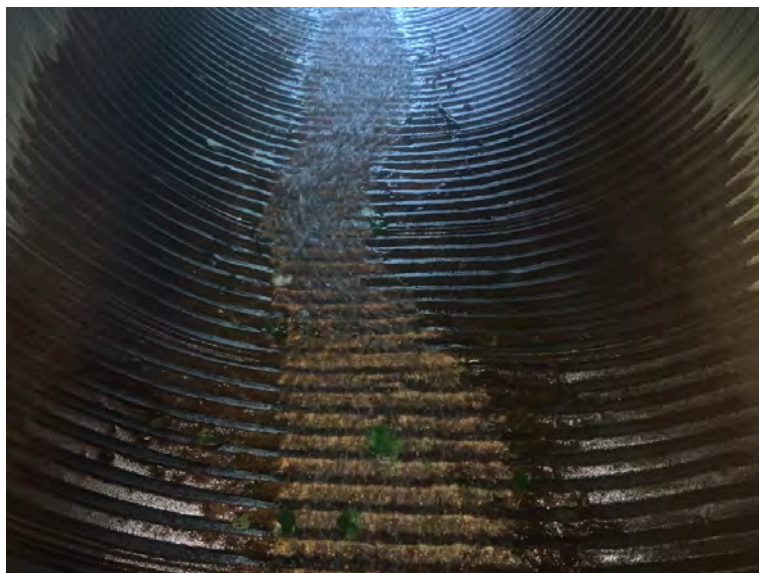
Culvert Floor

Coating      Fair      Floor is rusted

Floor      Fair      Some bulging, corrosion

| Item | Monitor Description | Frequency |
|---|---|---|
| 1 | Floor for further corrosion. | Routine Inspection |

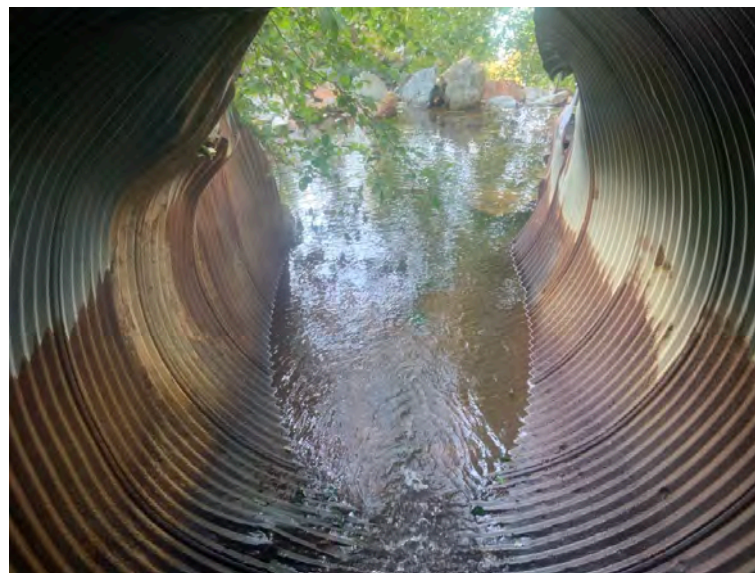
Outlet      Fair      Damage from fill
