SQ-3153  
SQ-3153

## BRITANNIA CREEK 6.9km

2022 Inspection

Structure Class Permanent Bridge

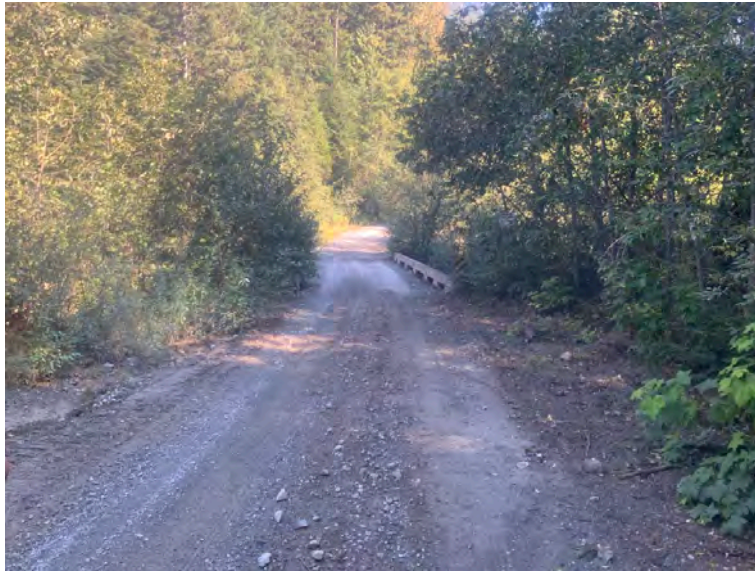
Approach from Left Bank when facing downstream

Fender Condition **Poor** **Missing or misligned, logs**

| Repair Item | Repair Description |
|---|---|
| 2 Approach. Approach fenders (re-Install). 2 # of units.<br>Priority:Medium | Re align approach logs on left bank |

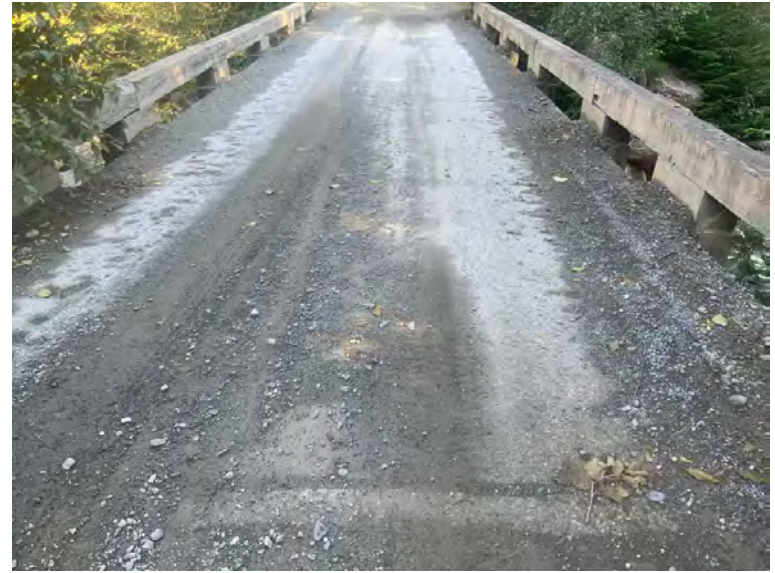
Concrete Deck      **Fair**      Minor surface dmaage

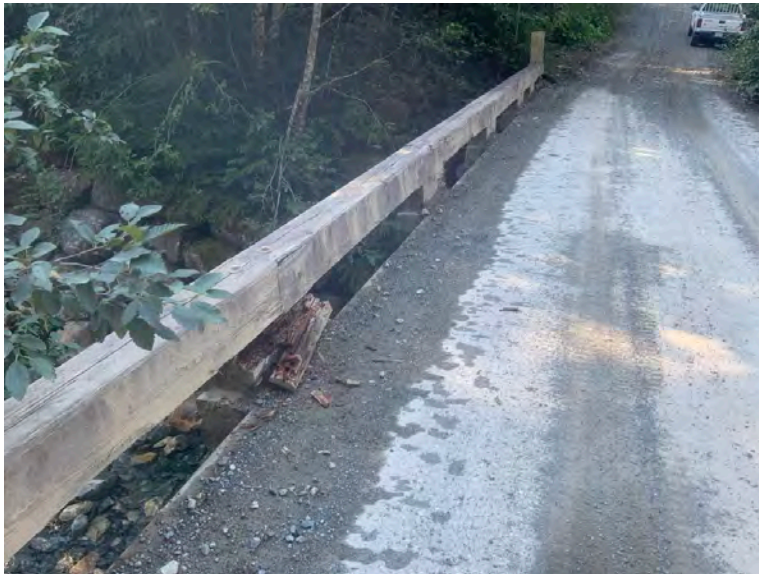
Guard Rail

Curb Rail/Blocks/Posts      **Fair**      Rotten risers

| Repair Item | Repair Description |
|---|---|
| 3 Structure. Curb Maintenance. # sites. Priority:High | Replace rotten risers. |

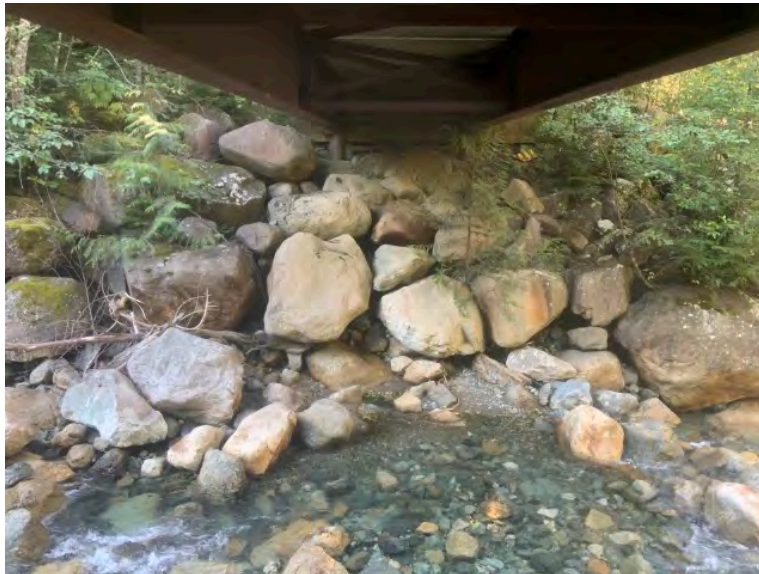
Left Bank Abutment when facing downstream

Left bank riprap may have seen movement. Very large rock at risk of becoming further unsupported. Monitor.

Riprap **Fair** **Large rock, at risk of movement**

| Item | Monitor Description | Frequency |
|---|---|---|
| 1 | Left bank riprap for movement. | Routine Inspection |
