SQ-3155  
SQ-3155

## SQUAMISH RIVER 53.1km

2022 Inspection

Crossing Name Shovel Nose Creek

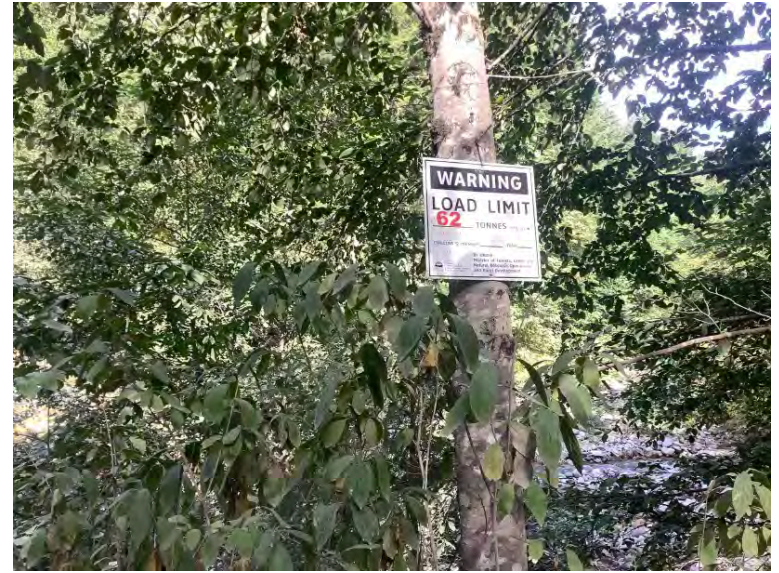
Load Rating Sign

Posted Load Rating 62

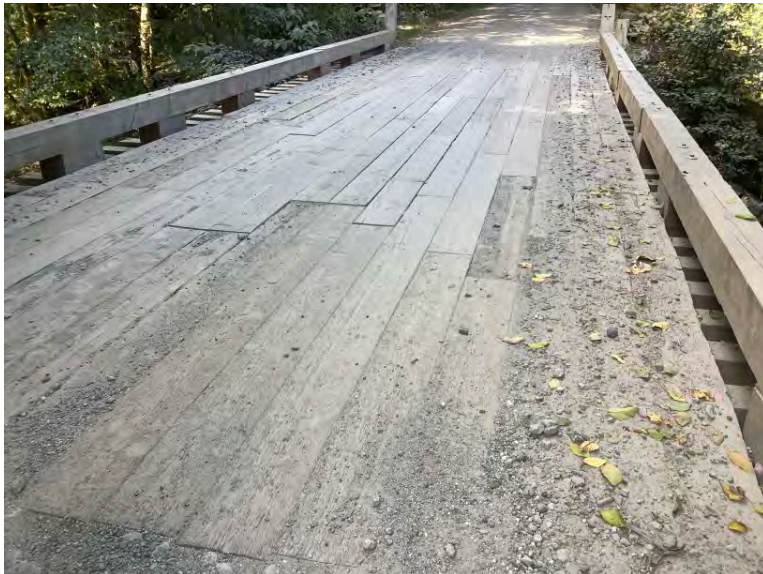
Sub Deck      Poor      Deck below ties is rotten.

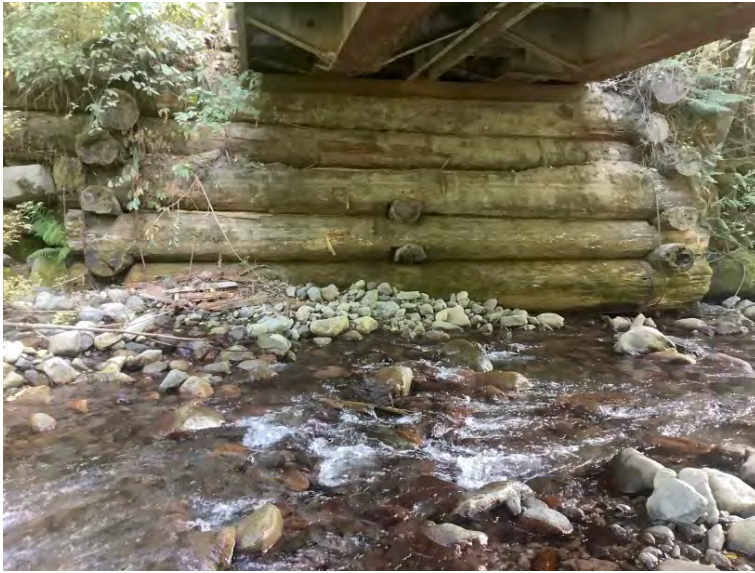
Left Bank Abutment when facing downstream

Log/Timber Cribbs Good Minor erosion

| Item | Monitor Description | Frequency |
|---|---|---|
| 1 | Minor erosion under downstream left bank abutment. | Routine Inspection |

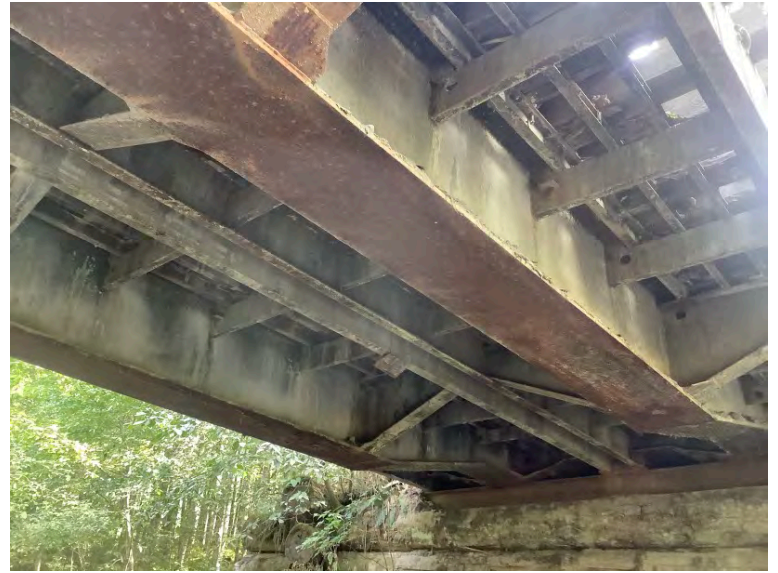
Superstructure

Deck to Girder Bolts      Fair      Timber washers bolted up next to steel runner on rail car.

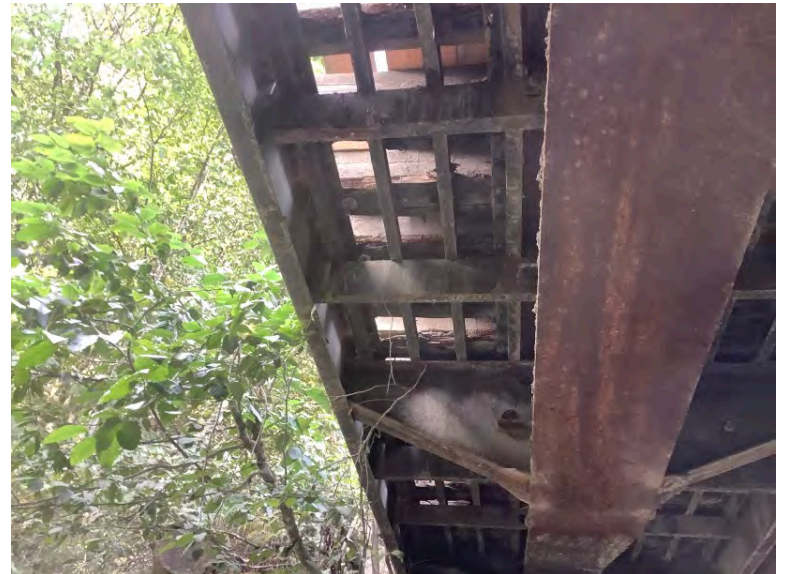
Ties      Good
