SQ-3156  
SQ-3156

## SQUAMISH RIVER 53.6km

2022 Inspection

Crossing Name Turbid Creek

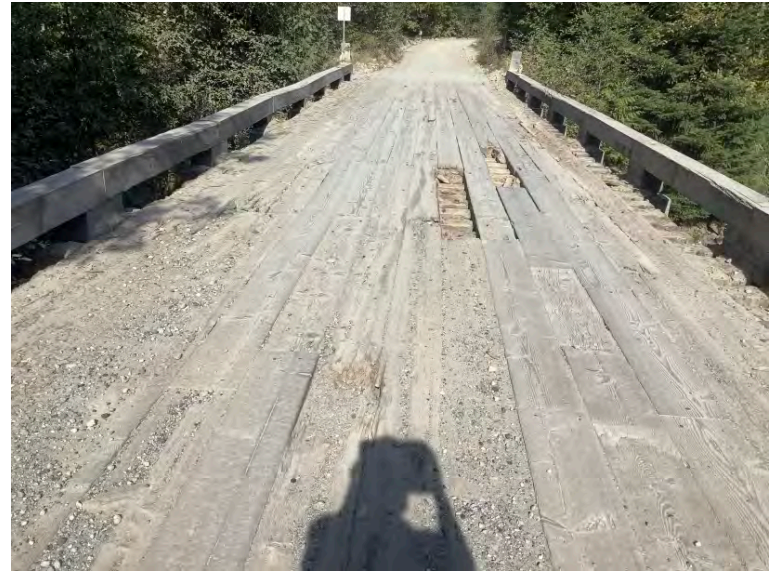
Deck

Ties      **Poor**      Nearing end of life. Estimate at least every 3rd tie contains some level of rot at ends and where guard rail is located.

Curb Rail/Blocks/Posts      **Poor**      Loose not functioning.

- 1 Structure. Major redecking (crossties or laminated deck). m. Priority:High Suggest complete redecking. Could consider on rails and running surface, but ties are not far away from replacing.

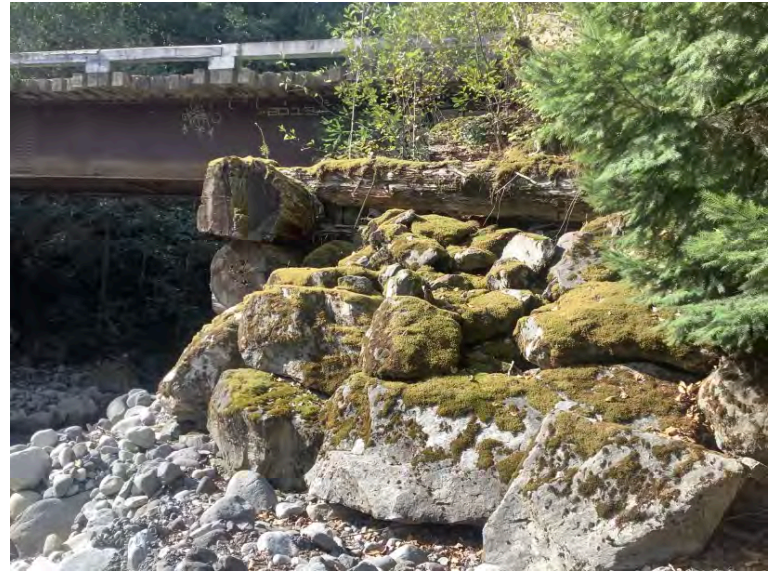
Right Bank Abutment when facing downstream

Log/Timber Cribs Fair Aging but okay.

Tie Backs Fair Some tiebacks starting to split.

Riprap Poor Potential for erosion of cribs, but given history, unlikely.

- 1 Monitor cribs for erosion.
