SQ-3157  
SQ-3157A

## SQUAMISH RIVER 53.9km

2022 Inspection

Crossing Name Mud Creek

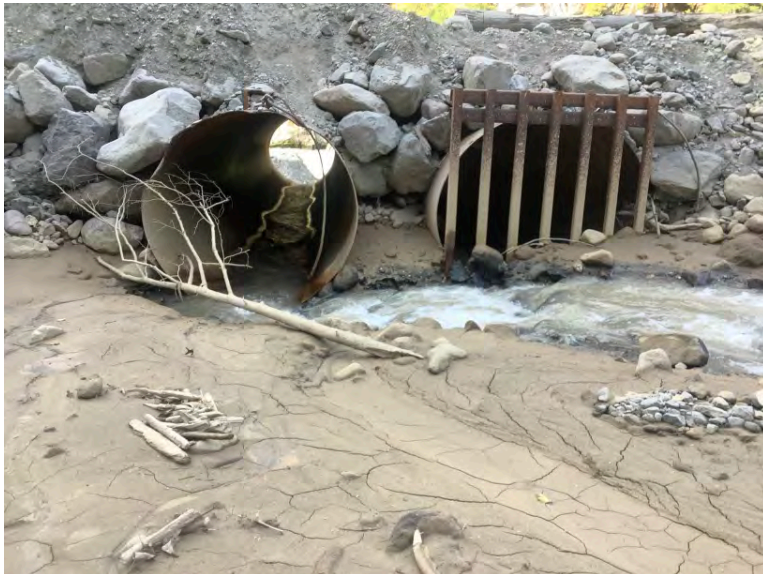
Fill      Poor      Inlet is not well armoured and pipes are perched at the outlet.

Inlet      Fair      Right bank culvert partially plugged. Is inlet grate serving any purpose?

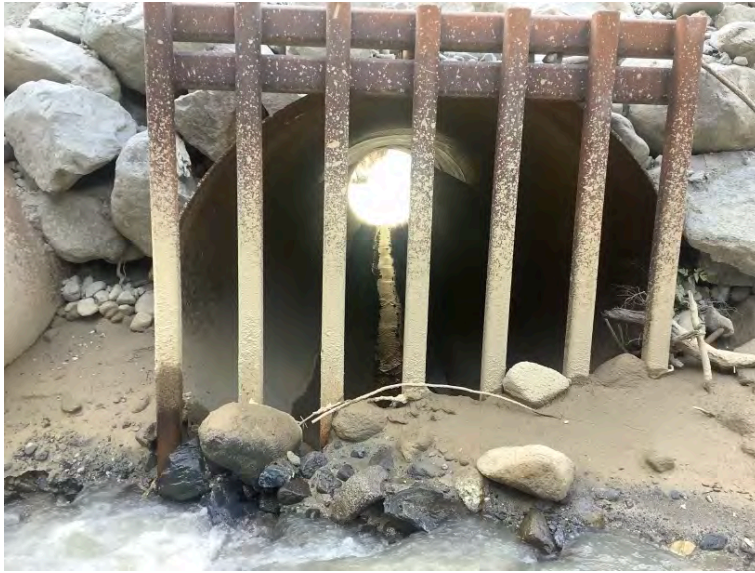
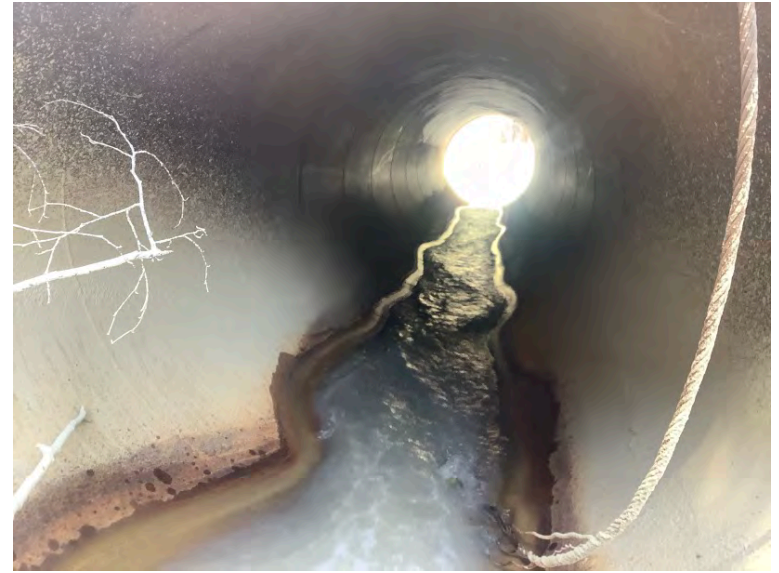
Culvert Barrel

Sidewalls      Fair      Some damage, but okay.

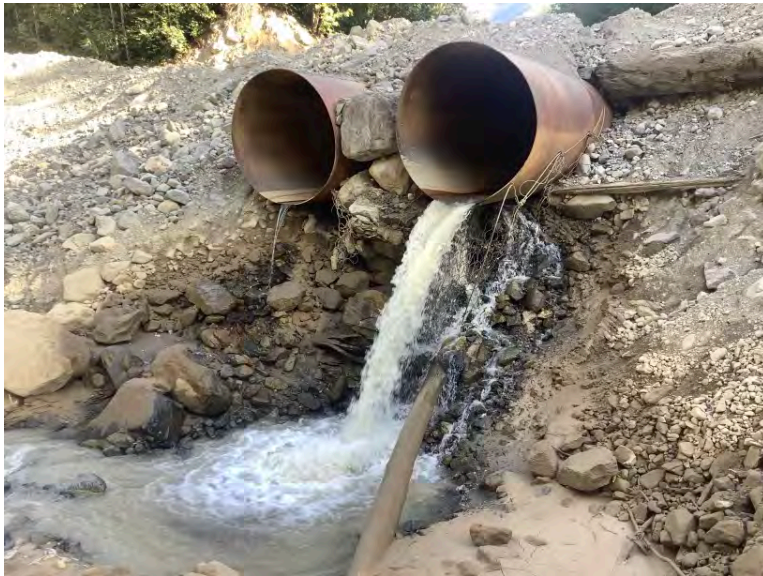
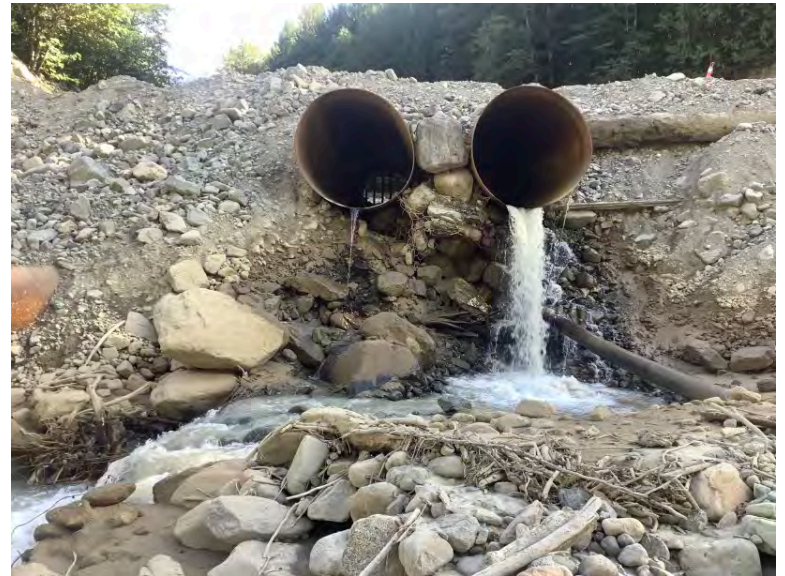
Outlet      Poor      Poorly armoured and severely undercut. Pipes are perched.
