SQ-3162  
SQ-3162

ASHLU RIVER 35.8km

2022 Inspection

Crossing Name Ashlu Creek (A4)

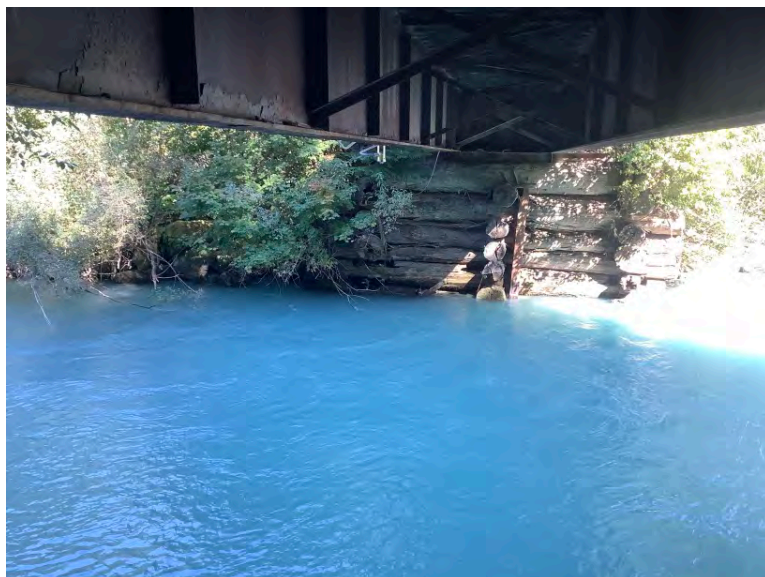
Left Bank Abutment when facing downstream

Log/Timber Cribbs Poor Rotting nearing end of life

Caps or Sills Poor River left side has significant scaling and diaphragms are buckling under load.

1 Miscellaneous. Total  
Structure Replacement. # of  
items. Priority:Medium  
Agree with 2020 comments from G. Fournier.

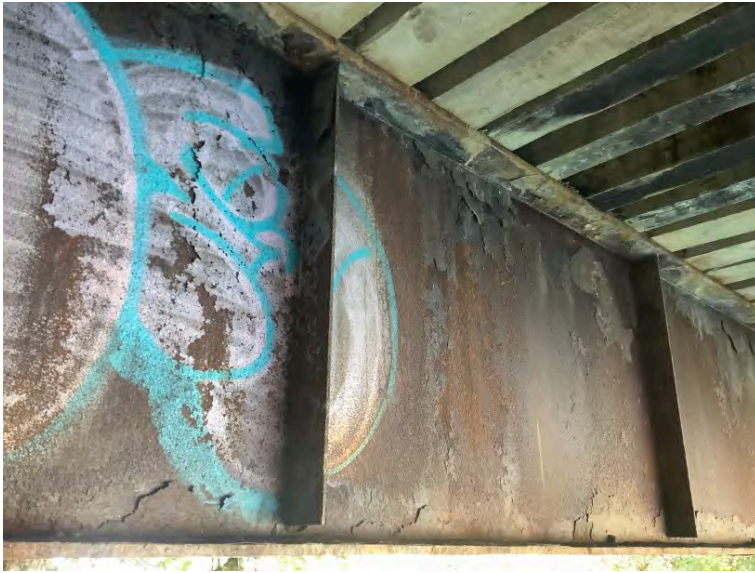
Superstructure

Girders Poor Significant rust scaling present

Diaphragms Poor Significant rust scaling present

Bracing Poor Significant rust scaling present

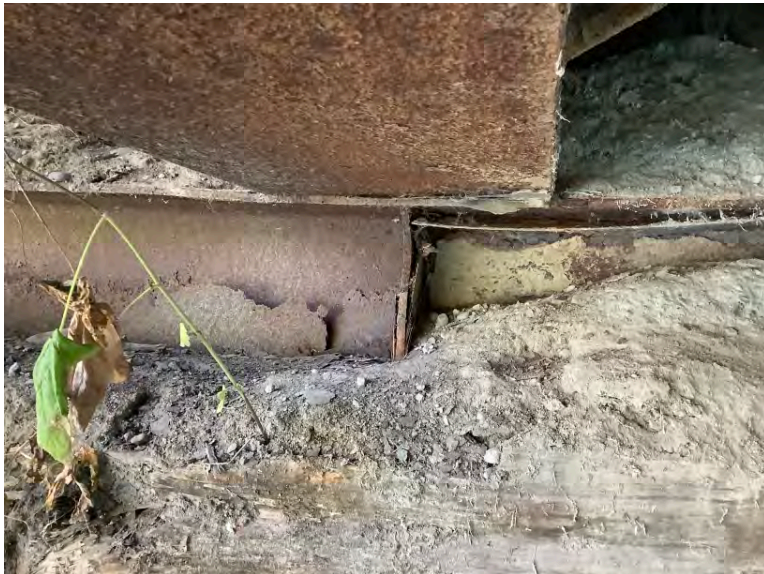
Bearing

Bearings Poor See caps above
