SQ-3165  
SQ-3165

KAKILA CREEK 60.4km

2022 Inspection

Crossing Name Kakila South Creek

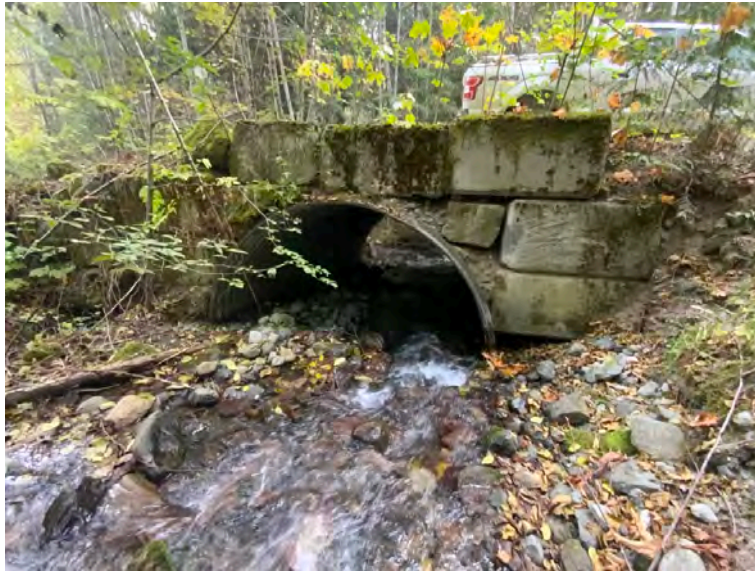
| Inlet | Poor | Too small. Structure should be replaced with bridge |

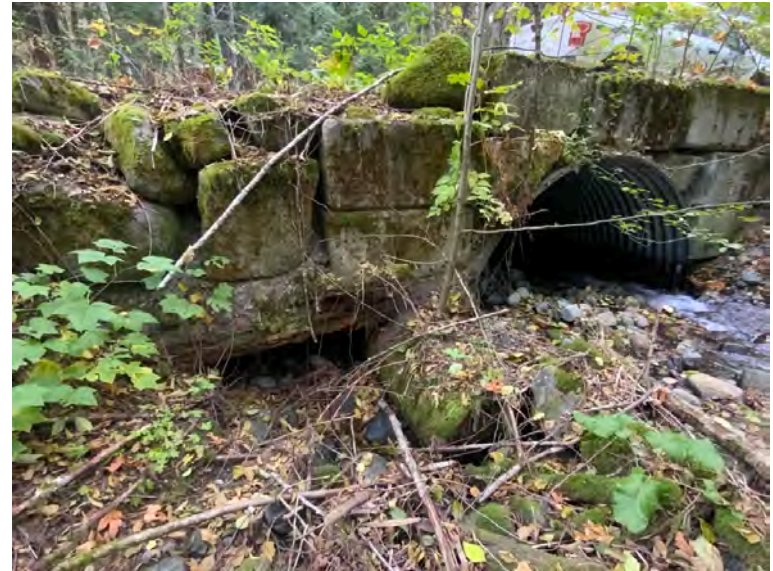
| Overall | Poor | Due to footing erosion and support to arch by old log culvert. |
| Rip Rap | Poor | Poor, due to placement on old log structure and vertically stacked. |

Inlet of both old log culvert and arch. Arch footing supported by log sill and old culvert supporting riprap

| Repair Item | Repair Description |
|---|---|
| 1 Structure. Multiplate/culvert maintenance. m³.<br>Priority:High | Replace structure with appropriately sized bridge, likely a slab would work. |

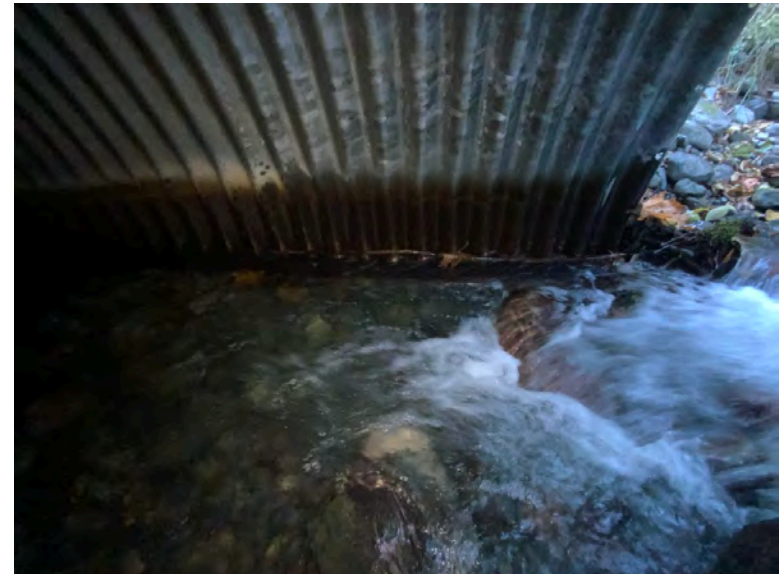
Fill Poor Erosion of fill under footing and behind structure on outside edges.

| Footing | Poor | Erosion on right side occurring. |

Right upstream footing erosion under footing.

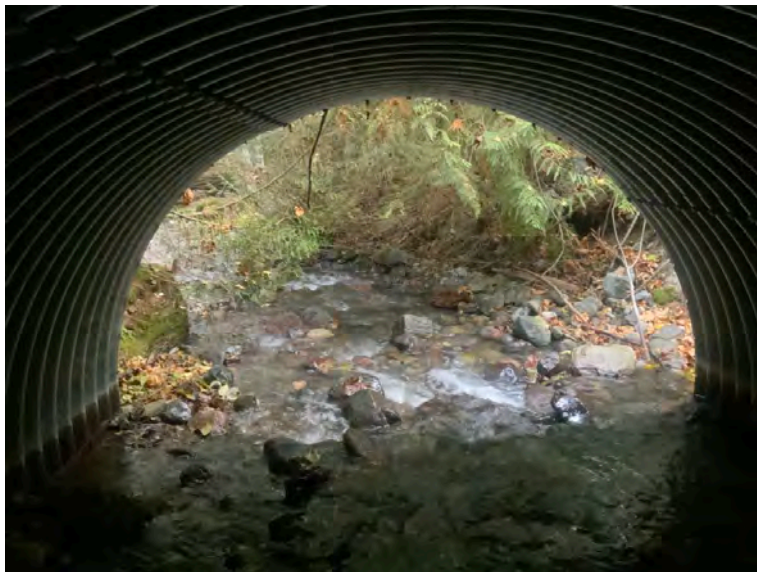
| Outlet | Poor | Erosion |

Looking at outlet.

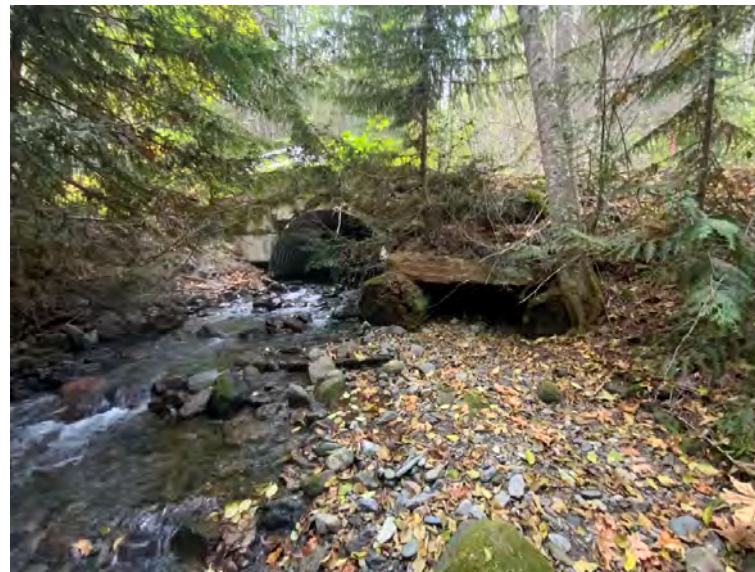
Looking at outlet from downstream.
