SQ-3169  
SQ-3169

FURRY CREEK 03 0.5km

2022 Inspection

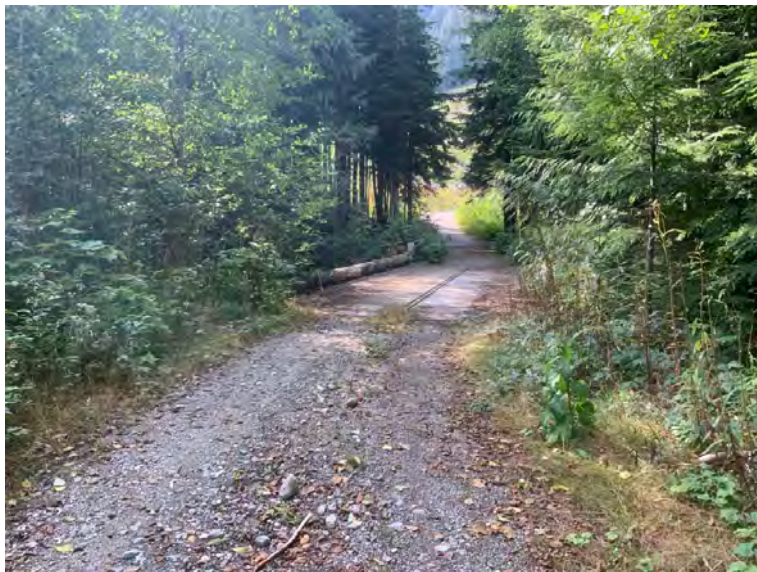
Approach from Right Bank when facing downstream

No approach barriers

| Repair Item | Repair Description |
|---|---|
| 1 Approach. Approach fenders (install). 4 # of units.<br>Priority:High | Add approach barriers |

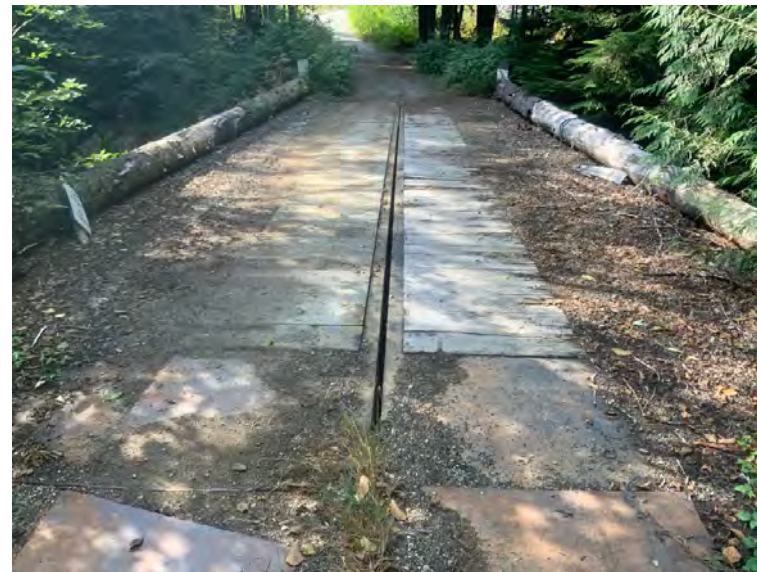
Running Planks      Poor      Rotten

Overall Deck Condition      Poor      Rotten deck

| Repair Item | Repair Description |
|---|---|
| 3 Structure. Major redecking (crossties or laminated deck).<br>m. Priority:High | Replace deck. |

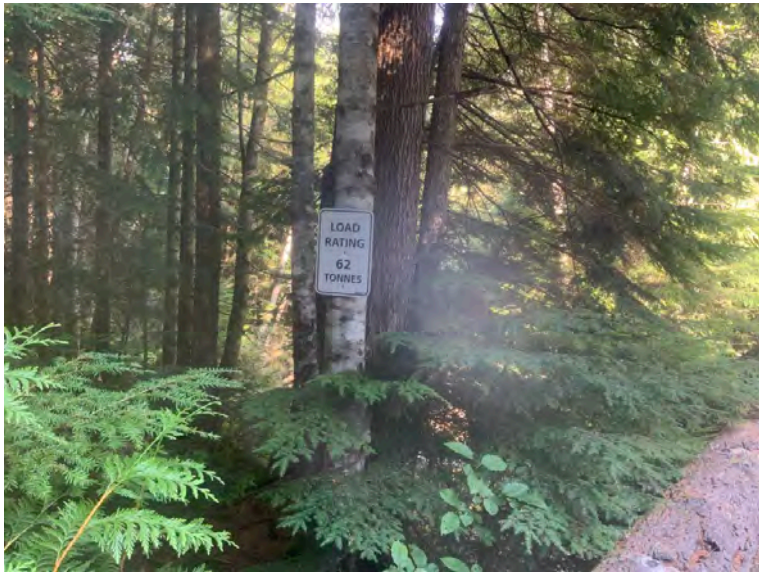
Load Rating Sign

Posted Load Rating 62

Bridge has been down rated to 5t

| Repair Item | Repair Description |
|---|---|
| 2 Approach. Add Warning Signs. 2 # of signs.<br>Priority:High | Post load rating sign |

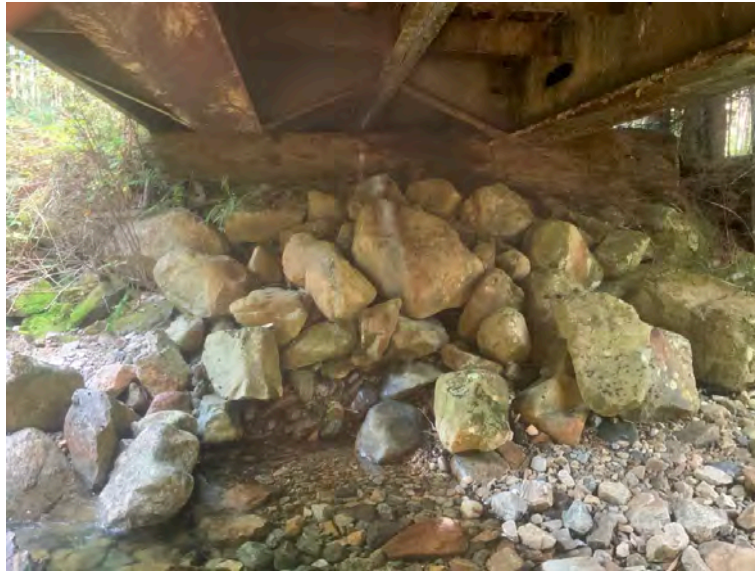
Left Bank Abutment when facing downstream

Riprap Fair Signs of movement. Left toe exposed

| Item | Monitor Description | Frequency |
|---|---|---|
| 1 | Left bank riprap for further movement | Routine Inspection |

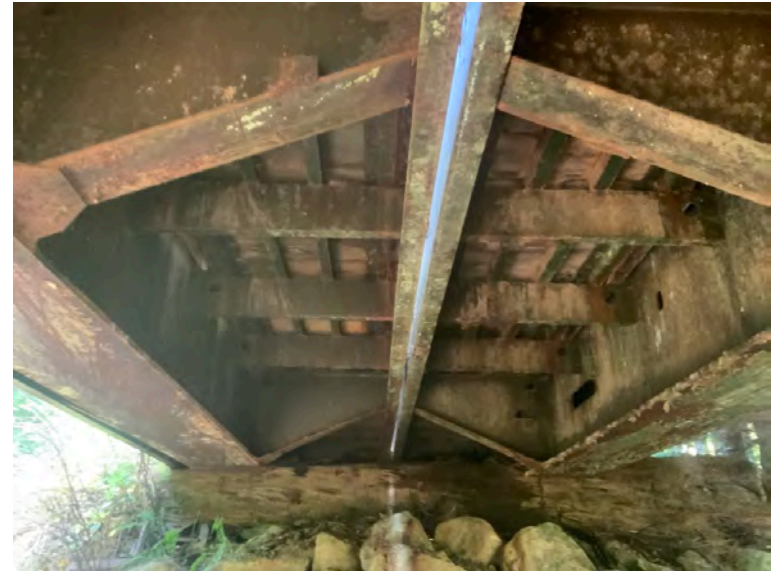
Superstructure

Girders Fair

All steel components, rusting
