SQ-3174  
SQ-3174

## CHEAKAMUS/BLACKTUSK

2022 Inspection

Structure Class Temporary Bridge

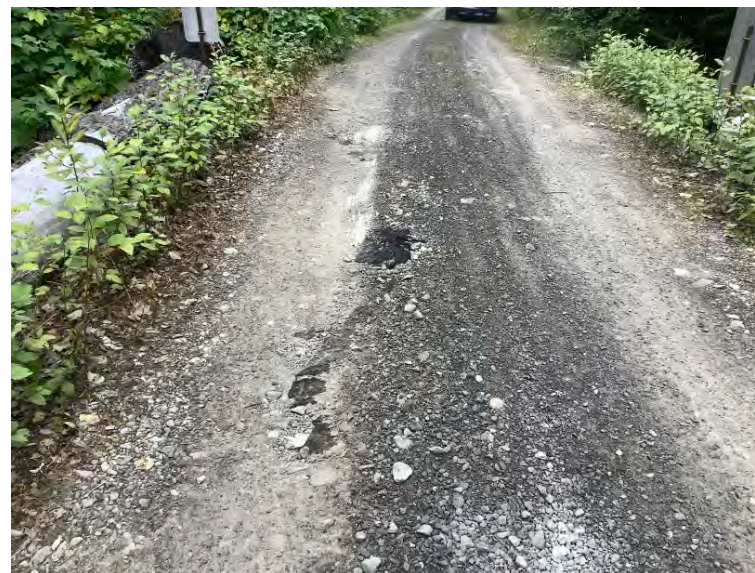
Deck

Gravel Surface      Poor      Low on fill

Gravel Depth (mm)      0      Stringer 3 protruding through road surface.

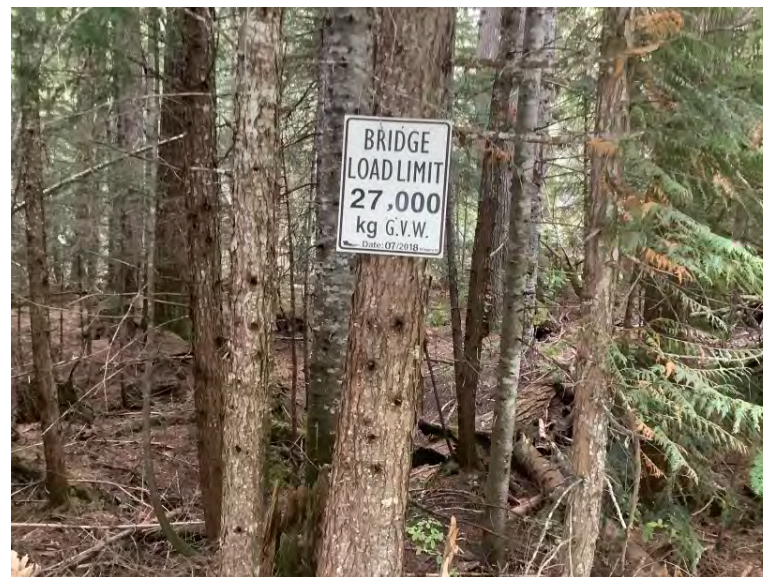
Load Rating Sign

Check load rating in office. Suggest as a bare minimum the load limit be reduced until fill is added. Very poor quality stringers due to high rot levels. Surprised conk is not present, but should still consider impacts of pocket rot if stringers are in fact Fd. Recommend somewhere around 30 tonne load limit but should be checked in the office. Post inspection: confirmed load rating reasonable at BCL625, per g.dohm.

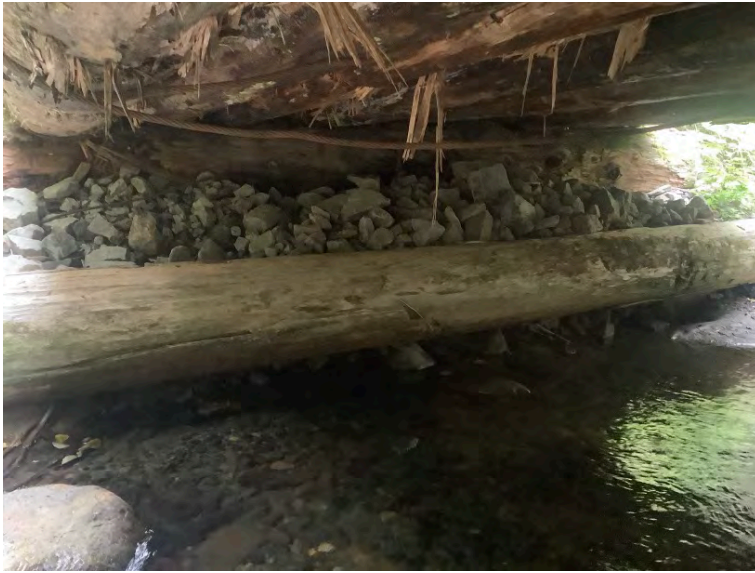
Right Bank Abutment when facing downstream

Log/Timber Cribs Poor Camp side is severely undermined.

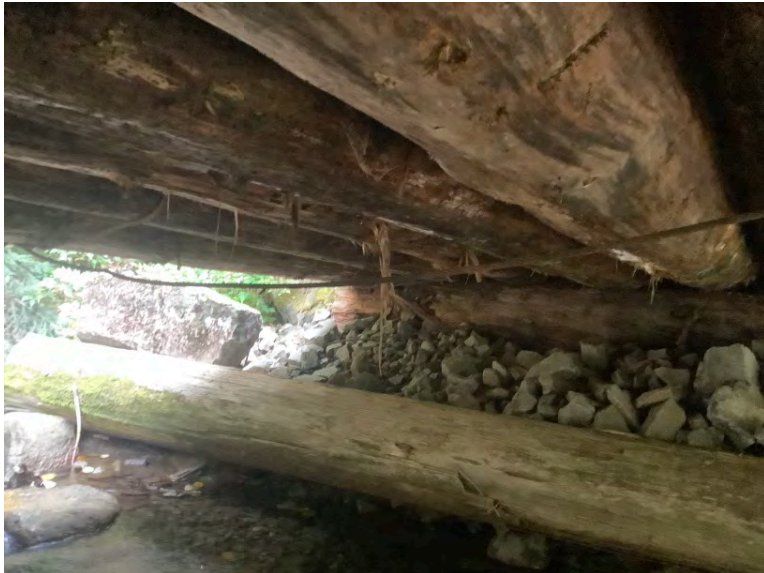
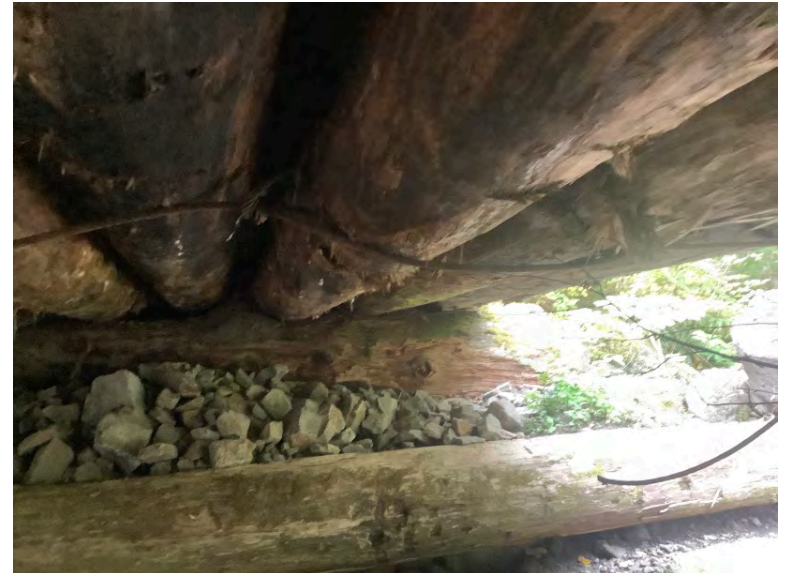
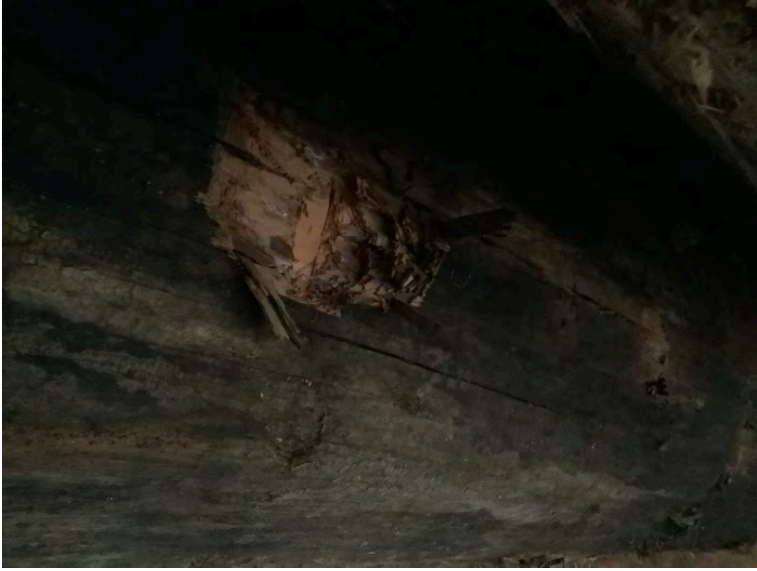
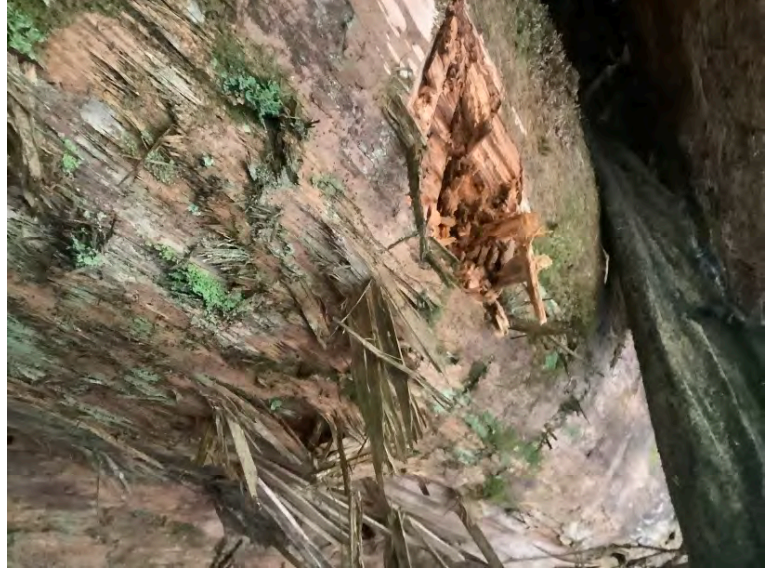
Stringers

| 1 | Fd | Y | 590 | 590 | Poor | Conk/fungus present. |
| 9 | Fd | Y | 660 | 660 | Poor | Conk/fungus present |

1 Miscellaneous. Total  
Structure Replacement. # of  
items. Priority:Medium
