SQ-3178  
SQ-3178

MILLER BENCH 1.9km

2022 Inspection

Crossing Name Trib to Ryan River

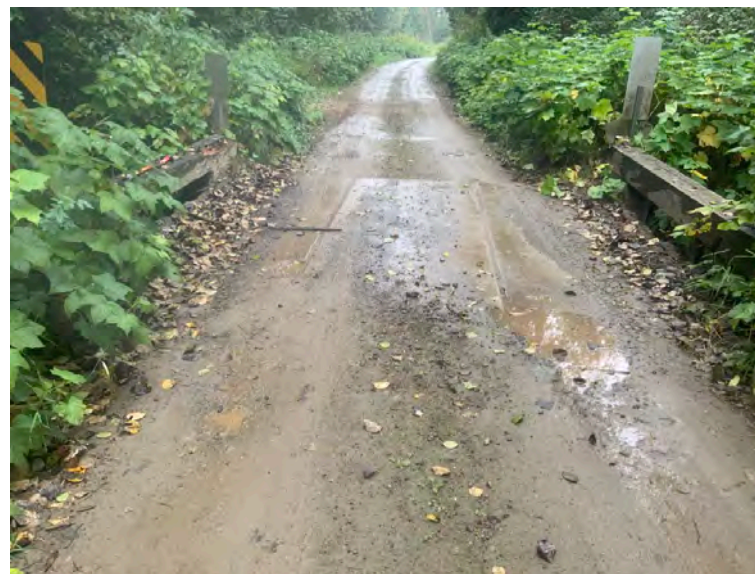
Running Surface      **Good**      Potholes, fill on deck

Overall Deck Condition      **Fair**      Clean deck and replace rails

| Repair Item | Repair Description |
|---|---|
| 2 Structure. Clean Deck. # of delineators. Priority:Medium | Clean deck and fill potholes |

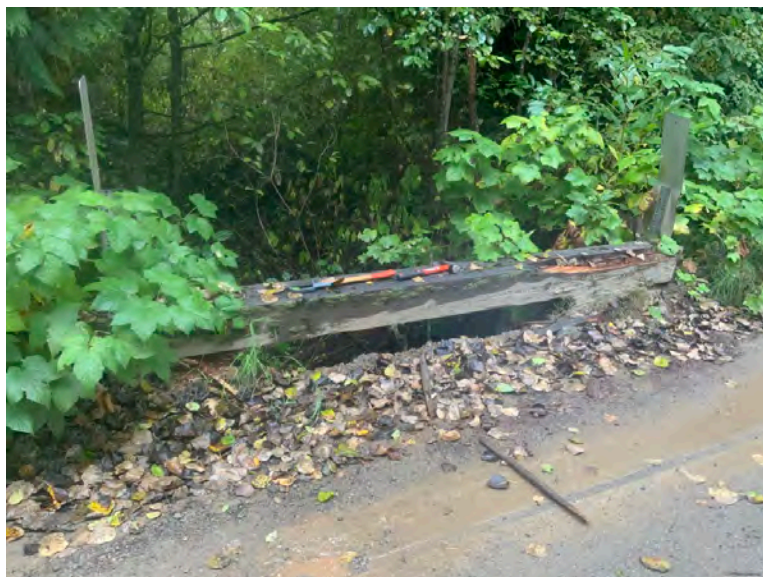
Guard Rail

Curb Rail/Blocks/Posts      **Poor**      Rotten risers, damaged rail. Upstream

Hardware      **Fair**      Loose rails

| Repair Item | Repair Description |
|---|---|
| 1 Structure. Curb Maintenance. # sites. Priority:High | Replace upstream guardrails and riser blocks. |

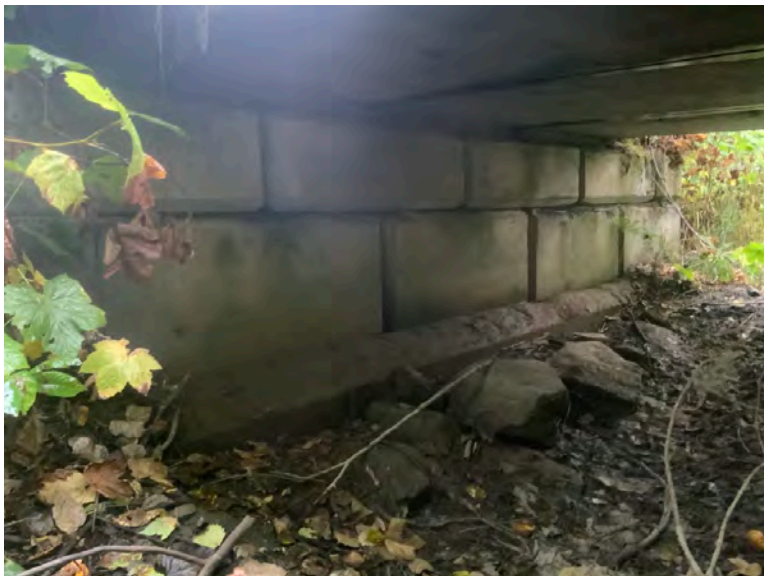
Left Bank Abutment when facing downstream

Footings becoming exposed, low velocity channel. Monitor. Replace upstream guardrail and risers. Ds appears to have been replaced prior.

| Item | Monitor Description | Frequency |
|---|---|---|
| 1 | Footings for scour/undermining | Routine Inspection |

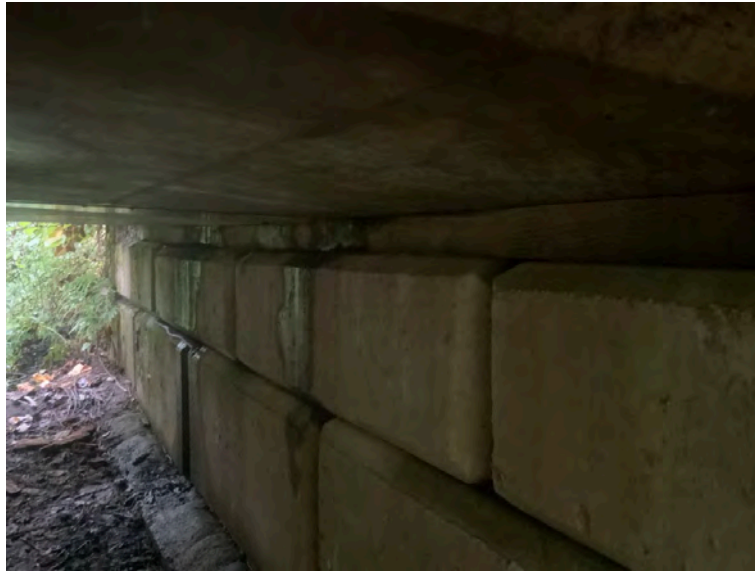
Bearing

Bearings **Fair**
