SQ-3179  
SQ-3179A

## MILLER BENCH 2.5km

2022 Inspection

Crossing Name Trib to Ryan River

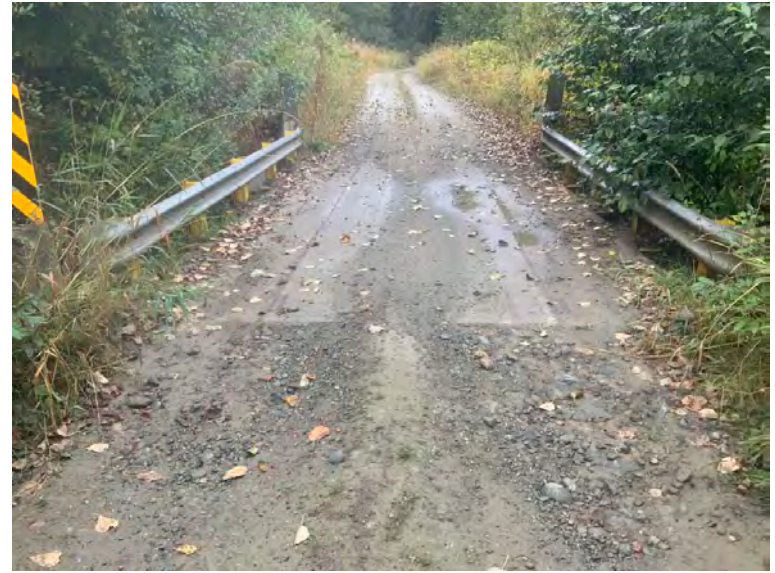
Deck

Running Surface      **Good**      Potholes both approaches

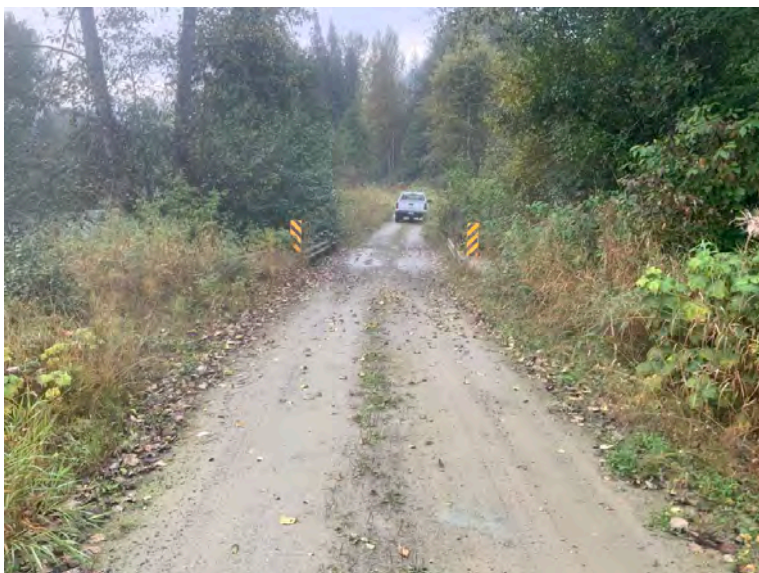
Approach from Left Bank when facing downstream

Road Surface **Fair** Potholes both approaches

| Repair Item | Repair Description |
|---|---|
| 1 Approach. Approach fill repair. m³. Priority:Low | Fill potholes, both approaches |

2 Approach. Area/sight line brushing. m². Priority:Low

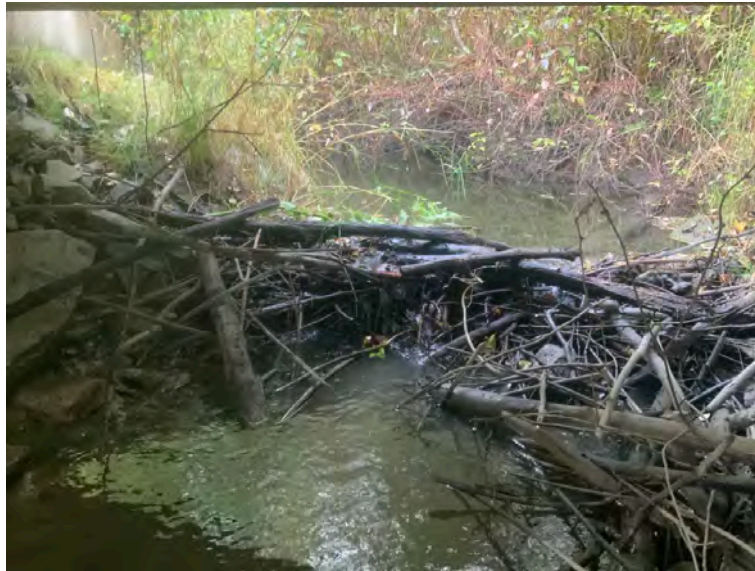
Upstream from Crossing

Comments Small beaver dam? Directly upstream . Monitor

| Item | Monitor Description | Frequency |
|---|---|---|
| 1 | Beaver dam upstream | Anually |

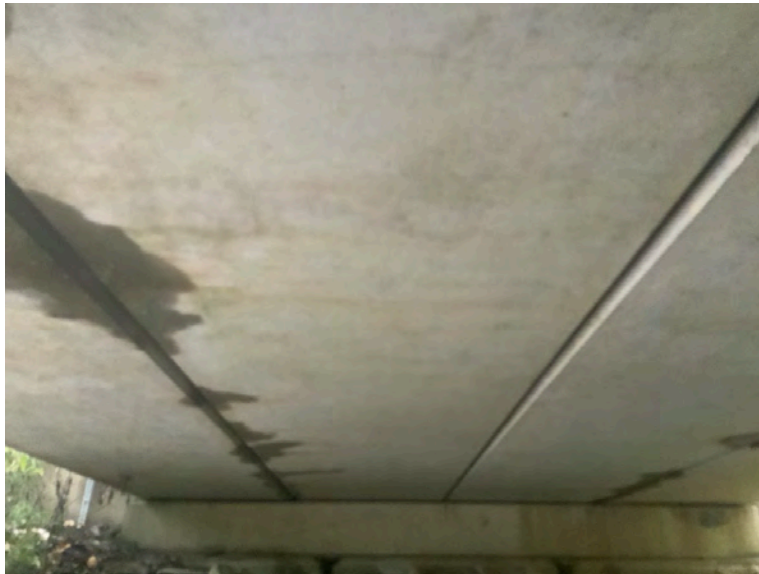
Superstructure

Girders **Good**

Welded/grouted  
shear connectors **Good**
