SQ-3180  
SQ-3180A

MILLER BENCH 2.6km

2022 Inspection

Crossing Name Trib to Ryan River

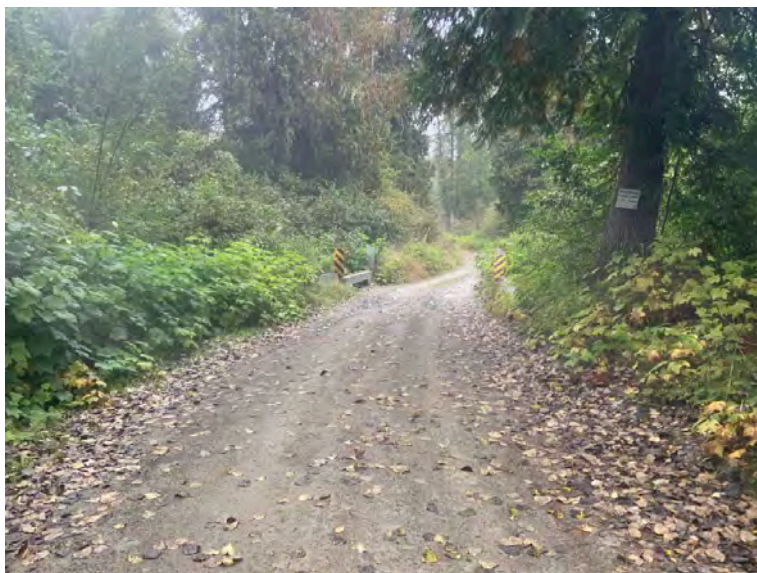
Approach from Right Bank when facing downstream

Road Surface **Fair** Potholes town approach

| Repair Item | Repair Description |
|---|---|
| 2 Approach. Approach fill repair. m <sup>3</sup> . Priority:Medium | Fill potholes town side |

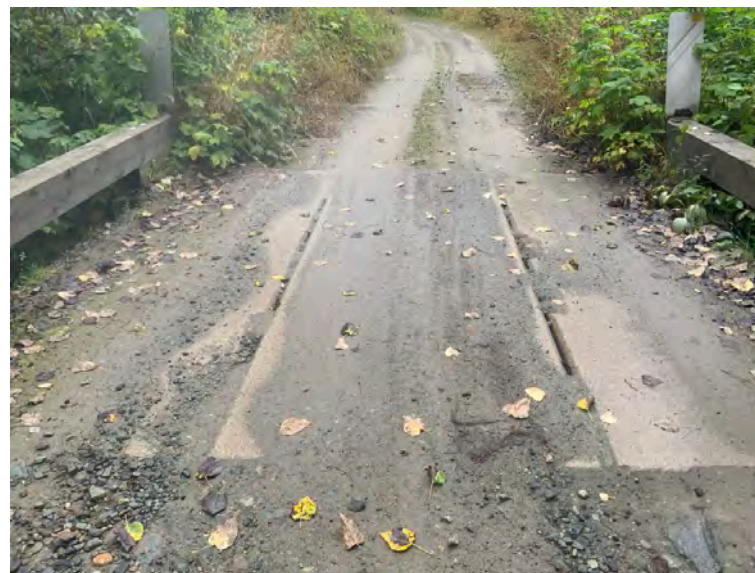
Concrete Deck      **Fair**      damaged patches on top, edge

| Repair Item | Repair Description |
|---|---|
| 1 Structure. Concrete structural maintenance. m <sup>2</sup> . Priority:Medium | Repair deck surface and edge |

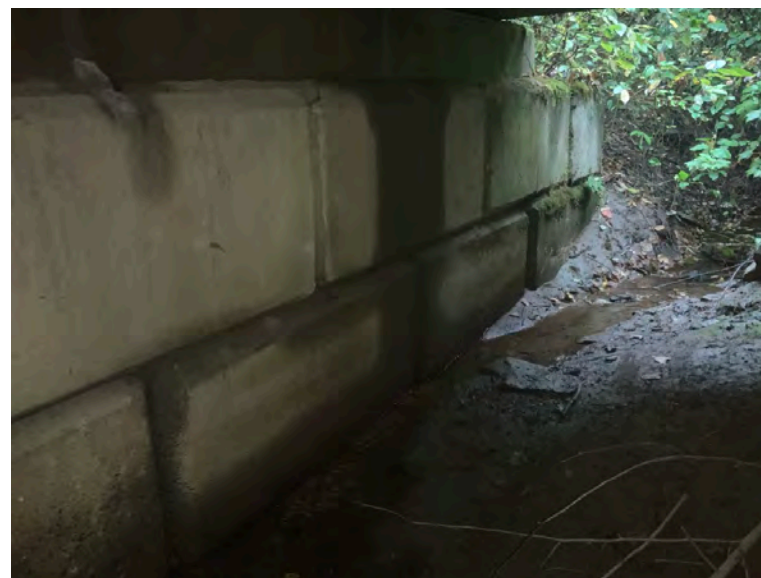
Right Bank Abutment when facing downstream

Low flow stream, no riprap. Check records to see how high lock block stack. If only 2 high Right bank sitting on stream and at risk of undermining. Lock blocks appear to be leaning slightly. Likely from install. Monitor both items.

Ballast Wall **Good** Lock blocks appear to be leaning slightly.

| Item | Monitor Description | Frequency |
|---|---|---|
| 1 | Right bank abutment for scour | Routine Inspection |
| 2 | Lock blocks for leaning | Routine Inspection |
