SQ-3184  
SQ-3184

## SQUAMISH RIVER 35.5km

2022 Inspection

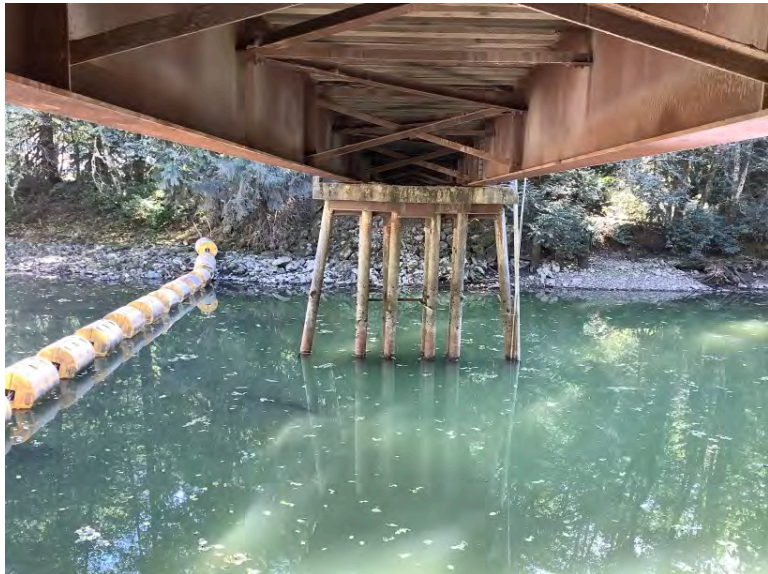
Pier Fair Unable to fully assess.

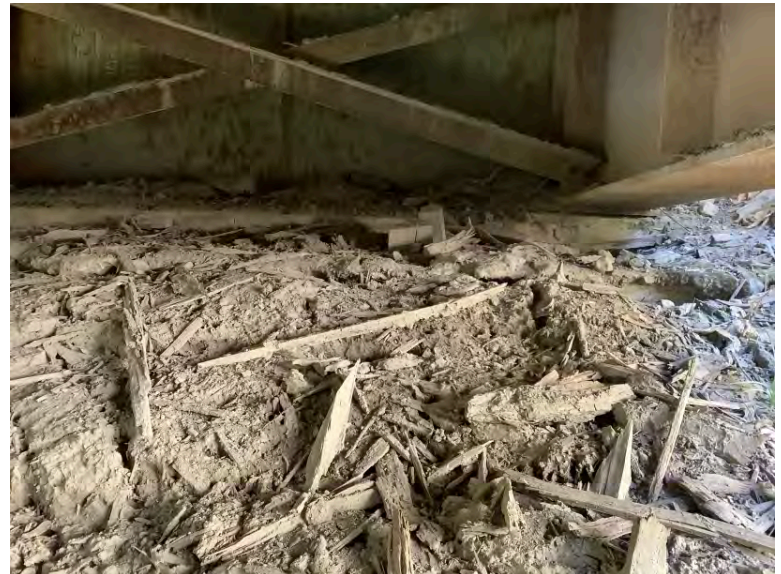
Bearing

Bearings Fair Some erosion under concrete on left bank
