SQ-3185  
SQ-3185

HIXON 6.9km

2022 Inspection

Crossing Name Belknap Creek

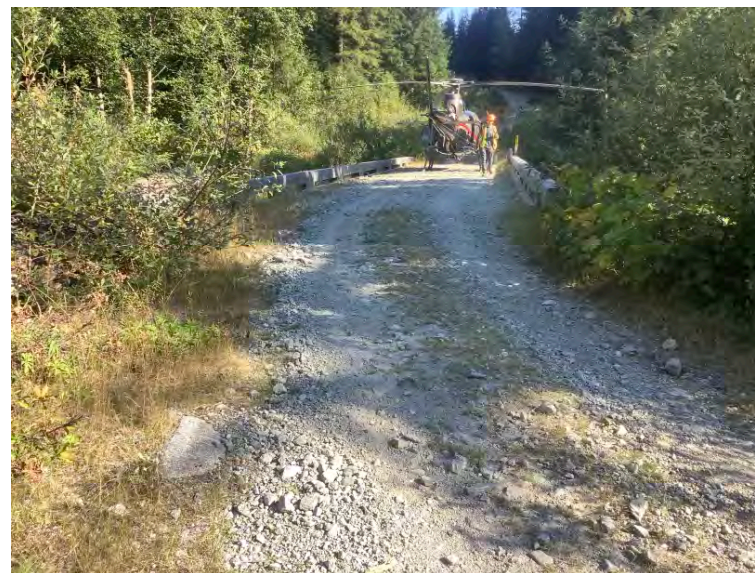
Approach from Right Bank when facing downstream

Substantial curve on river right approach

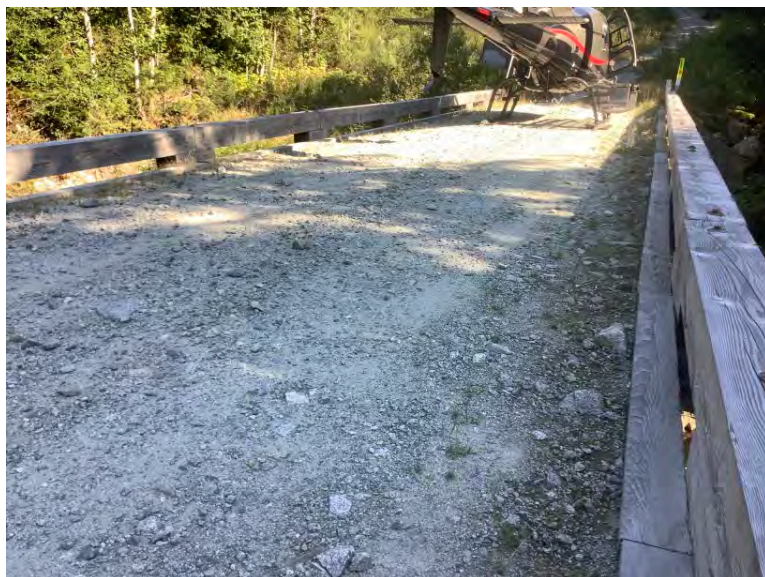
Overall Deck Condition      Good      Gravel over

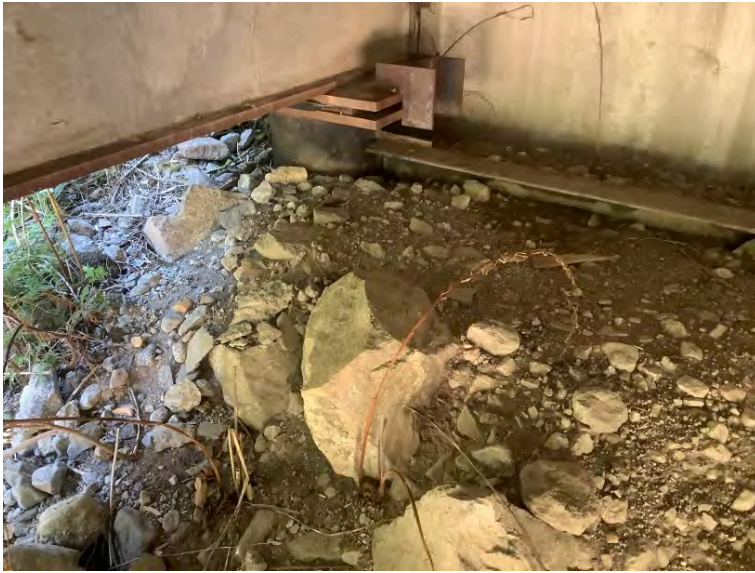
Bearing

Bearings Good
