## SPETCH CREEK 3.8km

2022 Inspection

Crossing Name Spetch Creek

Structure Class Temporary Bridge

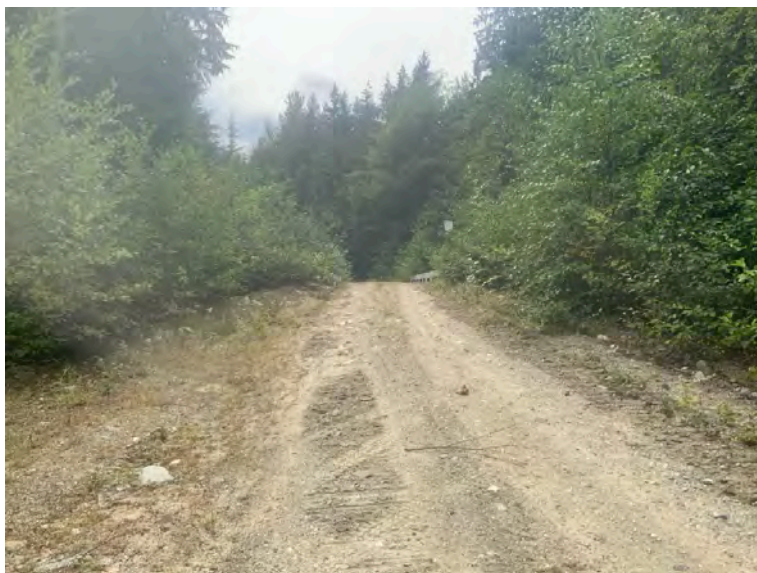
Approach from Right Bank when facing downstream

Fender Condition Fair

Logs, misaligned

| Repair Item | Repair Description |
|---|---|
| 3 Approach. Approach fenders (install). # of units. Priority:Medium | Install right bank ds |

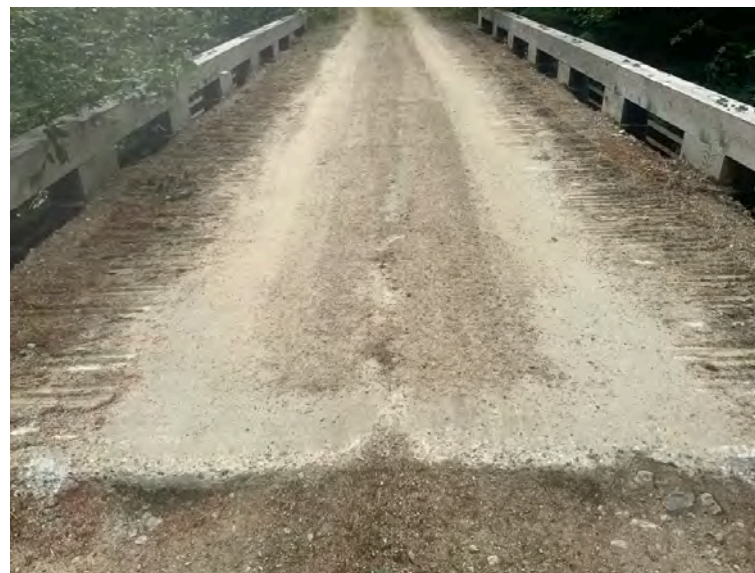
Concrete Deck      **Fair**      Surface wear

Curb Rail/Blocks/Posts      **Fair**      Wood rails. Solid

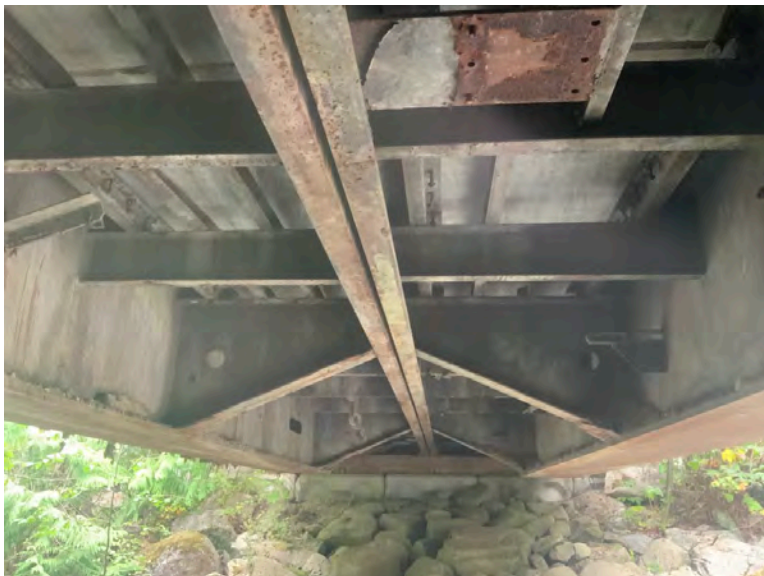
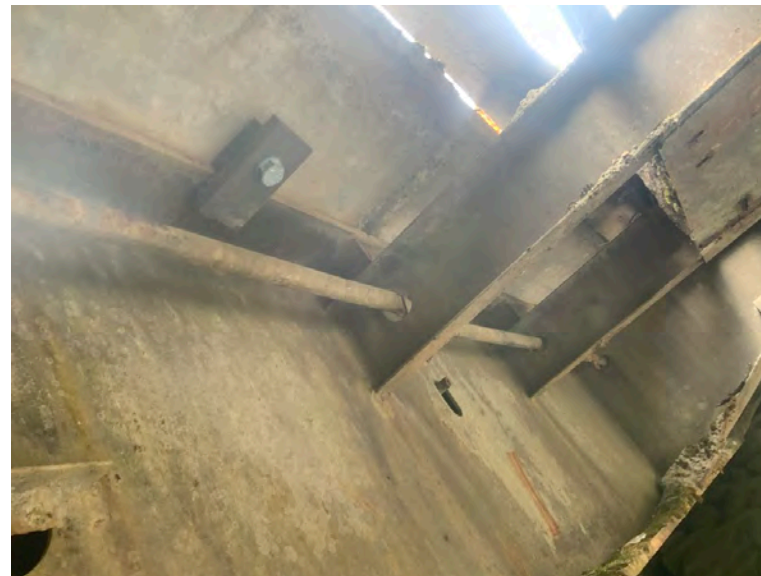
Superstructure

Girders Fair

Old rail car
