SQ-3197  
SQ-3197

LILLOOET WEST 58.7km

2022 Inspection

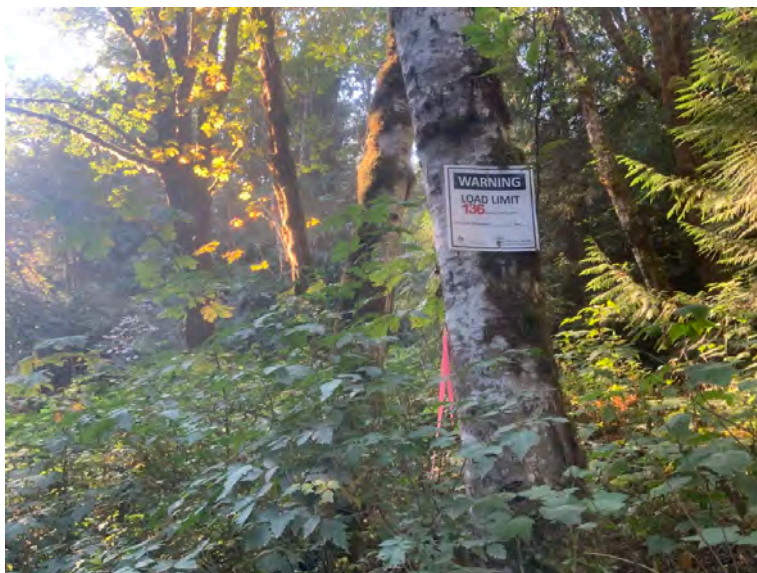
Load Rating Sign

Posted Load Rating **136**

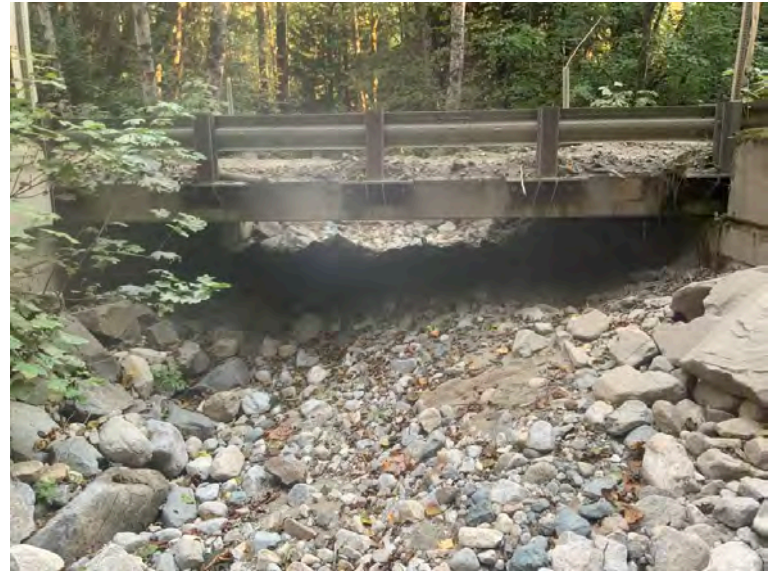
Upstream Profile

Comments Low clearance

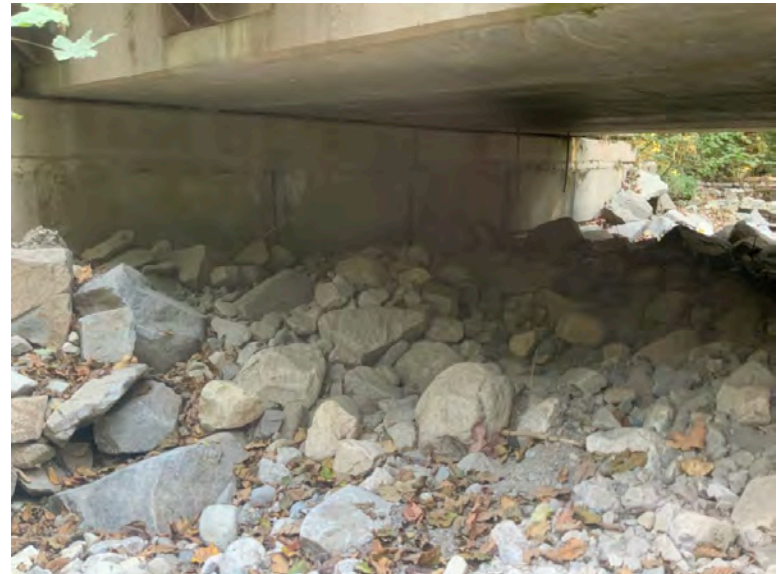
Left Bank Abutment when facing downstream

Left bank footing exposed. At risk of scour. Should add riprap, keyed in.

Riprap **Poor** Minimal both sides.

| Repair Item | Repair Description |
|---|---|
| 1 Channel. Add Riprap (placed). m³. Priority:High | Left bank riprap to be added |
