SQ-3199  
SQ-3199-A

## CHEAKAMUS/BLACKTUSK

2022 Inspection

Crossing Name Trib to Cheakamus River

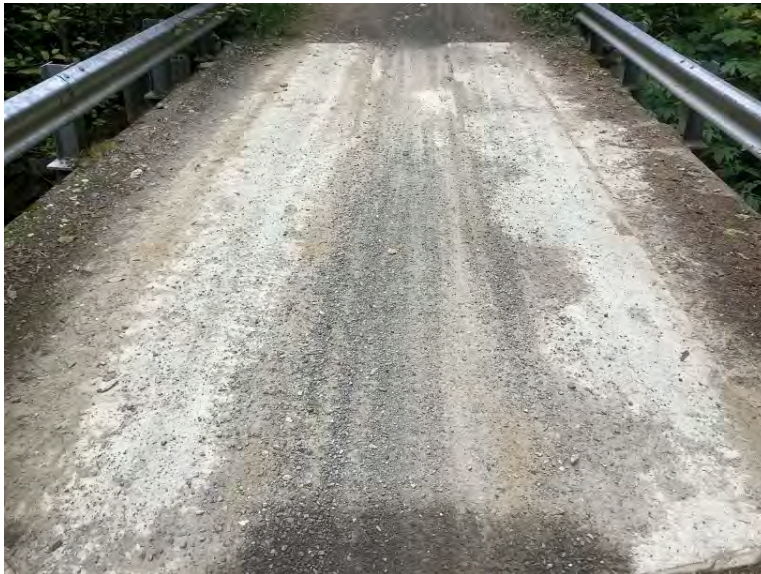
Deck

Fair

Some gravel on deck

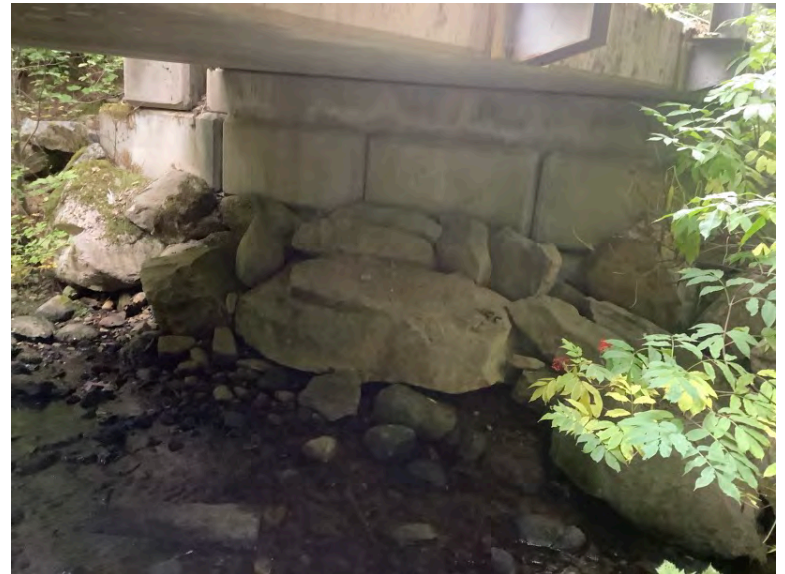
Left Bank Abutment when facing downstream

Ballast Wall Fair Lock blocks holding fill
