SQ-3202  
SQ-3202B

LILLOOET WEST 1.6km

2022 Inspection

Crossing Name 8 Mile Creek

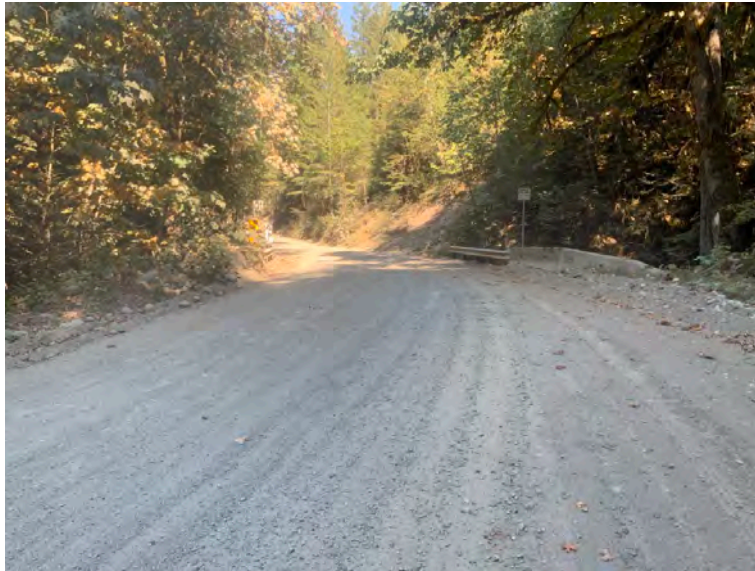
Approach from Left Bank when facing downstream

Delineator Missing  
Left ☐ 0 ☒ 1 ☐ 2

| Repair Item | Repair Description |
|---|---|
| 1 Approach. Add Warning Signs. 1 # of signs. Priority:High | Re-install delineator |

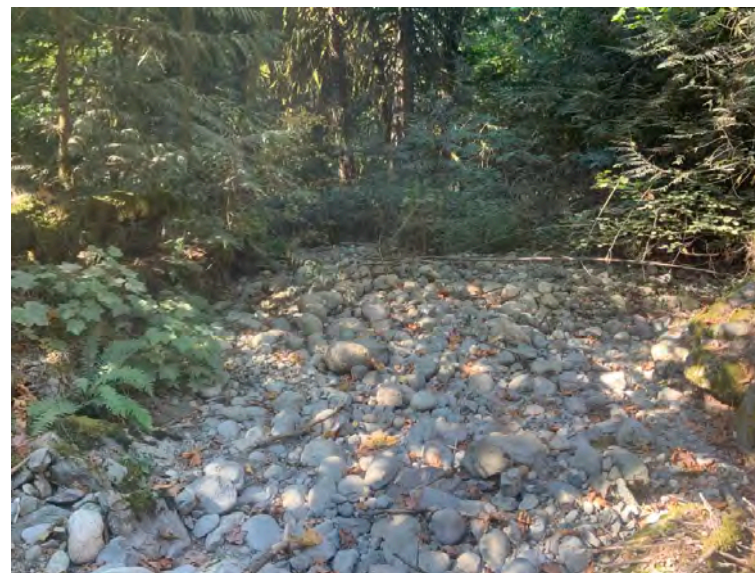
Downstream from Crossing

Comments Scour downstream from crossing
