SQ-3206  
SQ-3206B

## LEVETTE LAKE 2.1km

2022 Inspection

Crossing Name Evans Creek

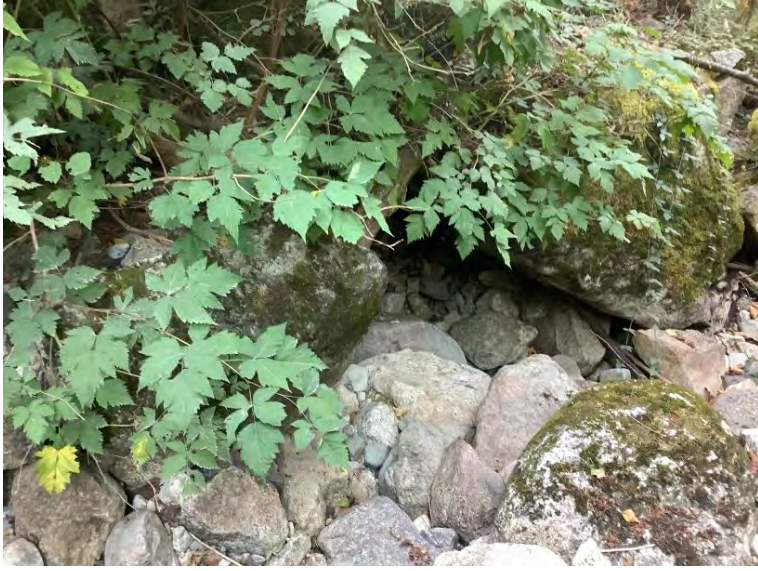
Riprap Good

1 Monitor downstream riprap for erosion.
