SQ-3212  
SQ-3212

CHEAKAMUS/BLACKTUSK 8.3km

2022 Inspection

Load Rated by: MOF, Greg Dohm, PEng., Oct. 14, 2022  
Load Rating: L75 or 68 tonnes  
Next Inspection: 2024  
Comments:

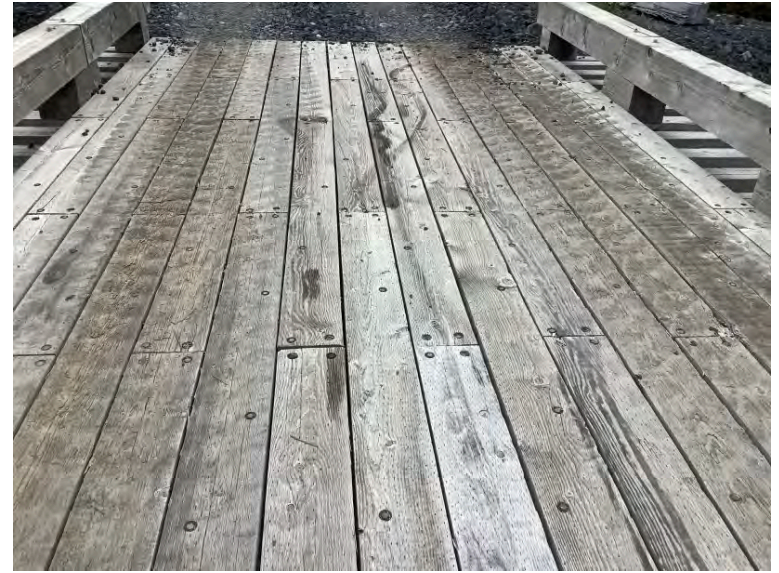
Deck to Girder Bolts      **Poor**      Lagged to old rotten decking. Not currently an issue.

Curb Rail/Blocks/Posts      **Fair**      Somewhat loose but not rotten. Low speed road.

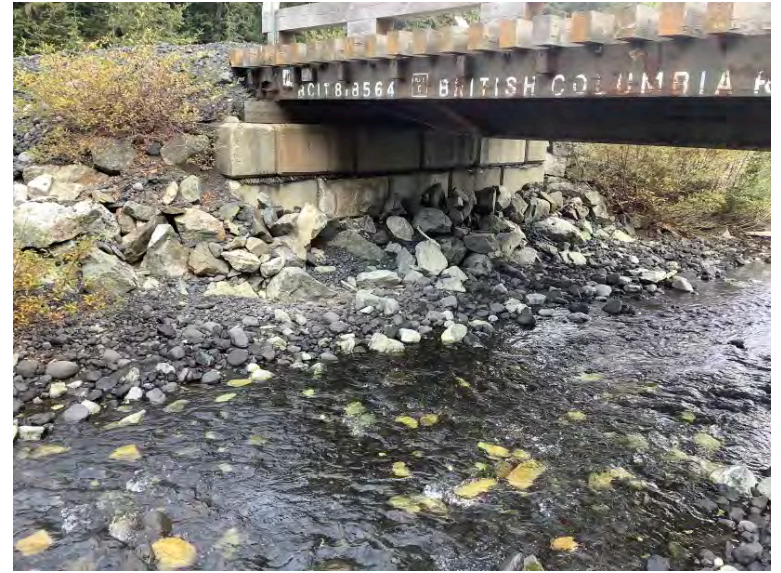
Left Bank Abutment when facing downstream

Concrete Good Geogrid installed

Caps or Sills Fair Two short Timbers notched into one long sill. Okay condition.

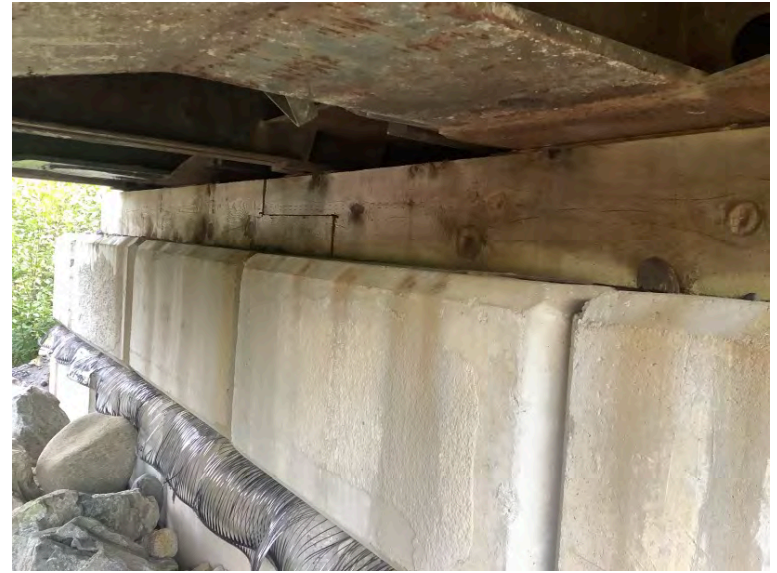
Bearing

Bearings Fair
