SQ-3213  
TCH-1202

SQ\_MAM1000 2km

2022 Inspection

Crossing Name Trib to Mamquam River

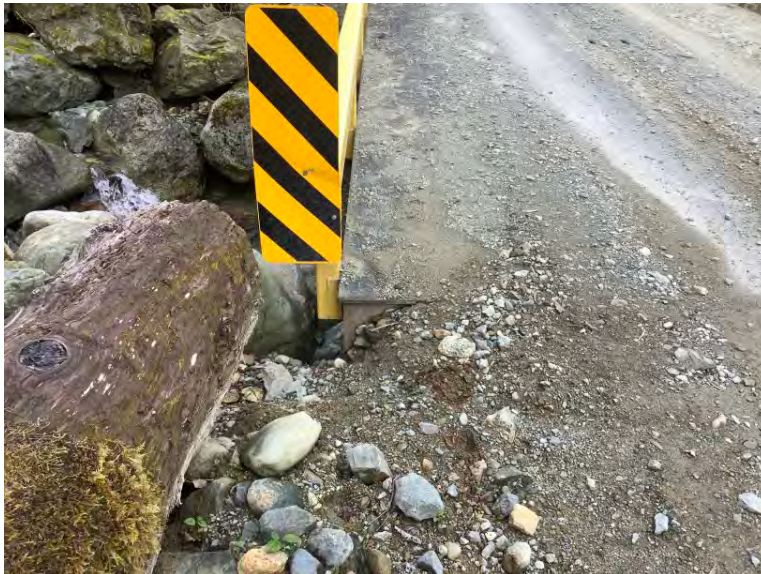
Ballast Wall Poor Not present or not functioning

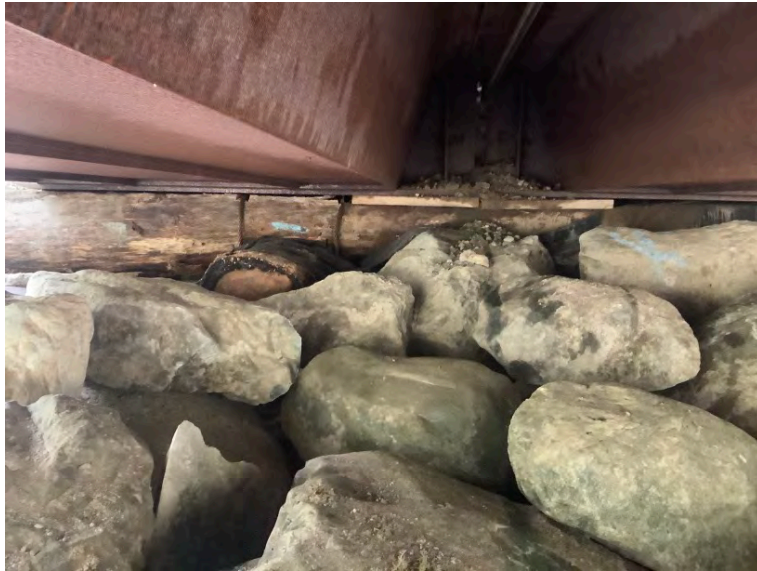
Right Bank Abutment when facing downstream

Log/Timber Cribs Fair Aging

Bearings Fair Shims functioning adequately

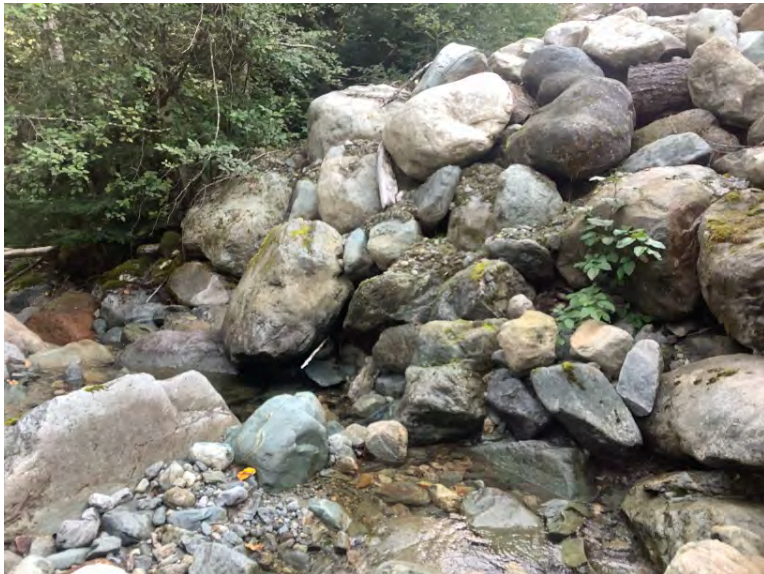
Right Bank Abutment when facing downstream

Riprap Fair

1 Monitor riprap for erosion
