SQ-3219  
SQ-3219

## MYSTERY CREEK 2.3km

2022 Inspection

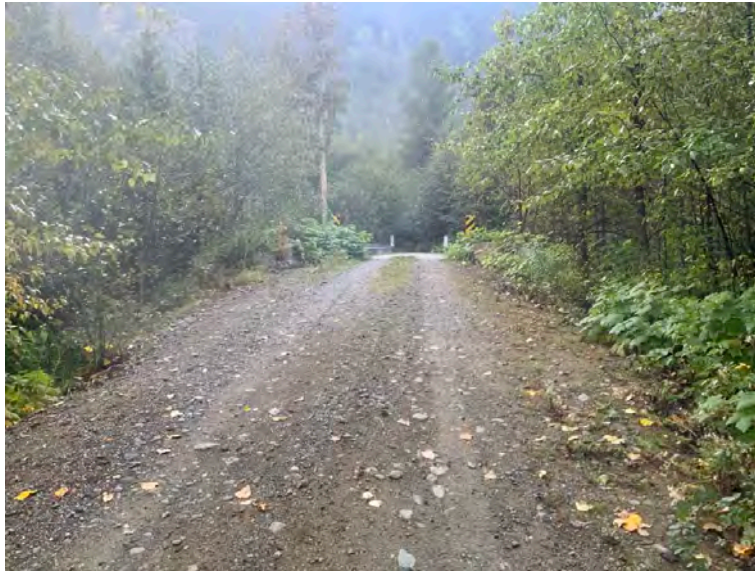
Approach from Left Bank when facing downstream

Bridge Ahead Signs  
Missing ☐ 0 ☐ 1 ☒ 2 Consider adding.

Road Surface **Fair** Low use, getting overgrown

| Repair Item | Repair Description |
|---|---|
| 1 Approach. Area/sight line brushing. m². Priority:Low | Brush approaches |
| 2 Approach. Bridge Ahead Signs. 2 # of signs. Priority:Low | When road brushed or opened to full width |

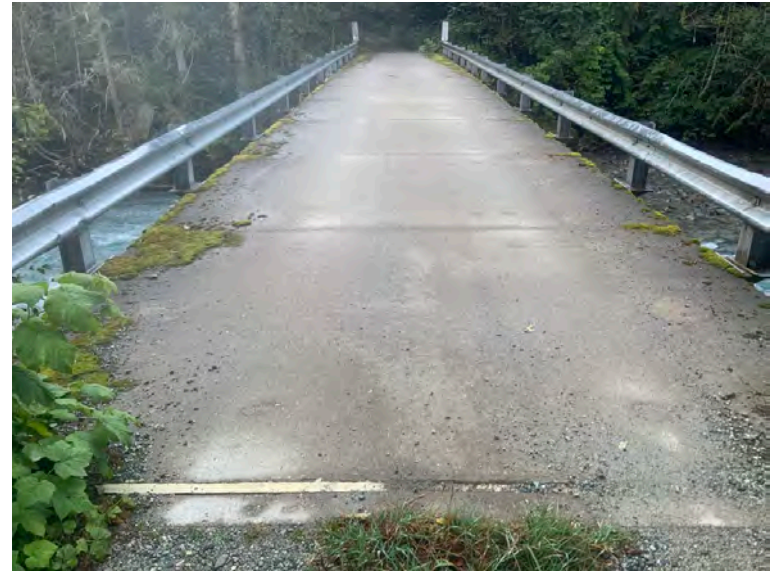
Deck

Running Surface      **Good**      Low use, getting overgrown

| Repair Item | Repair Description |
|---|---|
| 3 Structure. Clean Deck. # of delineators. Priority:Low | Clean fill and moss off deck |
