## SLOQUET CREEK MAIN 12.1km

2022 Inspection

Crossing Name Tributary to Sloquet

Structure Class Temporary Bridge

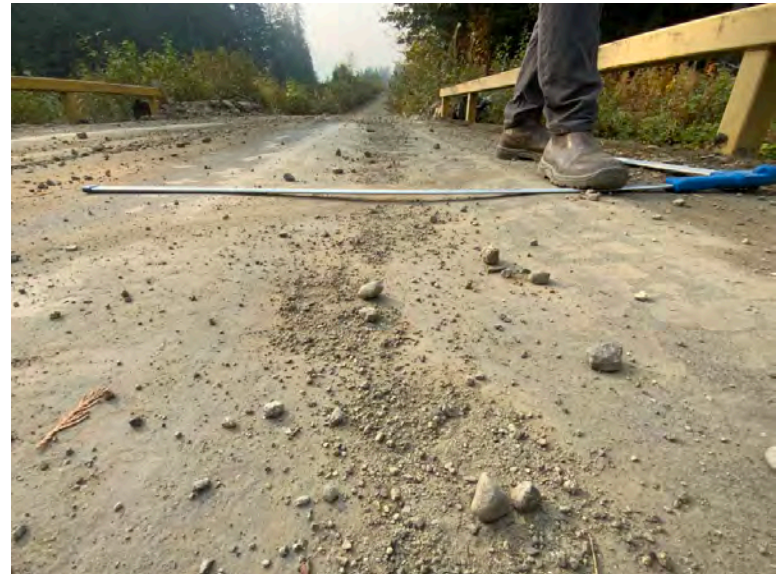
Steel Deck Plate Fair Steel buckling under wheel path bot sides

Steel plate between stringer boxes buckling likely due to overloads

Deck buckle under wheel track upstream.

| Item | Monitor Description | Frequency |
|---|---|---|
| 1 | Monitor buckling of steel deck under wheel path | Routine Inspection |

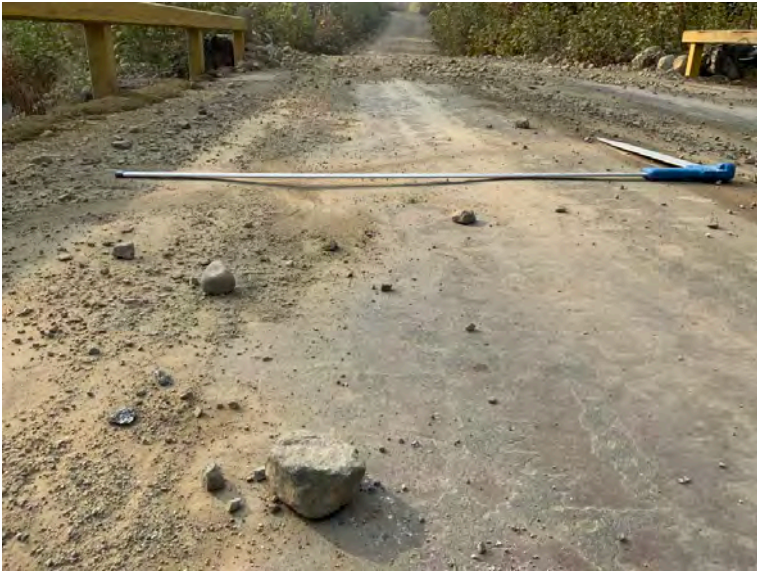
Deck buckle under wheel track downstream
