SQ-3221  
SQ-3221B

## SLOQUET CREEK MAIN 12.6km

2022 Inspection

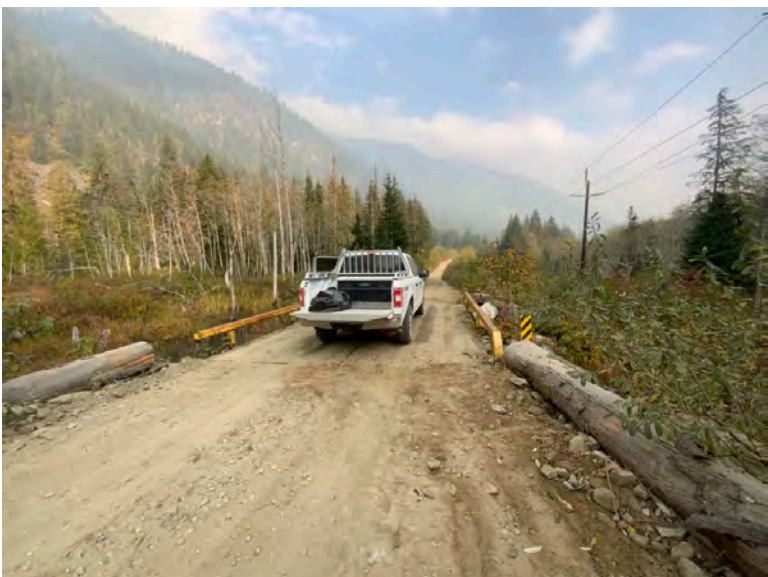
Steel Deck Plate Fair Anti skid worn out but fine for slow speed, flat road.

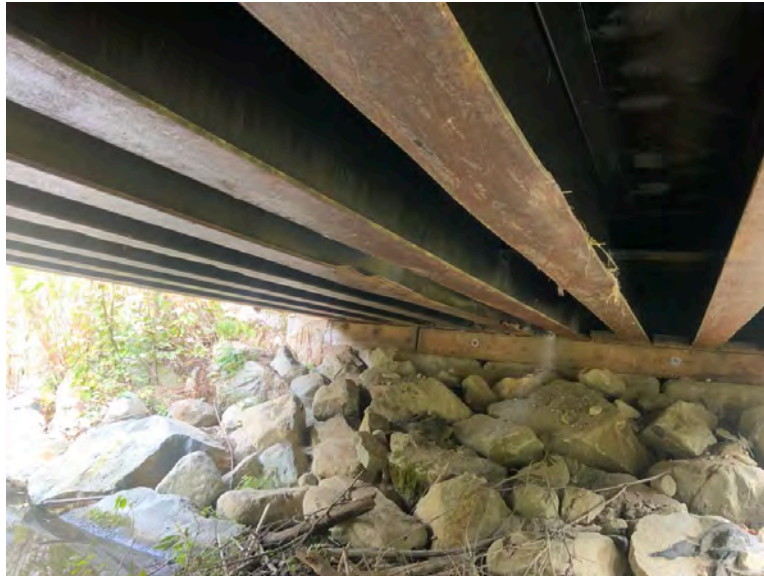
Girders Fair

Stringers, dents likely done during installation
