SQ-3224  
SQ-3224B

IN-SHUCK-CH 18.8km

2022 Inspection

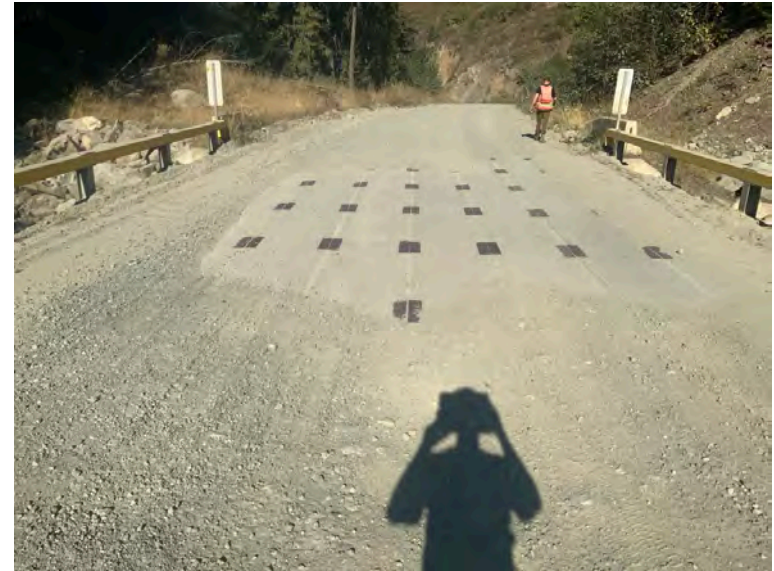
Concrete Deck      **Good**

Overall Deck Condition      **Good**

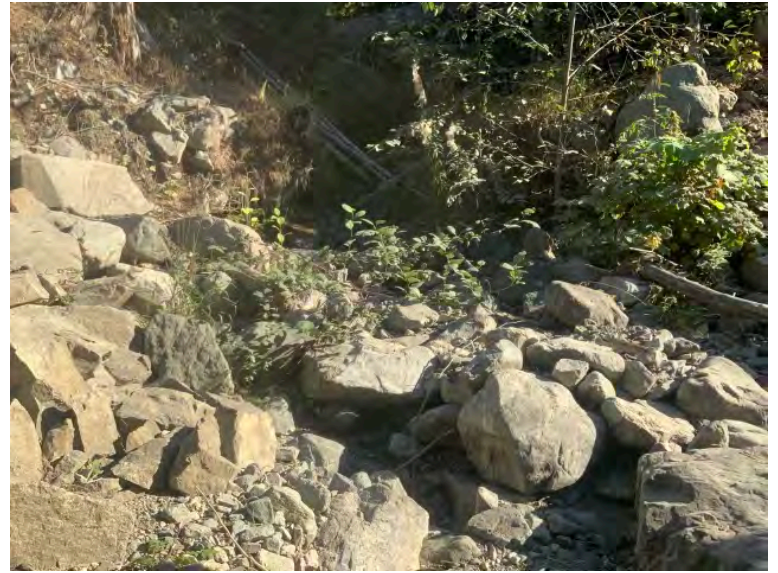
Upstream from Crossing

| Comments | Scour upstream from crossing | | | | |

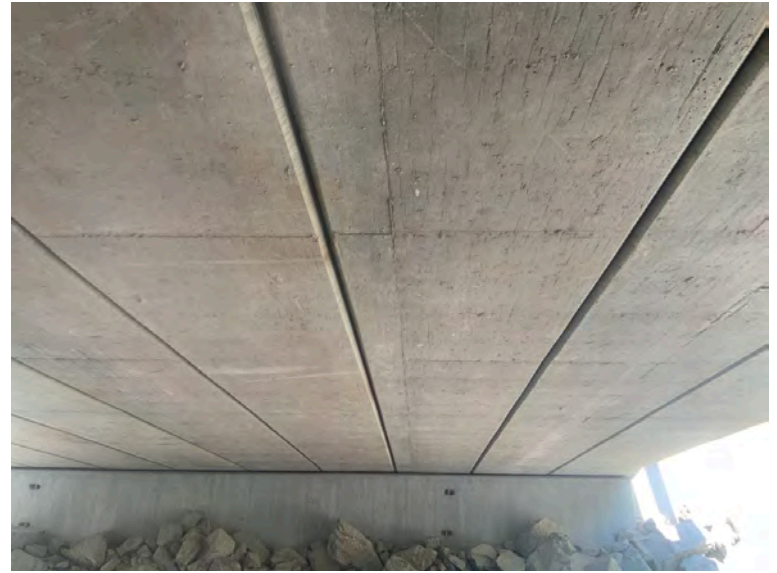
Superstructure

Girders **Good**
